Peace Building Inspection Ltd.

Property Inspection Report

9715 - 100th Street, Peace River, AB. T8S 1S8
Inspection prepared for: Tanya Bell (Town of Peace River, AB.)
Real Estate Agent: Layne Gardner - Re/Max Northern Realty

Date of Inspection: 4/9/2024 Time: 11 a.m. Size: 19,300 sq. ft.
Weather: Sunny
Building is 41 years old.

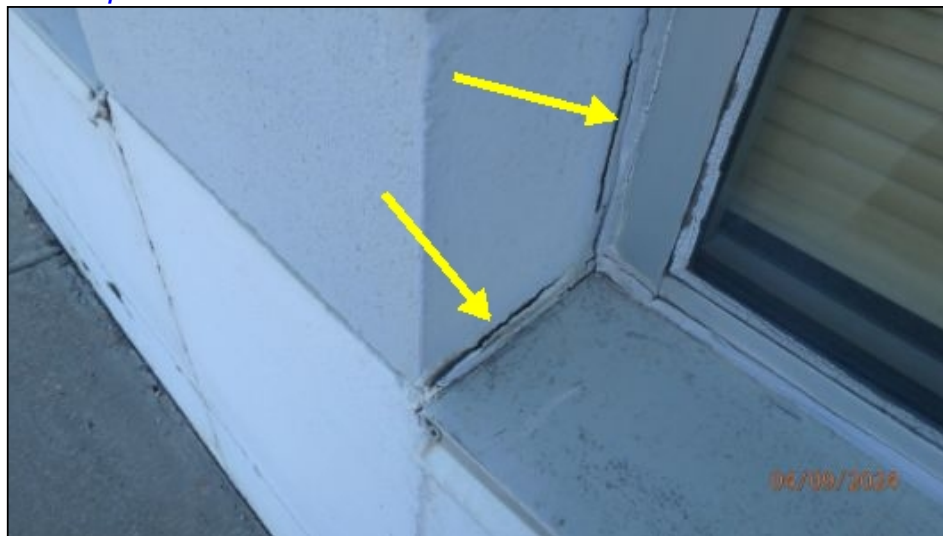
Sealant around windows was old, discoloured, cracked, and needed maintenance to avoid potential moisture intrusion. The Inspector recommends maintenance be performed by a qualified contractor.

Exterior window trim requires improved sealant to prevent leakage

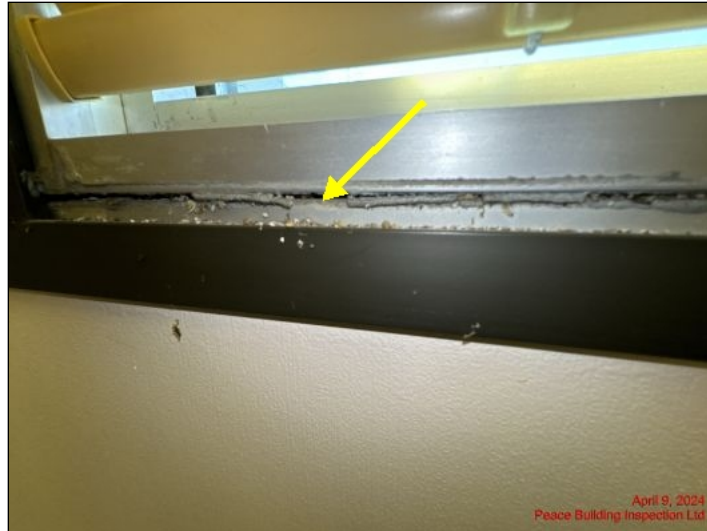
Window jambs in the building exhibited minor deterioration. Gaps in the interior jamb is allowing wall insulation to enter the building. Window sealant improvement recommended.

Vermiculite insulation is entering building around the windows. All interior window trim requires sealing

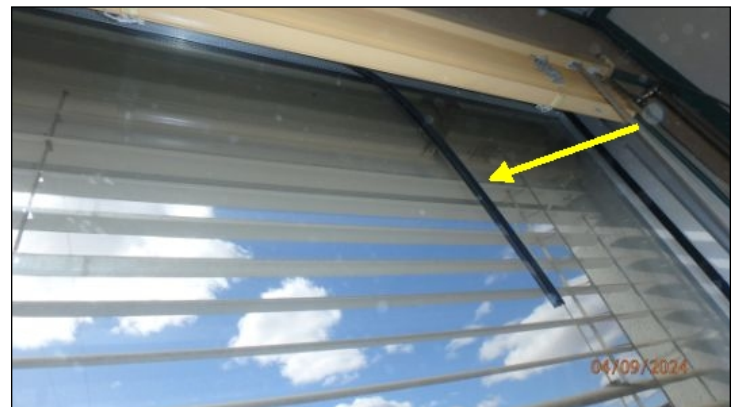
Although no condensation was visible at the time of the inspection, several windows basement indicated a loss of thermal integrity. The seal gasket was visible in the window. The Inspector recommends that you consult with a qualified contractor to discuss options and costs for repair or replacement of any window with exposed loose seals.

A few window seals have failed

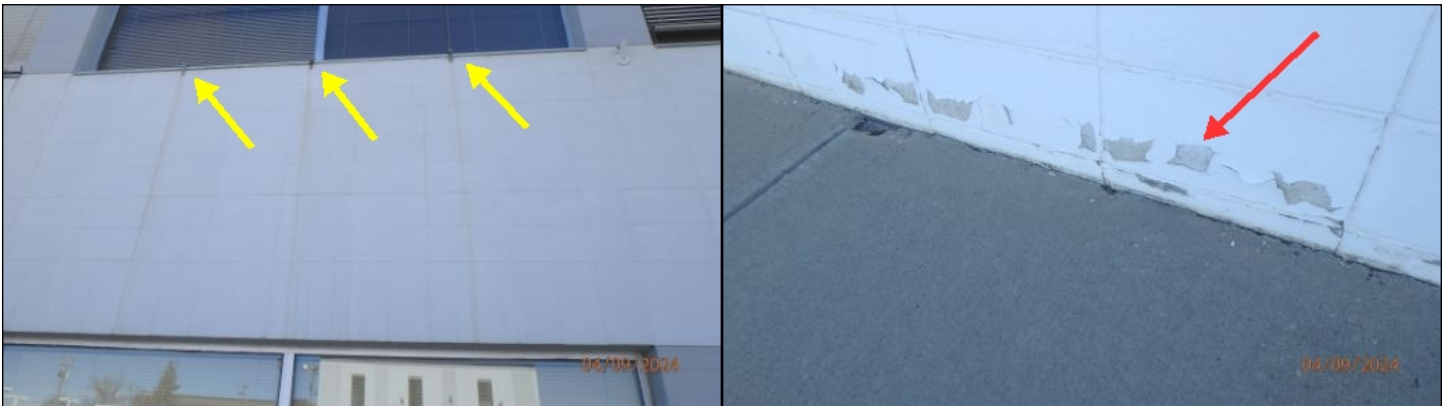
Rust stains at walls due to exterior window blind bracket fasteners that are rusting. Replacement with stainless steel fasteners will eliminate rusting. Wall painting recommended once repairs are completed.

Exterior walls requires some scraping and painting to protect the concrete block walls

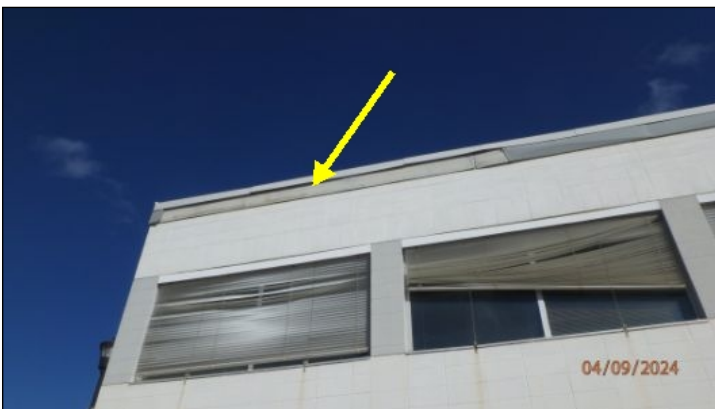
Fascia was missing in places and needed or replacement. All work should be performed by a qualified contractor.

Southwest corner of building is missing a 10 foot section of fascia

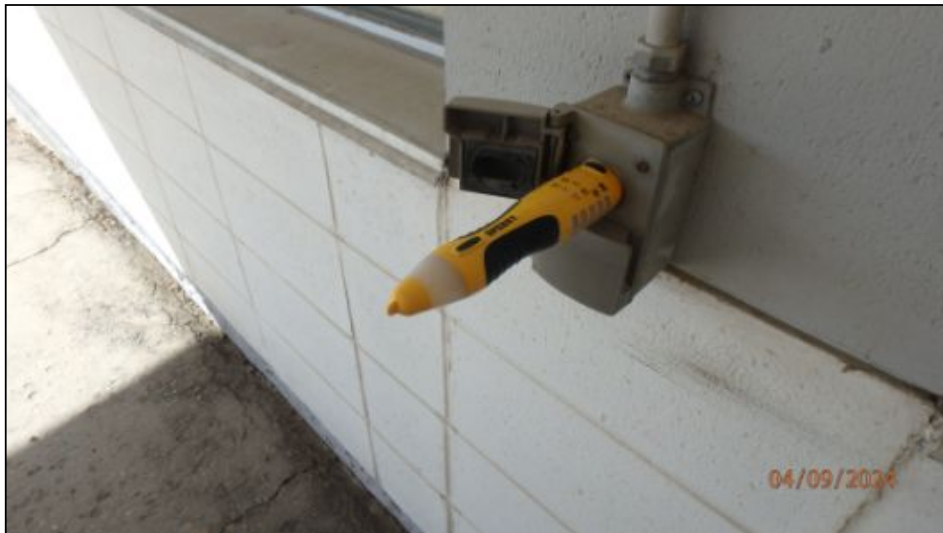
One or more exterior electrical receptacles did not have any power when tested. Further investigation and repair by a qualified electrician is recommended.

The exterior electrical receptacles at the rear of the building do not have Ground Fault Circuit Interrupter (**GFCI**) protection at the time of the inspection. This was not required when the structure was built but is a recommended upgrade.

Power to exterior outlets was shut off at time of inspection. Upgrade to GFCI outlets recommended

For safety reasons, the Inspector recommends that all exterior electrical receptacles be provided with GFCI protection in good working order to avoid potential shock or electrocution hazards. This can be achieved by:

1. Replacing the current standard receptacles with GFCI receptacles.
2. Replacing the electrical circuit receptacle located closest to the main electrical service panel with a GFCI receptacle.
3. Replacing the breaker currently protecting the electrical circuit that contains these receptacles with a GFCI breaker.

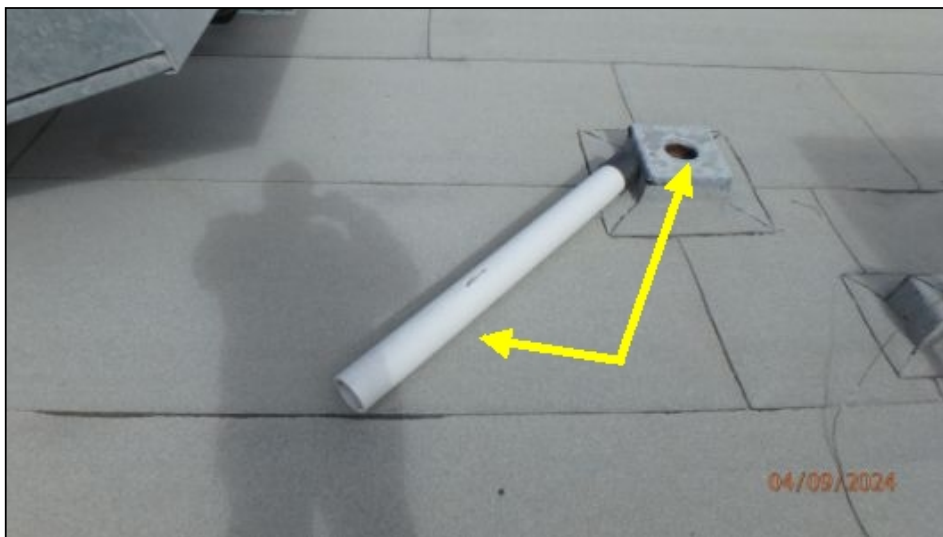
A plumbing vent pipe serving the drain, waste and vent system had inadequate clearance above the roof. One vent pipe extension was disconnected.

One plumbing vent stack needs to be attached

To help ensure that they perform according to their design, plumbing vent pipes need to be installed above the level of anticipated snow accumulation. The Inspector recommends correction by a qualified plumbing contractor.

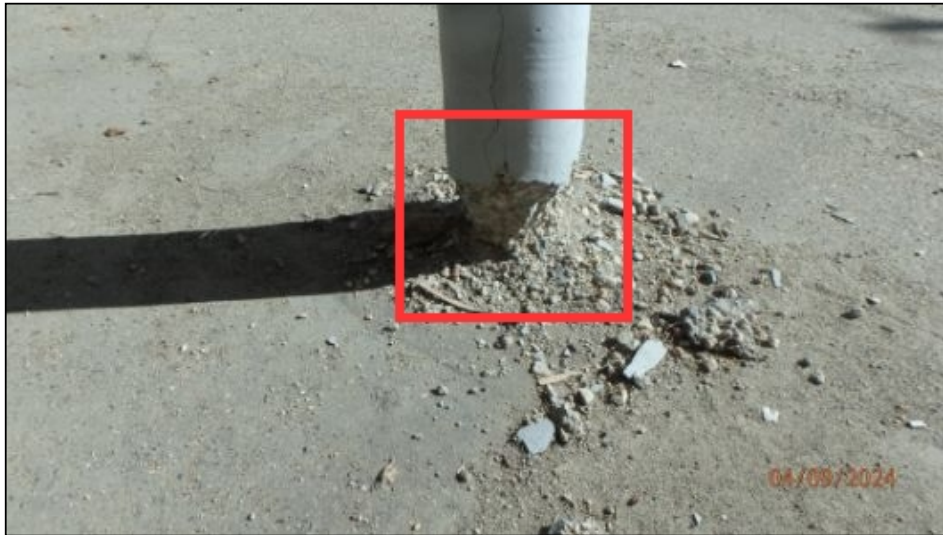
The rear building extension over the parking lot had a steel piling foundation. The steel pilings are encapsulated inside a concrete tube to prevent corrosion. One piling has concrete that has spalled away thus exposing the steel piling to the elements. This piling needs repair at the base to ensure the steel is not exposed to the elements. Further investigation and repair by a qualified contractor is recommended.

Rear structure pier has concrete around the steel support piling. Concrete repairs recommended

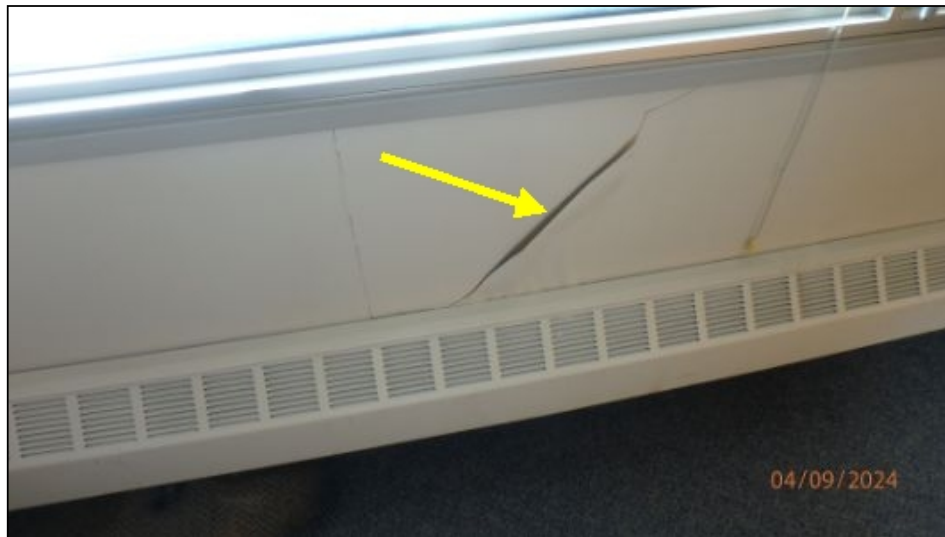
Interior walls in the building exhibited general minor damage or deterioration at the time of the inspection.

Room #245 has some minor wall damage that requires repair before painting

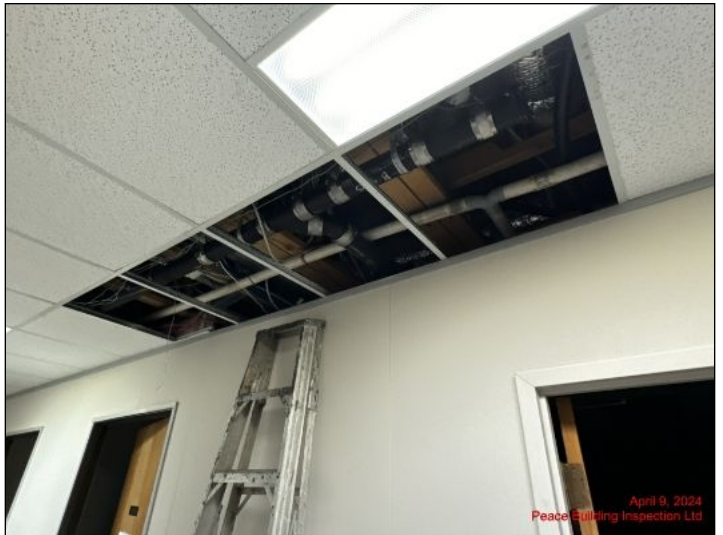
Damaged or missing ceiling tiles from past leakage repairs

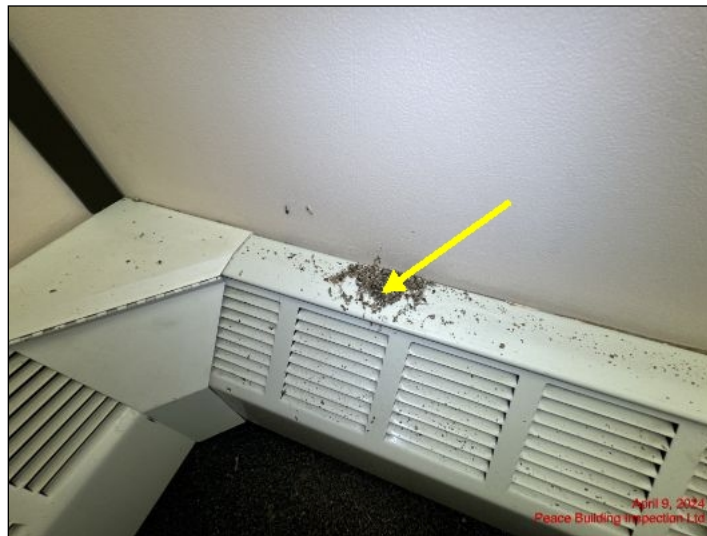
The visible insulation is entering the building around window seals. If the window trim is properly sealed there is no likelihood of insulation entering the building. Further investigation and repair by a qualified contractor is recommended to seal the windows and remove any loose visible vermiculite insulation.

Concrete block walls are insulated with vermiculite which may contain asbestos

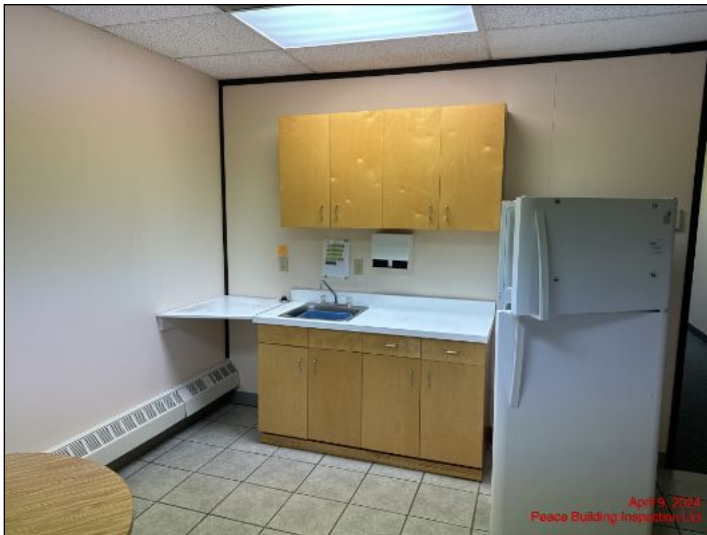
Lower level kitchen/Break Room sink requires repairs

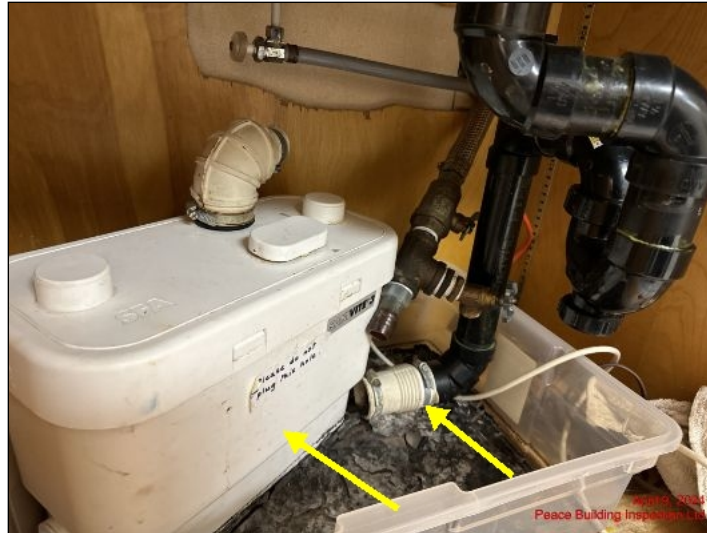
Lower level kitchen sink drain and pump were not operational at time of inspection. The Inspector recommends repair by a qualified plumbing contractor.

Lower level kitchen/break room sink drain was disconnected and lift pump could not be tested

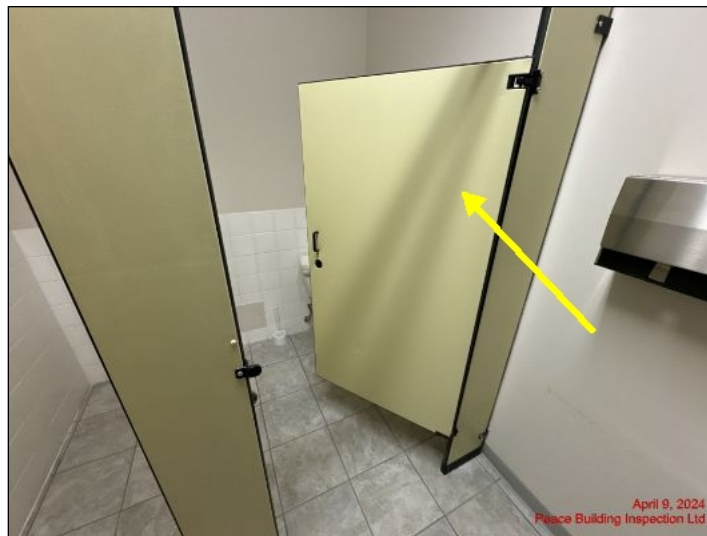
At the time of the inspection, one ore more bathrooms exhibited general minor wear and deterioration commensurate with the age of the building. One bathroom stall door is very loose at the hinge and requires repairs.

One lower level bathroom door is very loose at hinge

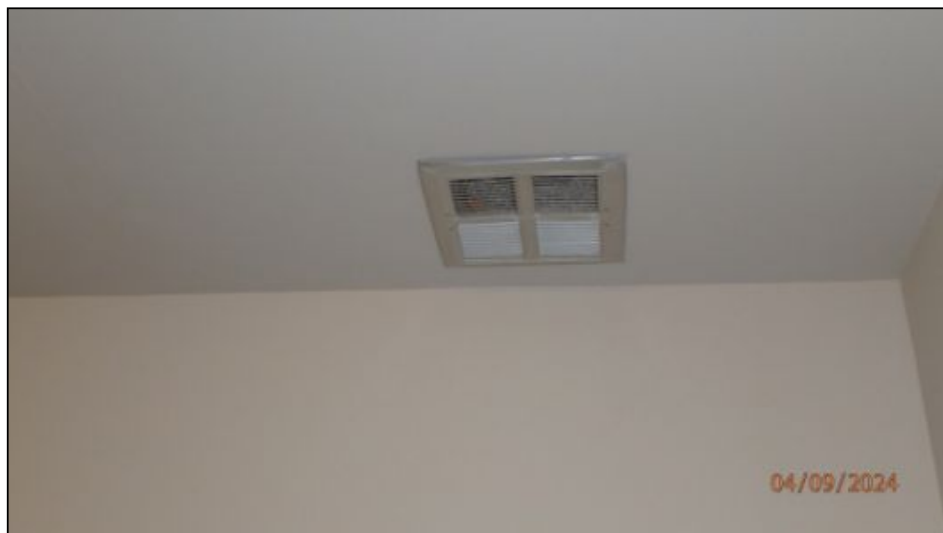
One or more bathroom exhaust fans were excessively noisy at the time of the inspection and may need to be replaced soon. All work should be performed by a qualified contractor.

One upper level bathroom ventilation fan (near room #205) was noisy during operation

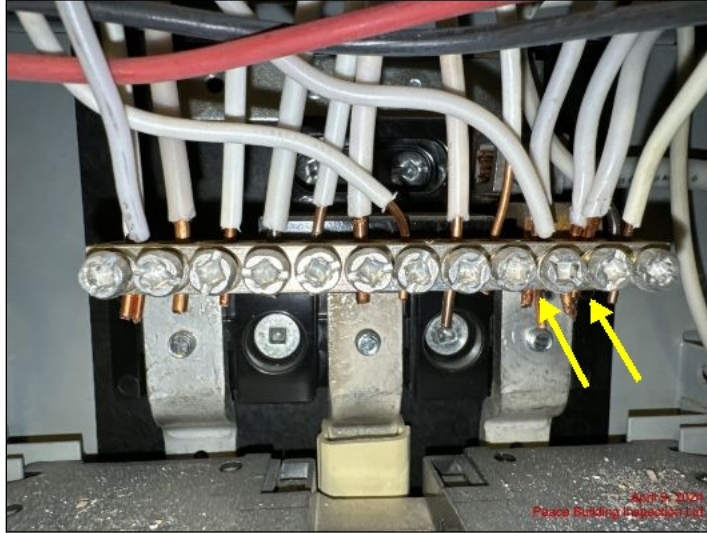
The reason that two neutral wires can't be connected to a single terminal in a service panel is so that the circuit can be isolated if it needs to be worked on, there is also a possibility the connections might come loose, which could lead to a fire. Although this condition may have been present for many years, the inspector recommends correction by a certified electrical contractor.

Some service panels have double lugging at the neutral bus bar. Further investigation and repair recommended

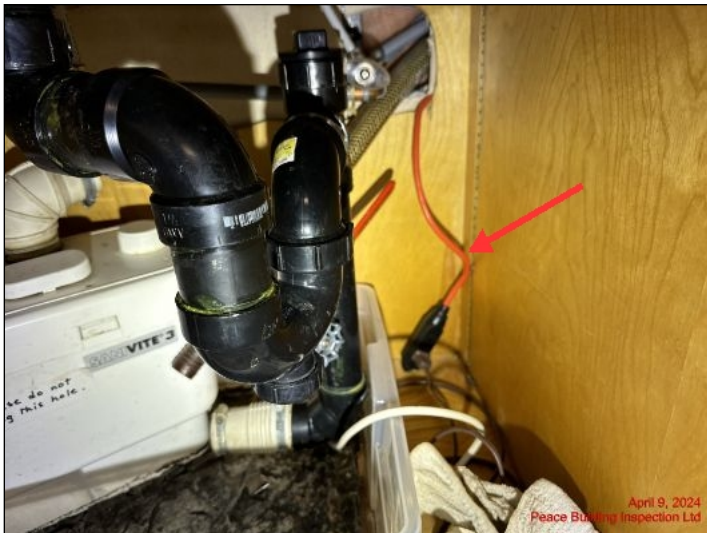
Extension cord used as permanent wiring was visible at the lower level kitchen. This condition is a potential fire hazard. The Inspector recommends that any such wiring be removed and replaced with properly installed, approved wiring by a qualified contractor.

Extension cord used for permanent wiring under lower level kitchen sink drain lift pump

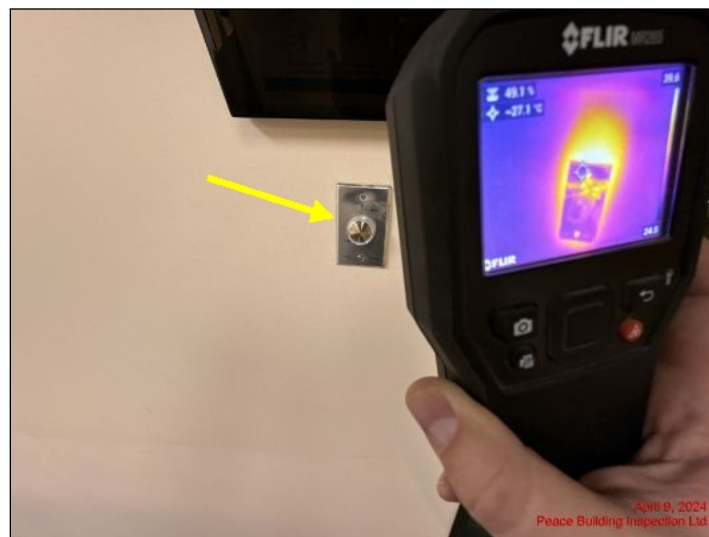
A switch in one room exhibited visible overheating to the touch. This switch was further examined with a Flir thermal camera indicating excessive heat. This condition is a potential fire hazard and should be investigated and any repairs made by a qualified electrical contractor.

Light switch in room #139 was very hot at time of inspection. Replacement recommended

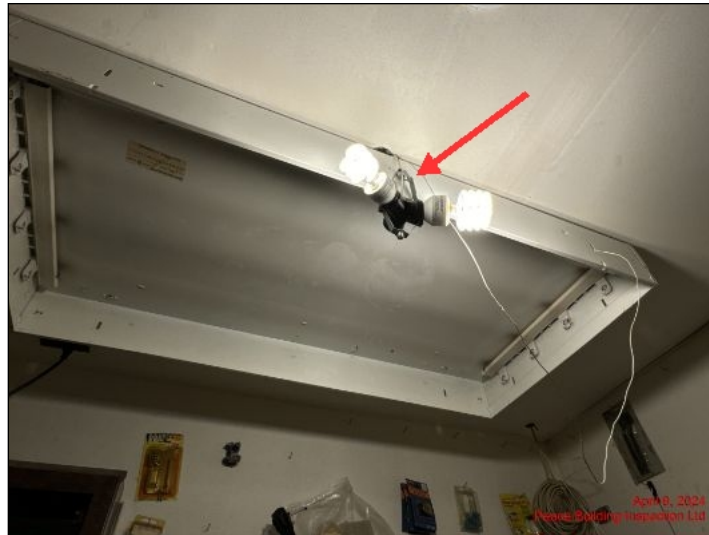
Poor light ballast installation observed at lower level maintenance shop

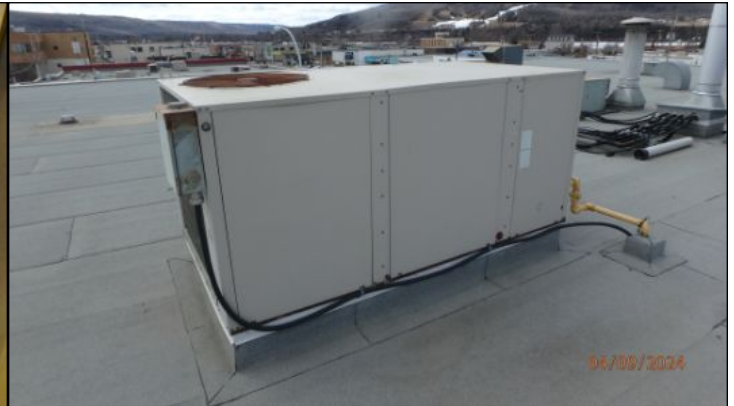
Building is equipped with an older HVAC unit. Unit label was missing. Inspector unable to determine age. Further investigation recommended for this unit

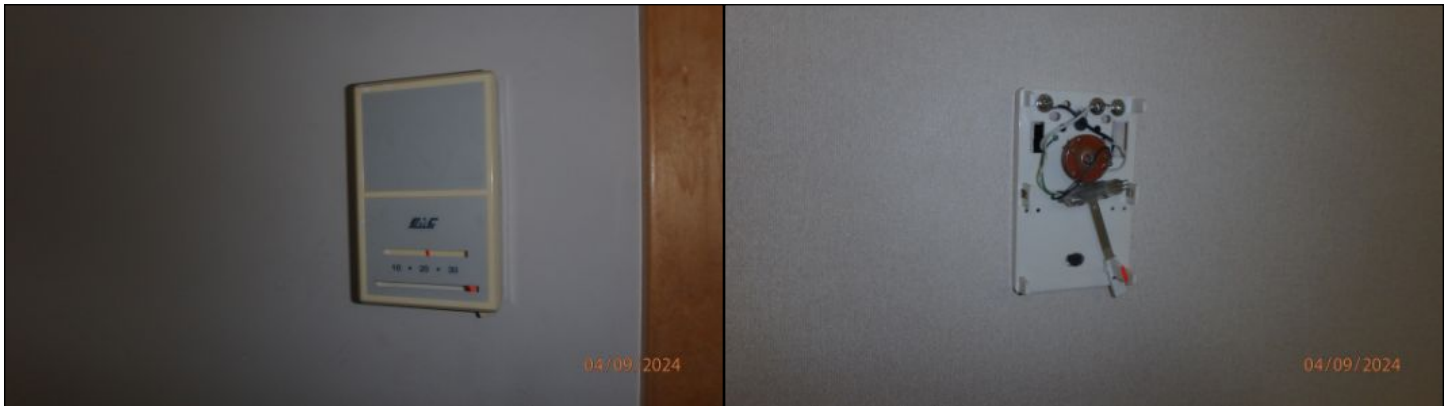
Several thermostat were set at 30 degrees but no heat provided to the room. This typically indicates zone valve failure at this location

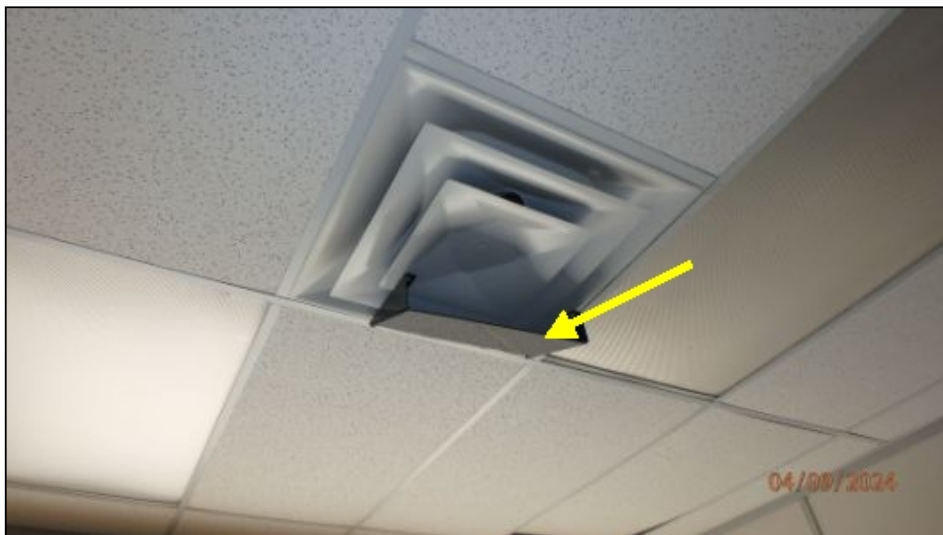
Room #234 has a metal deflector at ceiling that could fall and cause injury

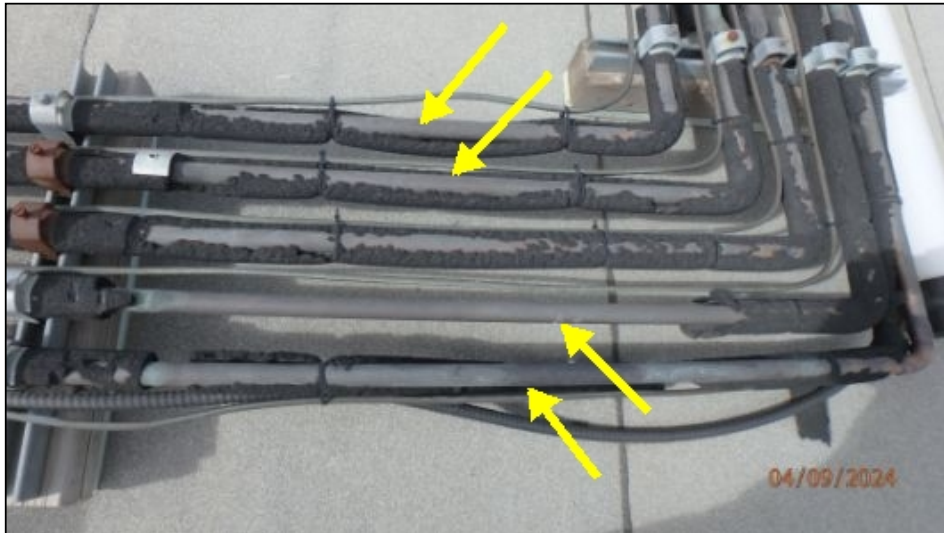
Most refrigerant lines have damaged or missing insulation

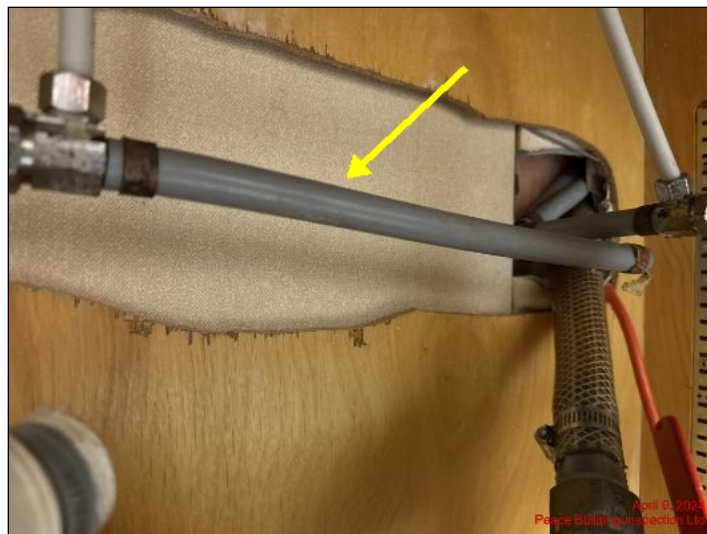
Building is equipped with Poly B water supply lines that are prone to leakage. Replacement recommended

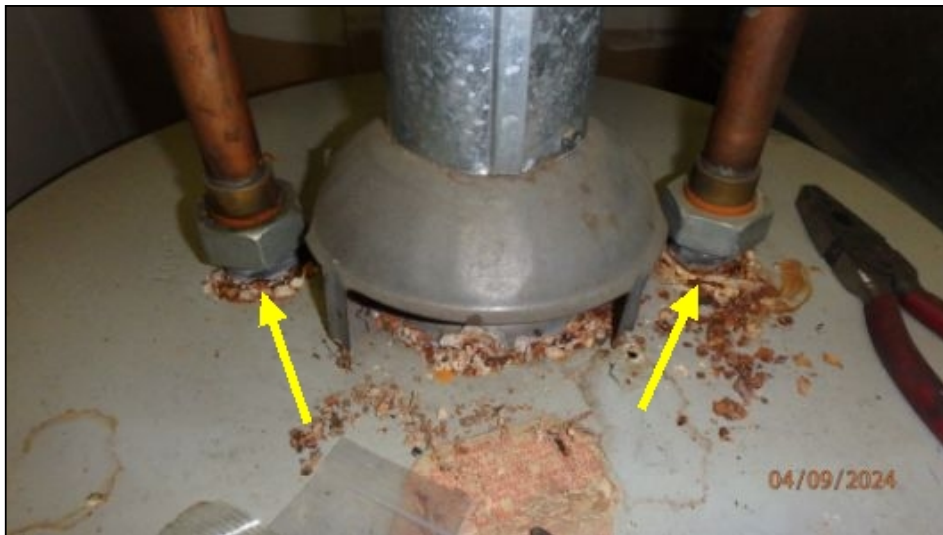
Water heater pipe connections are severely corroded. Tank replacement recommended

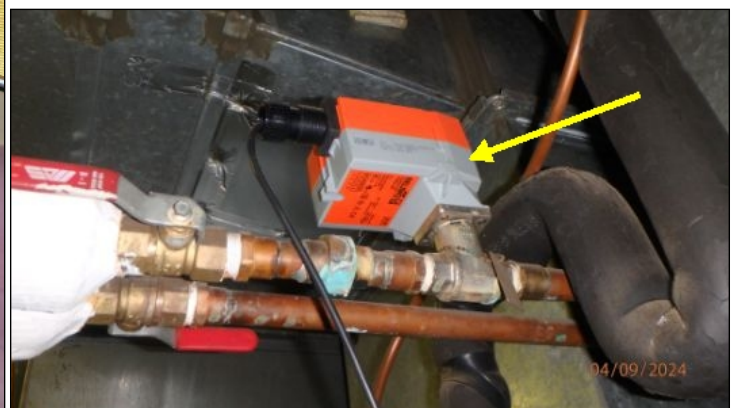
Some baseboard heaters had no heat at time of inspection. Some zone valves likely need replacement

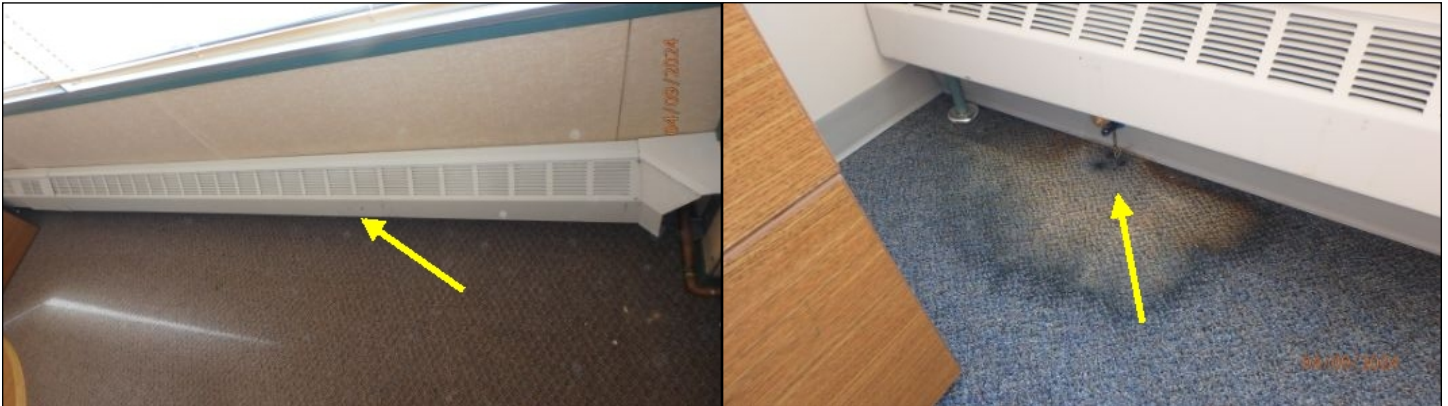
Several radiant baseboard heaters did not provide heat. Further investigation recommended

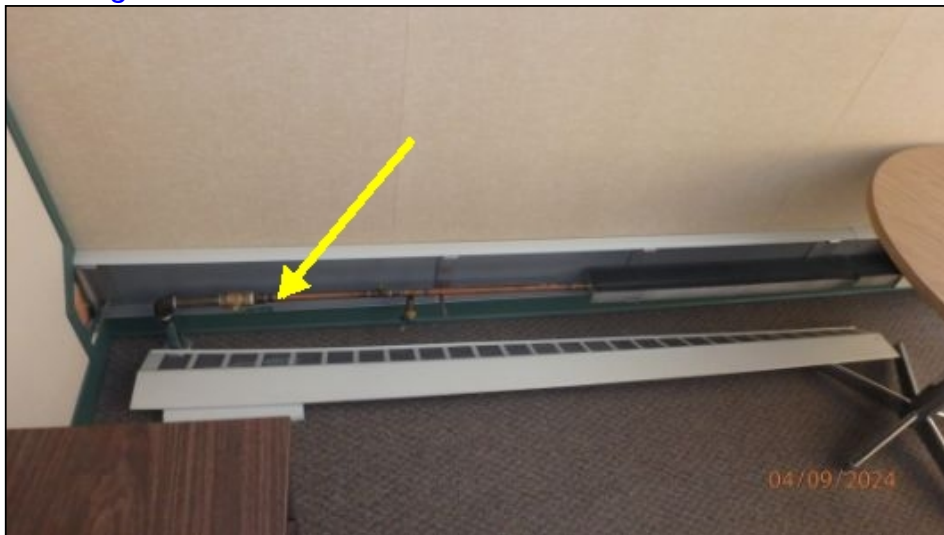
Repair any baseboard radiant heater covers that are damaged or missing
