Peace Building Inspection Ltd. Property Inspection Report

9911 - 100th Street, Peace River, AB.

Inspection prepared for: Tanya Bell (Director of Community Services)

Date of Inspection: 7/16/2024 Time: 11 a.m. Size: 16,500 sq. ft.

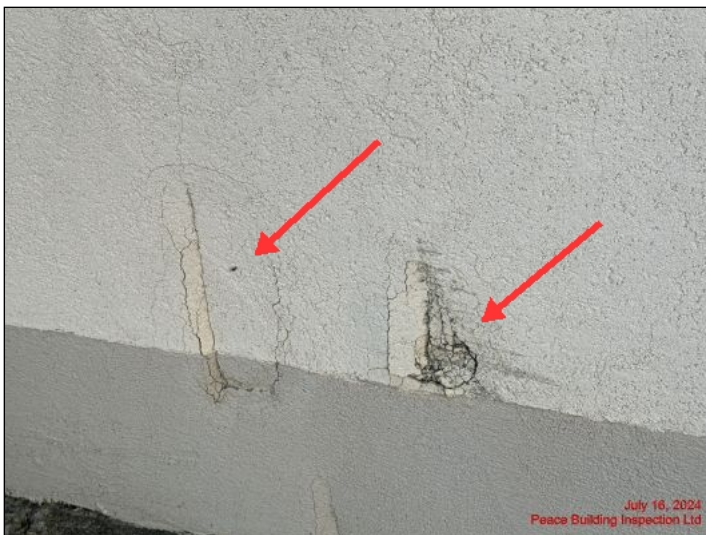
Stucco covering exterior walls of the building had minor damage visible at the time of the inspection.

Some minor stucco damage observed at the lower portion of the building *Exterior synthetic stucco in mostly good condition at time of inspection*

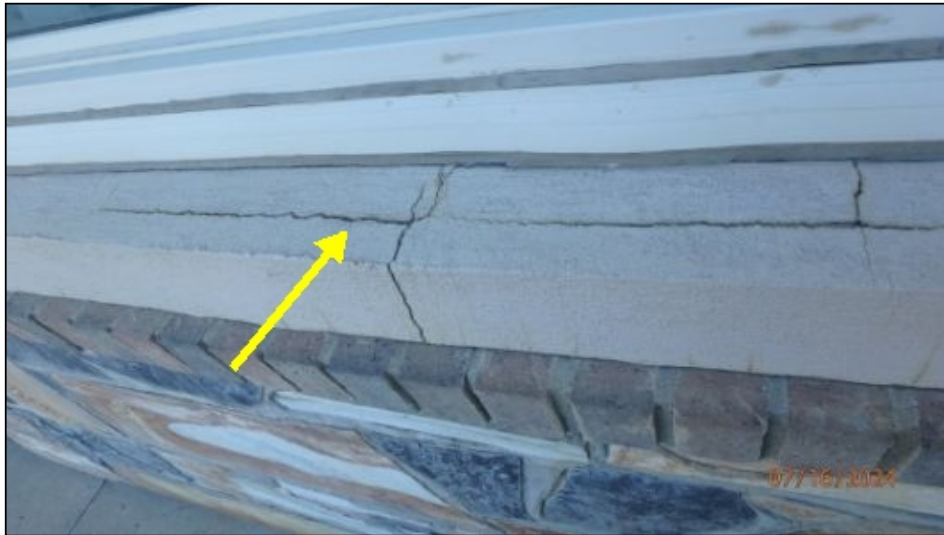
The stucco covering exterior walls showed moderate cracking at the windows. This type of cracking, called "thermal cracking" is a reaction to internal stresses created by stucco expansion and contraction caused by daily and seasonal temperature changes. This condition is made worse over time by exposure to freezing moisture. Cracks of this size should be filled with an appropriate material sealant to minimize future damage from moisture penetration. Thermal cracking is common as stucco ages and minor cracks are a cosmetic concern. This type of cracking can be expected to continue slowly over time.

Stucco is cracked at front window locations. These areas require sealant to prevent moisture damage

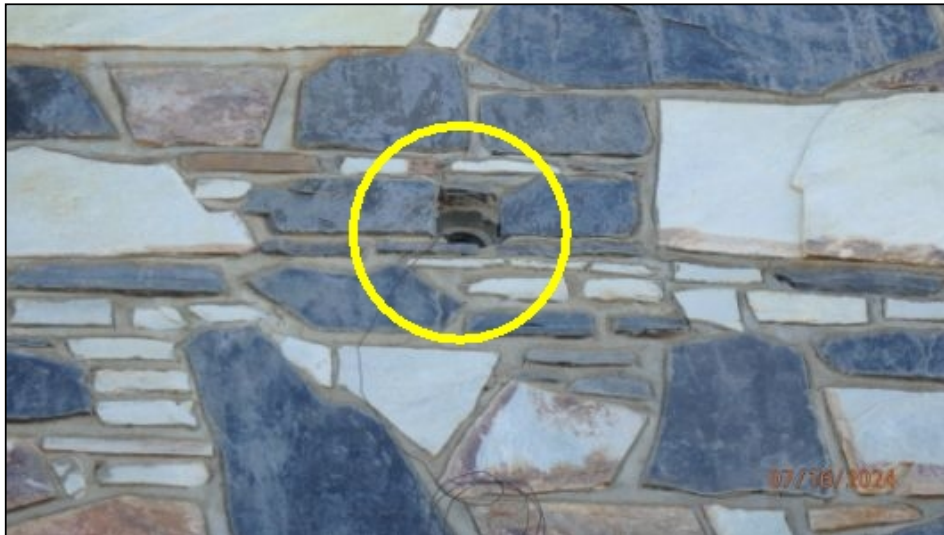
One or more vent covers have damaged or missing screens. This allows bird, insect or vermin entry into the building. Installation of vent screens by a qualified contractor is recommended.

All exterior wall vents require screens to prevent bird entry

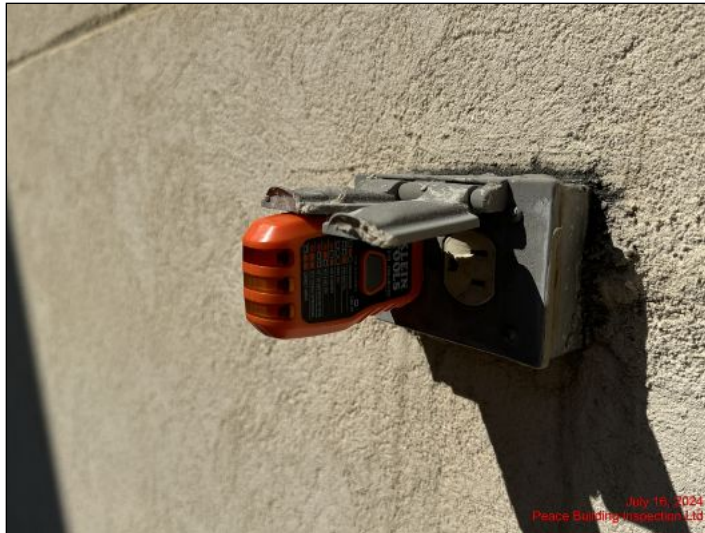
One or more exterior electrical receptacles did not have any power when tested. Further investigation and repair by a qualified electrician is recommended unless the power was simply shut off at the breaker panel.

Exterior outlets did not have power when tested

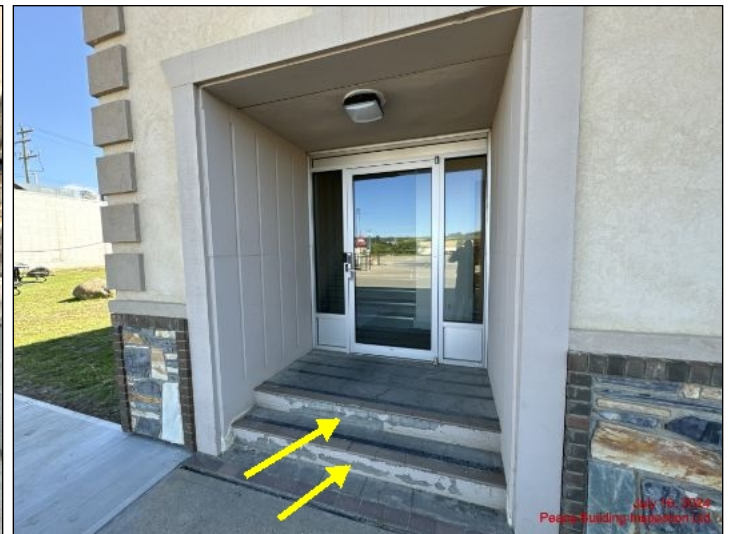
Stair stringers in good condition at time of inspection. One set of stairs has minor paint peeling and needs maintenance for aesthetic reasons only.

Some minor stair maintenance recommended at front of building

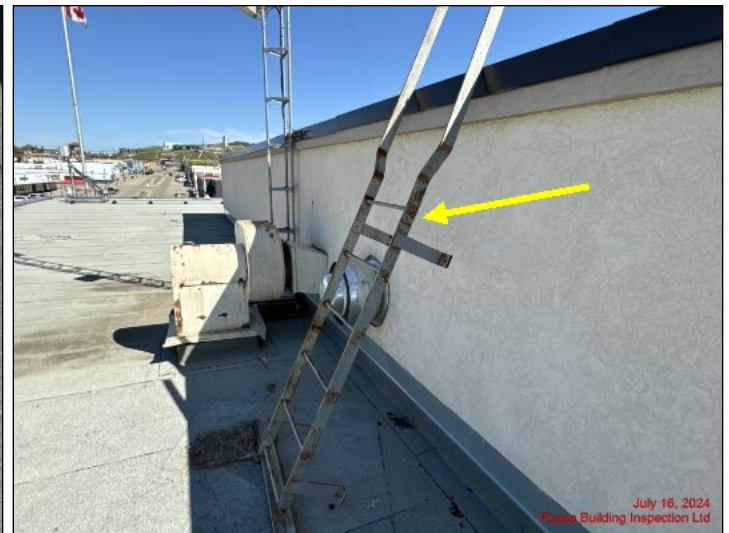
Roof access ladder is not properly installed. Adequate anchors are required to attach the ladder to the building roof. This is required for safe access to each level of the building roof.

Roof access ladder is not properly installed. Adequate anchor to building is required for safety reasons

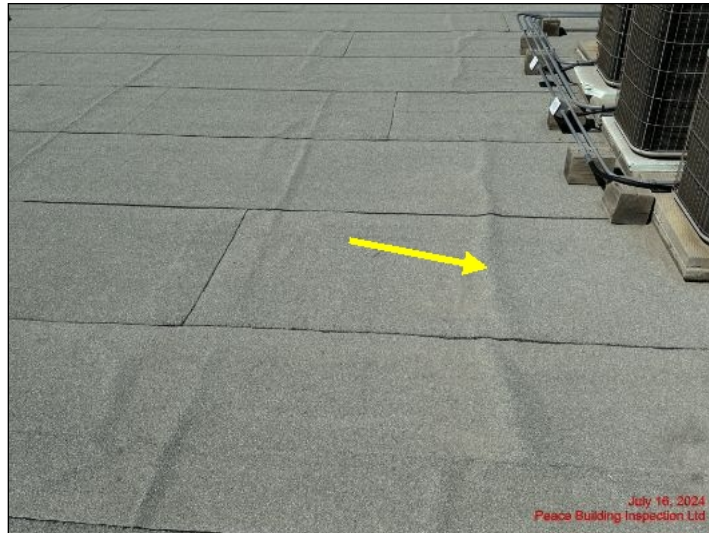
Ripples were observed at the roof cover in some areas. This does not appear to affect the ability for the roof to perform as intended.

Ripples observed at roof in some areas. No roof leakage concerns visible at time of inspection

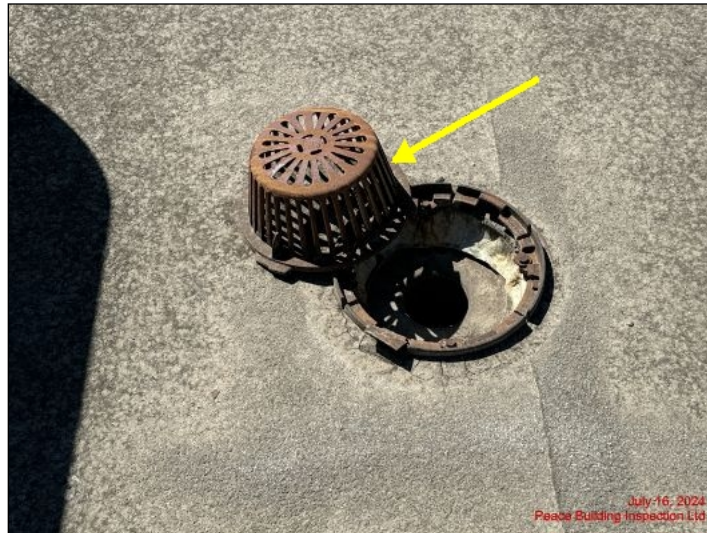
The Inspector observed no deficiencies in the condition of the the roof drainage system. Ensure roof drain covers are installed to prevent leaves and debris from plugging the rain gutters.

Building roof drain covers need to be installed to prevent drains from plugging

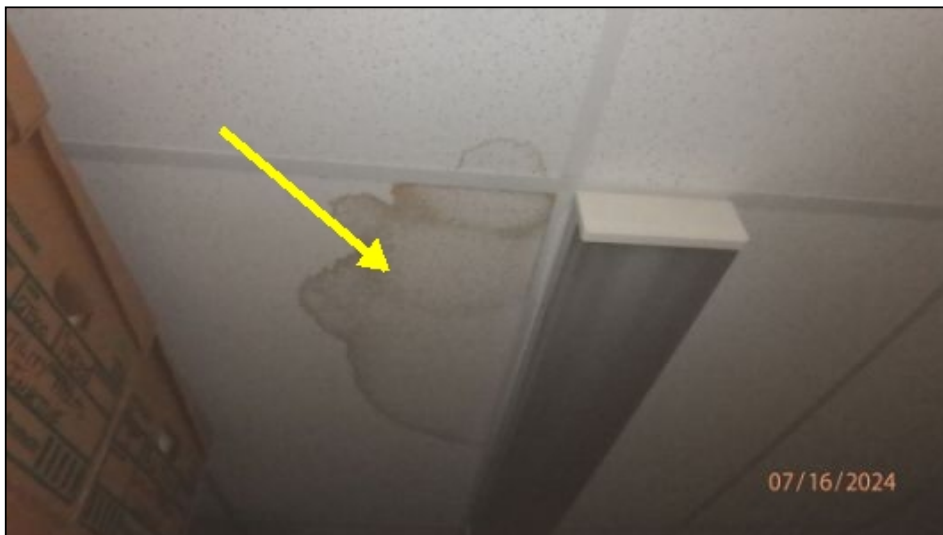
Stains on the ceiling in the basement visible at the time of the inspection appeared to be the result of moisture intrusion from plumbing fixtures or pipes located in or at the floor above. The moisture meter showed no elevated levels of moisture present in the affected areas at the time of the inspection, indicating that the source of moisture may have been corrected.

Basement ceiling storage area has some water stains

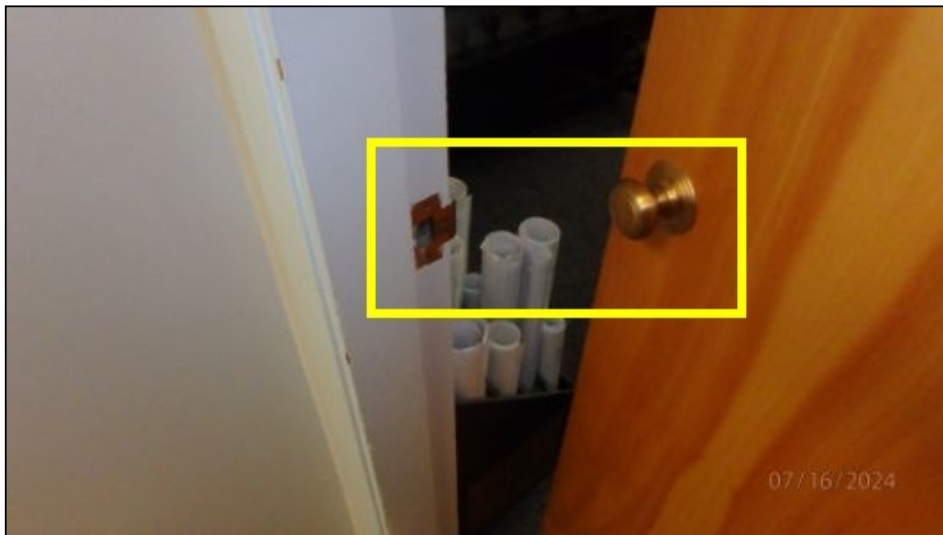
The latch bolt of several interior doors did not align with the hole in the strike plate and did not hold the door closed. Any doors found in this condition will need adjustment to operate properly. The Inspector recommends service by a qualified contractor.

Several interior doors do not latch closed

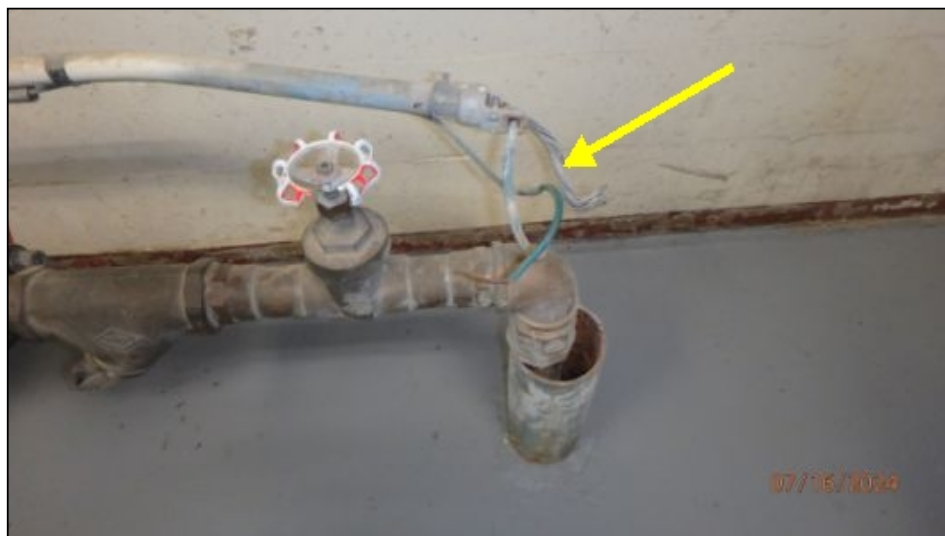
No electrical service grounding system was connected at the time of the inspection. The grounding conductor was not connected to the water supply line to the building. The Inspector recommends that you consult with a qualified contractor to discuss options and costs for connecting the service grounding system.

Main electrical service is not properly grounded at water line

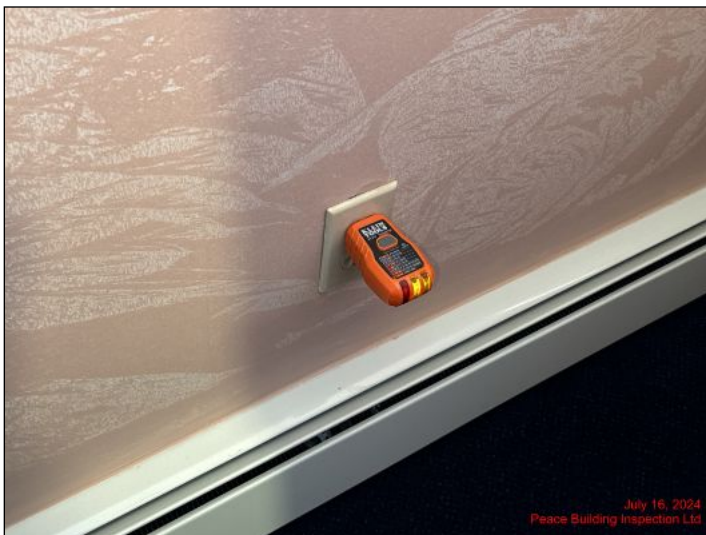
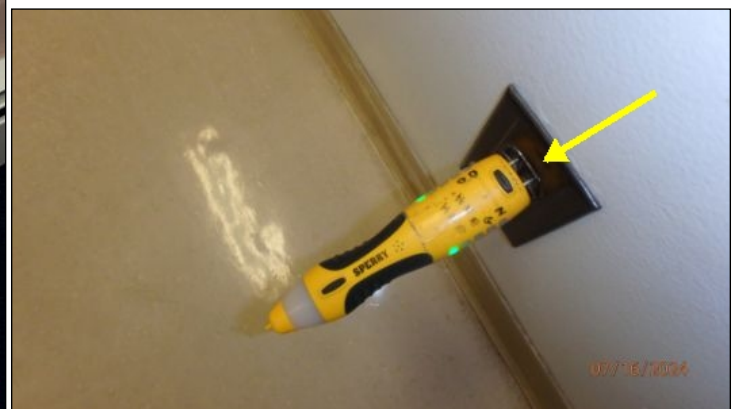
Electrical receptacles at various areas in the building are older and a plugged in device did not stay in the outlet when plug was inserted. There are also several outlets that moved in the wall when a testing device was inserted. Receptacles in this condition should be upgraded to prevent fire, shock and/or electrocution hazard. Loose outlets should be corrected by a qualified electrical contractor.

Board room area had several loose outlets

Several outlets are loose when a device is plugged in

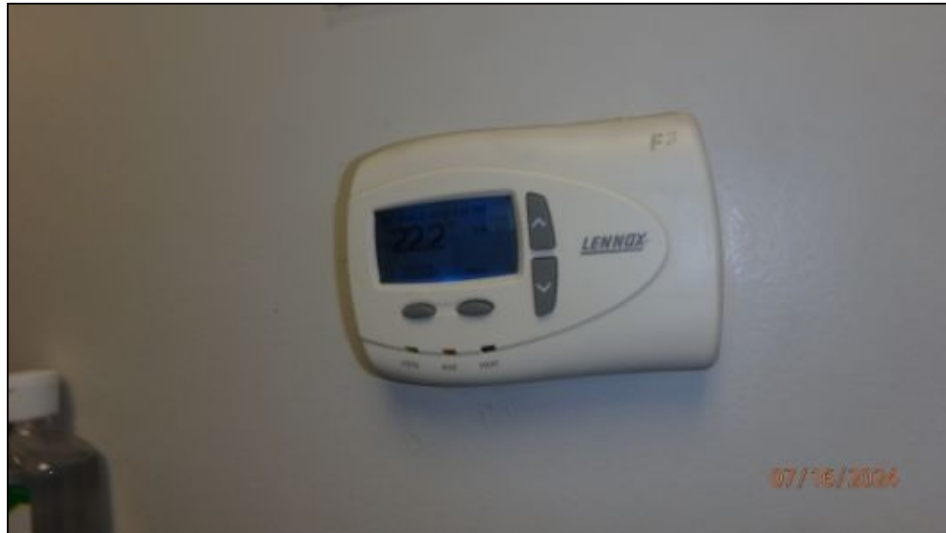
The building is equipped with a thermostat for each furnace/air conditioner. Thermostats should be located such that they provide consistent temperature for an entire area. Any thermostat that is located inside an office may not provide an accurate reading for that particular furnace/air conditioner. Further investigation and proper thermostat placement by a qualified heating contractor is recommended.

Some thermostats were not properly located

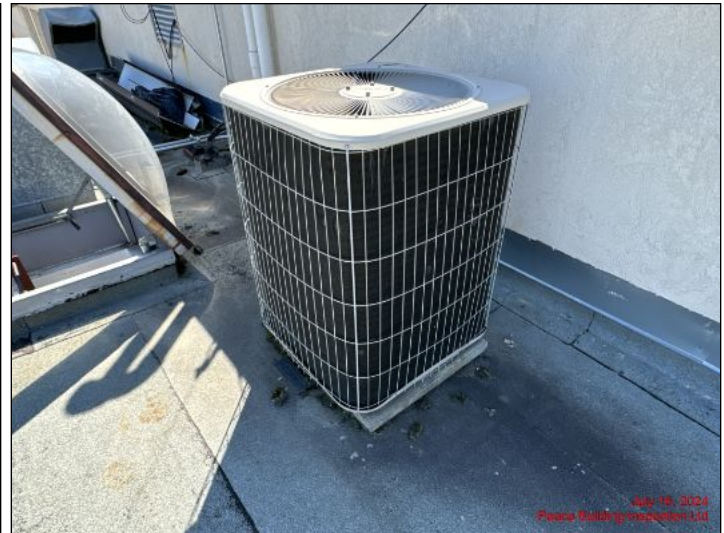
Page 52 Item: 3	General Condition	<p>The air-conditioning systems are now (20) years old. Six of the seven air conditioners were functioning at the time of the inspection. The inspector is not required to determine the proper size air conditioners for a building of this size. Examination of the existing air conditioning units indicates that at least 3 of the air condition units may be undersized for this building.</p> <p>Further investigation and calculation by a qualified contractor/engineer is recommended to determine if the amount and size of existing air conditioners adequately meet the cooling requirements for a building of this size and configuration.</p>
Page 53 Item: 4	System Response	<p>One air-conditioner was not operational at time of inspection. This unit is soon to be under repair by a qualified HVAC technician.</p>

One air conditioner was not operational at time of inspection

Further investigation and calculation by a qualified contractor/engineer is recommended to determine if the amount and size of existing air conditioners adequately meet the cooling requirements for a building of this size and configuration.

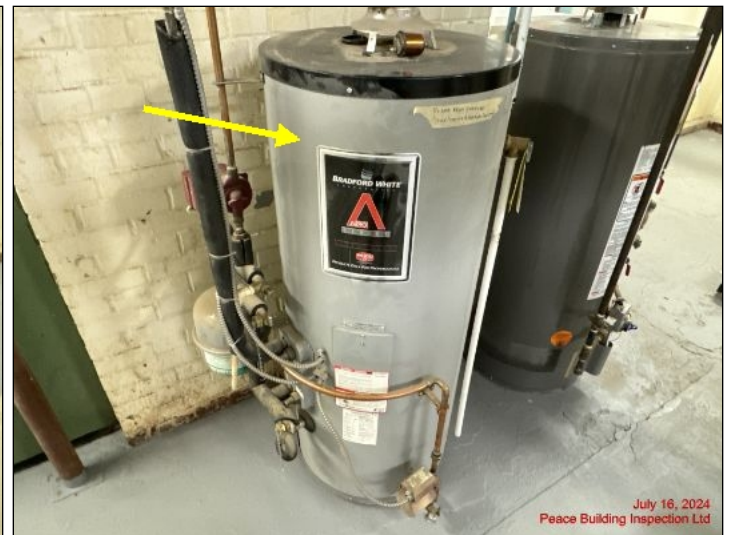
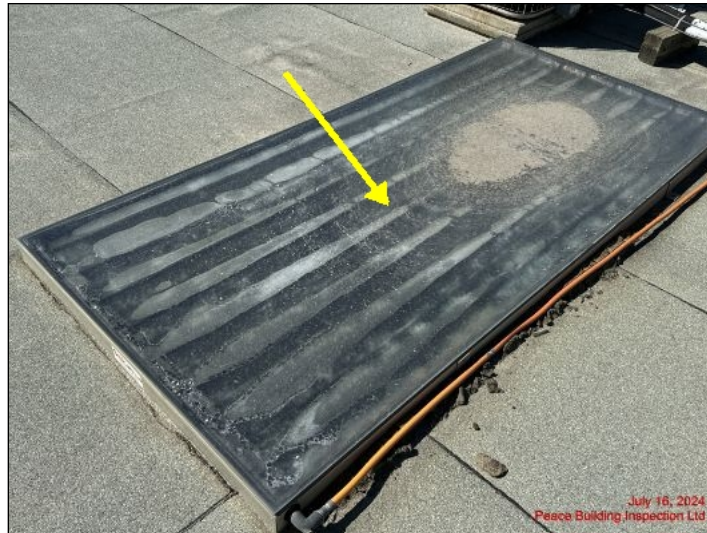
The solar water heater is equipped with a solar panel on the roof of the building. This solar panel has failed and is no longer operational. The solar panel will require replacement and the water tank it services is an older unit approaching end of service life. The Inspector recommends replacement by a qualified contractor.

Solar water heater is not providing any heat input as the solar panel on the roof has failed

Solar water heater panel has failed. This solar panel will require replacement

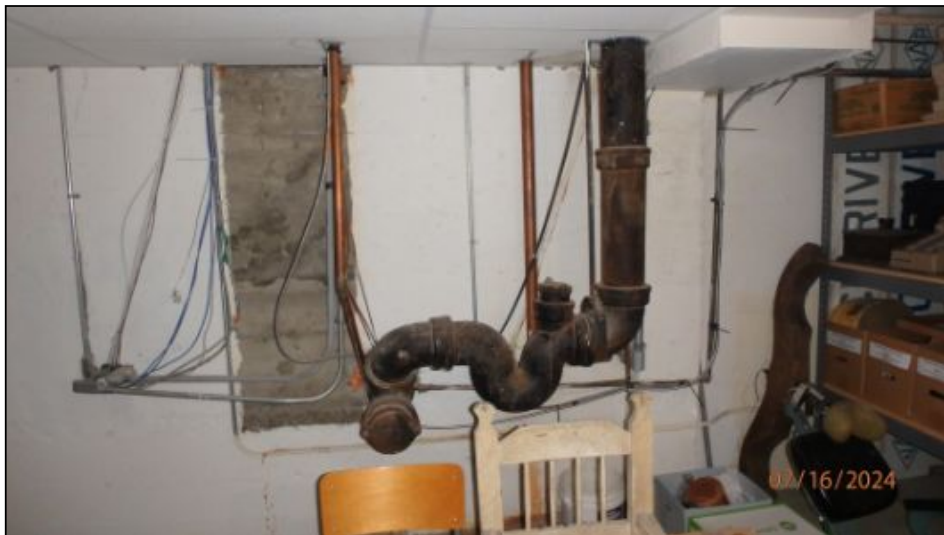
Page 62 Item: 2	DWV Pipe Condition	<p>Portions of the drain waste piping are cast iron. This material is now over 50 years old. I am unable to see inside this piping and cannot verify the integrity of the material. I recommend having the sewer pipe scoped with a fibre optic camera. This service is provided by some plumbing companies.</p> <p>By viewing the sewer pipe you will be able to determine if there are any concerns such as sagging, crushed, disconnected or partially plugged sewers.</p>
-----------------	--------------------	-------------------------------------------------------------------------------------------------------------------------------------------------------------------------------------------------------------------------------------------------------------------------------------------------------------------------------------------------------------------------------------------------------------------------------------------------------------------------------

Building equipped with cast iron sewer piping. Normal life is 50 years

By viewing the sewer pipe you will be able to determine if there are any concerns such as sagging, crushed, disconnected or partially plugged sewers.

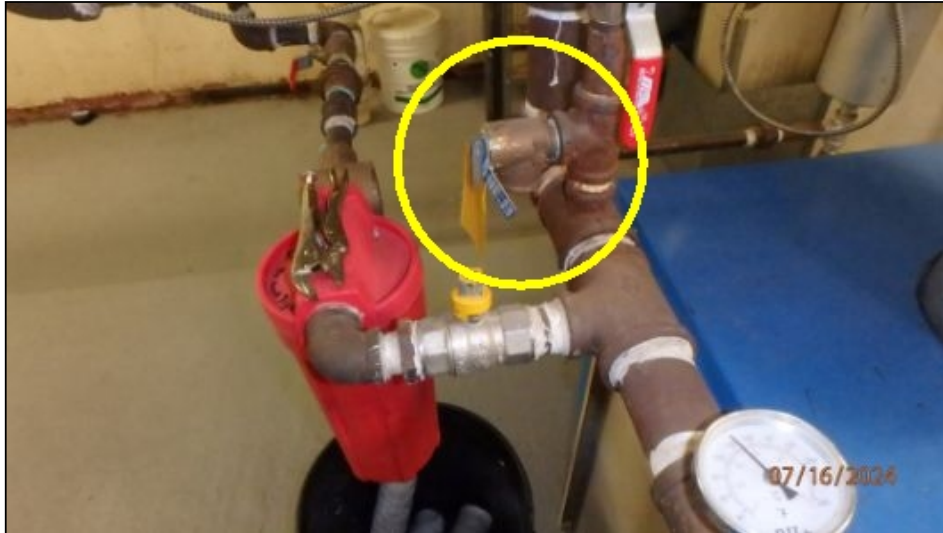
Page 67 Item: 15	TPR Discharge Pipe	<p>The discharge pipe of the boiler temperature/pressure relief (TPR) valve was terminated more than 6 inches above the floor. This condition could result in scalding if the pressure relief valve were activated while a person was nearby. The Inspector recommends correction by a qualified plumbing or HVAC contractor.</p>
------------------	--------------------	-----------------------------------------------------------------------------------------------------------------------------------------------------------------------------------------------------------------------------------------------------------------------------------------------------------------------------------

Boiler pressure relief valve should terminate at the floor level

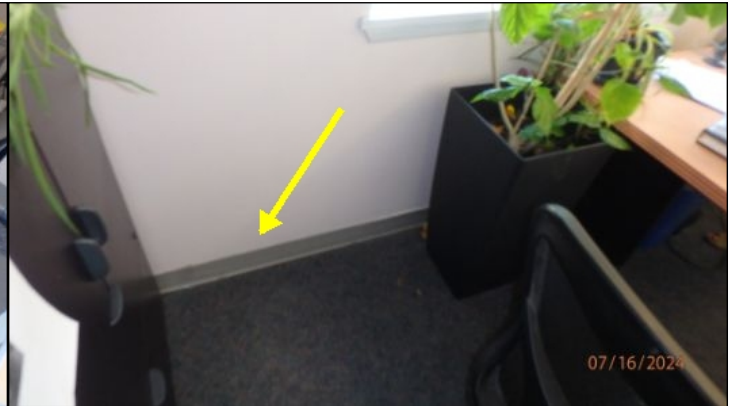
Page 69 Item: 19	Hot Water Baseboard Distribution	Baseboard heaters did not extend through the entire room. Some office areas require space heaters to provide adequate heat during colder weather. The Inspector recommends adding baseboard heaters to walls that are missing these units in order to provide more consistent heat coverage. Further investigation and installation recommendations by a qualified plumbing or HVAC contractor is recommended.
WOOD STOVE (W.E.T.T)		
Page 72 Item: 1	Wood Stove	<p>A wood stove was located in the basement. This unit is no longer used and should be removed.</p> <p>The wood stove is equipped with a natural gas lighter. This was commonly used in years past. Unfortunately gas lines into a wood firebox is no longer allowed. The gas line will need to be disconnected and no longer used. The first gas valve in the line should be shut off and the end of the gas line capped off for safety reasons. The Inspector recommends correction by a qualified gas fitting contractor.</p>

Some office areas are missing full wall baseboard heaters. Portable heaters observed in some office rooms for supplemental heat

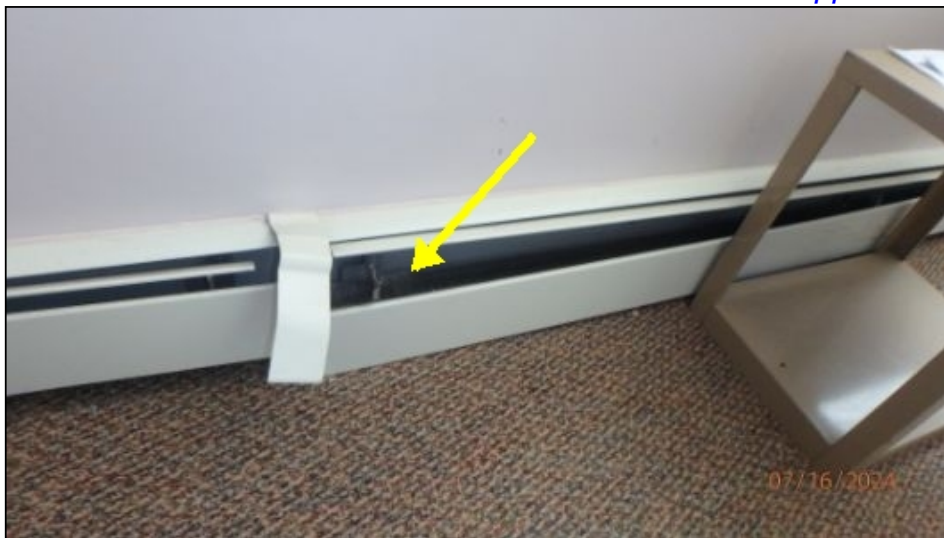
Several baseboard heater covers are loose or damaged
