Airport Assessment and Gap Report Peace River Airport

Airport Assessment and Gap Report Peace River

August 16th, 2013

LPS Aviation Inc.
One Antares Drive, Suite 250
Ottawa, Ontario
CANADA K2E 8C4

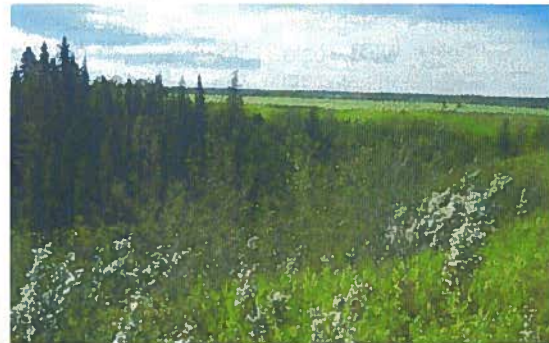
There are two ravines beyond the airport property boundary, on the extended centreline of both Runway 04 and Runway 22. These ravines are estimated to be over 30 m (100') in depth, and provide habitat for many plants and animal species.

Runway 04-22 expansion is limited by major physical constraints at both ends.

The runway extension options presented within this Airport Assessment and Gap Report do not encroach into the existing ravines; however, an environmental review should be conducted prior to extending the runway to examine future drainage impacts, and potential species at risk.

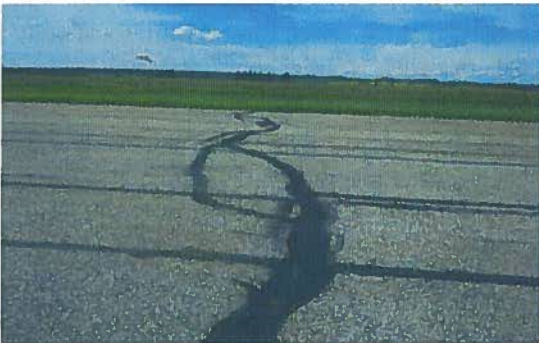
Longitudinal and transverse cracking on Runway 04-22.

The runway is experiencing longitudinal and transverse (discrete) cracking throughout its surface. This is likely due to the age of the asphalt with the last rehabilitation taking place in 1997. Also, discrete cracking is common among airfield pavements in cold weather regions.

The runway ends appear to be showing signs of reflective cracking in a consistent 6m x 6m pattern, which is likely a result of asphalt movement with respect to the underlying concrete panels.

It is recommended that Runway 04-22 undergo full depth asphalt removal and replacement as recommended by the Runway 04-22 Preliminary Design Report submitted to the Town of Peace River by Genivar in April 2012.

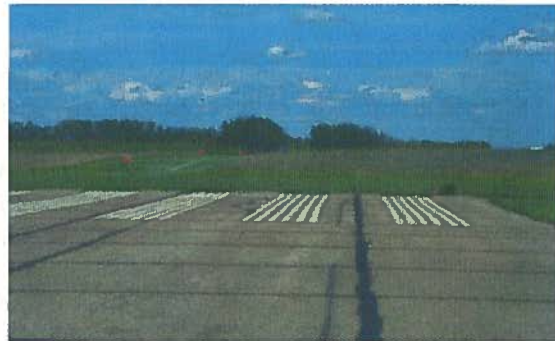
Runway 04-22 has dimensions of 1,524.0m x 45.5m (5,000' x 150'). As per the results of the B737-400 Aircraft Performance Analysis, a 5,900' (1,798m) runway length is recommended to support the B737-400 at the Peace River Airport.

It is recommended that Runway 04-22 be extended by 170.7m (560') to the west, and 103.7m (340') to the east in order to provide adequate runway length to support the B737-400. The DHC8-400 will be able to operate from the current length of 1,524m (5,000').

Runway 04-22 will be expanded to the west by 170.7m and will include a RESA.

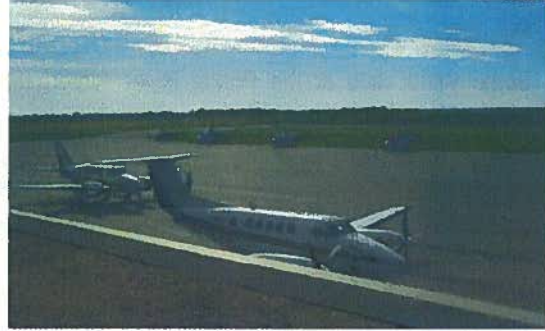
No deficiencies were observed in the structural capability of Apron I as it was recently overlaid.

It is recommended that four (4) aircraft parking stands be established with appropriate markings to facilitate use by B737-400, DHC8-400, B1900D and B350 aircraft simultaneously.

Apron I can provide four (4) aircraft stands accommodating the B737-400, DHC8-400, B1900D, and B350 aircraft.

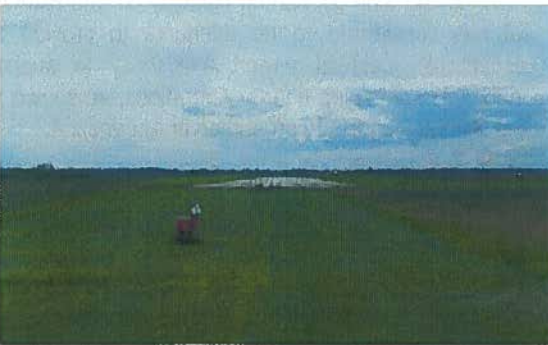
The P2-type PAPI systems supporting Runways 04 and 22 will require relocation to correspond with the new threshold locations as a result of extending the runway.

The Simple Approach Lighting Systems (ODALS) will also require relocation as a result of extending Runway 04-22. These systems will extend outside the current airport boundary, and land easement agreements with Alberta Highways on the east end, and the adjacent landowner to the west should be updated and/or renegotiated to allow for ODALS relocation.

Simple Approach Lighting Fixtures (ODALS) fixtures and PAPI fixtures will require relocation to accommodate the extension of Runway 04-22 at both ends.

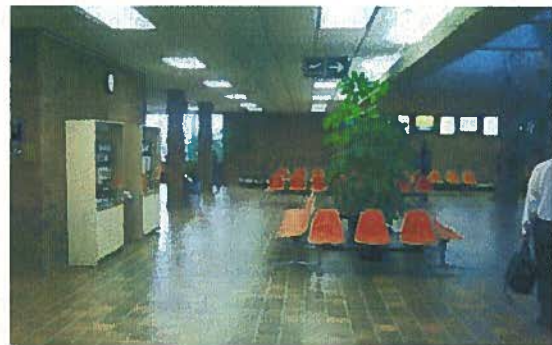
As seen from Table 4-5, the main deficiencies with respect to the terminal functional areas are the holdroom and future security processing function.

It is recommended that a portion of the underutilized space within the ATB be used to expand the current holdroom to the approximate 180 m² required to facilitate a PDV of 140.

A portion of the existing Public Area will be used for Holdroom expansion and future security area.

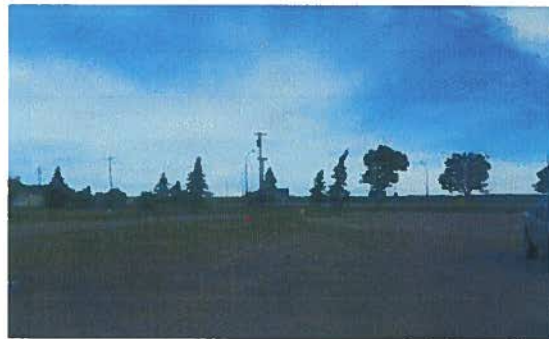
Consultations with the Peace River Airport indicate that the ATB frontage road has undergone a major rehabilitation in the summer of 2013, as the pavement was considered to be in very poor condition and reached the end of its service life.

It is recommended that the long-term parking area be rehabilitated in order to support industry's vehicle parking requirements. Consultations revealed a requirement for approximately 100 parking stalls.

The Long-Term Parking Lot will be restored to accommodate additional parking stalls.
