Peace Building Inspection Ltd.

Property Inspection Report

9715 - 100th Street, Peace River, AB. T8S 1S8
Inspection prepared for: Tanya Bell (Town of Peace River, AB.)
Real Estate Agent: Layne Gardner - Re/Max Northern Realty

Date of Inspection: 4/9/2024 Time: 11 a.m. Size: 19,300 sq. ft.
Weather: Sunny
Building is 41 years old.

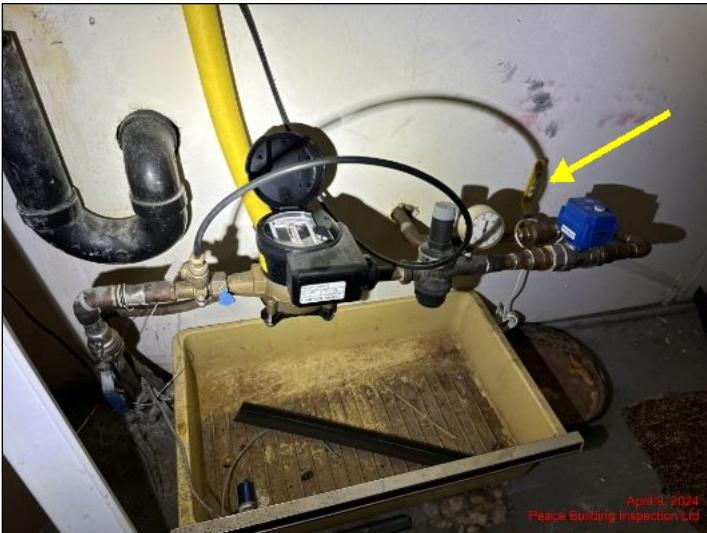
Main water supply line was shut off at time of inspection

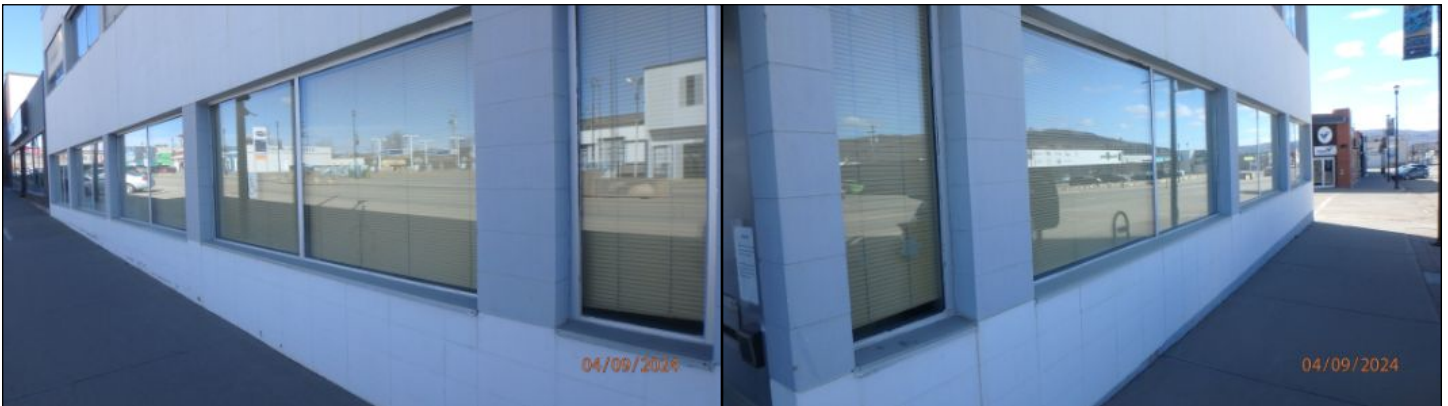
Exterior windows in mostly good condition at time of inspection

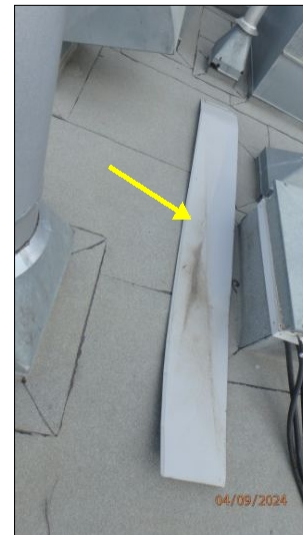
Fascia was missing in places and needed or replacement. All work should be performed by a qualified contractor.

Missing fascia was located on roof of the building

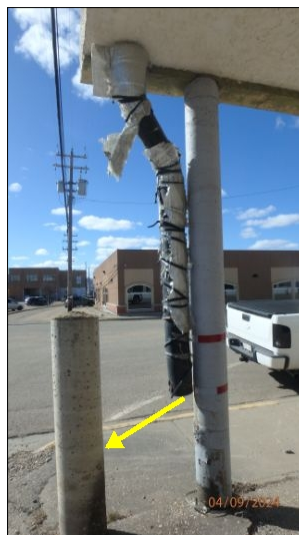
One downspout discharged roof drainage next to the structural support piling. This condition can effect the ability of the soil to support the weight of the structure above and can cause damage related to soil/foundation movement. The Inspector recommends the installation of downspout extensions to discharge roof drainage a minimum of 2 feet from the piling.

Rear downspout should drain away from the structure support post

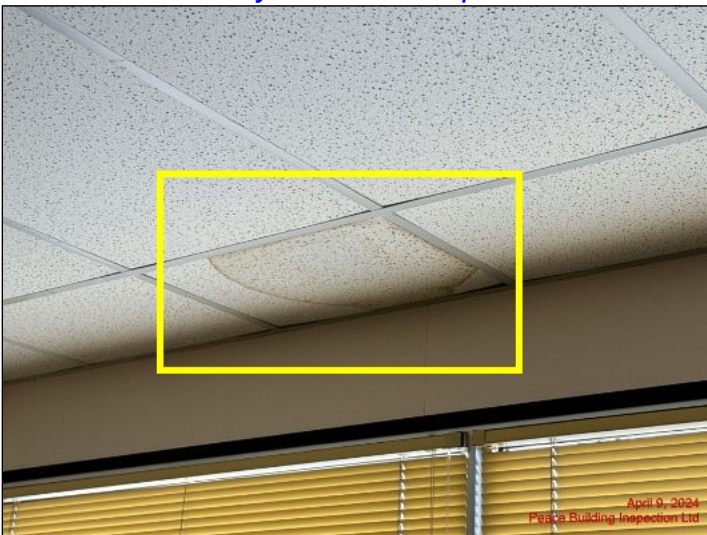
All lower level ceiling stains were dry at time of inspection

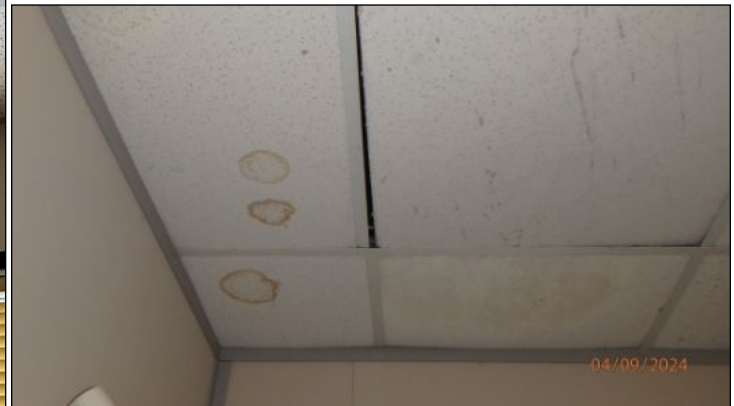
Upper level ceiling stains were dry at time of inspection

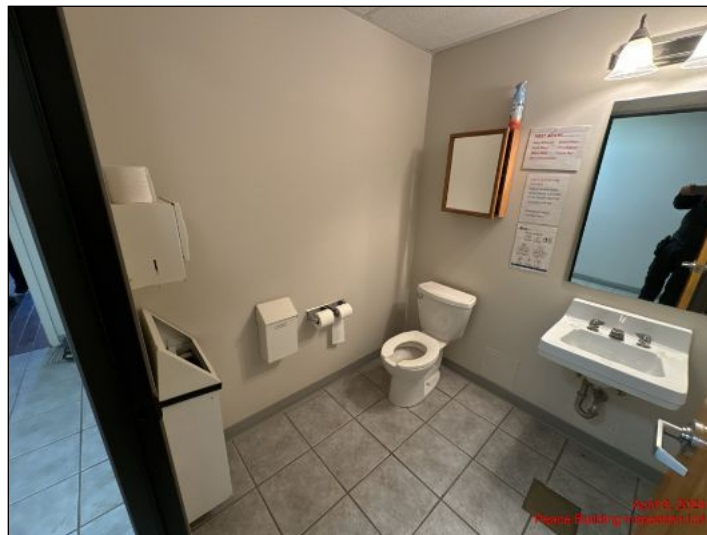
Water shut off at time of inspection. The Inspector recommends evaluation and any corrections be performed by a qualified contractor once water is restored.

Bathroom sinks could not be tested. Water off at time of inspection

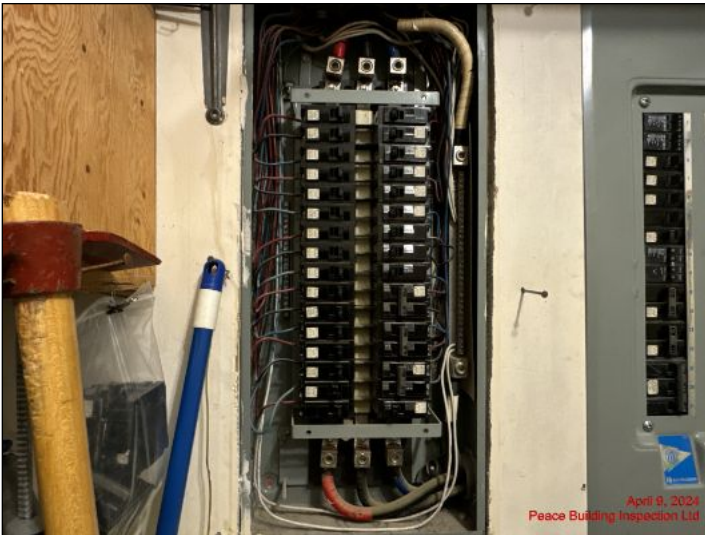
All service panel interiors in mostly good condition

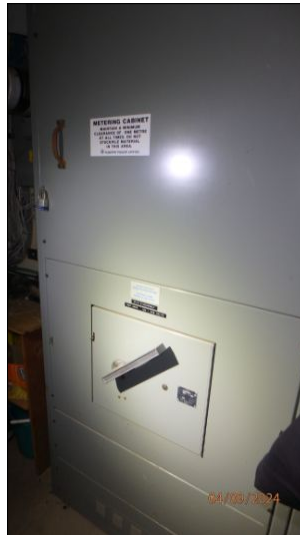
The electrical service disconnect was rated at 600 amps.

Building equipped with a 600 amp main breaker

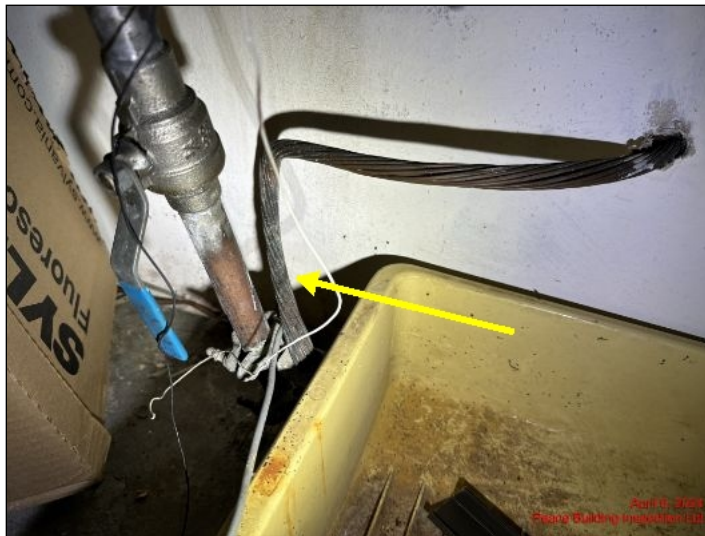
The main water supply pipe served as the sole grounding electrode for the home electrical service. This was common practice at the time the home was built.

Electrical service is grounded to the water supply inlet

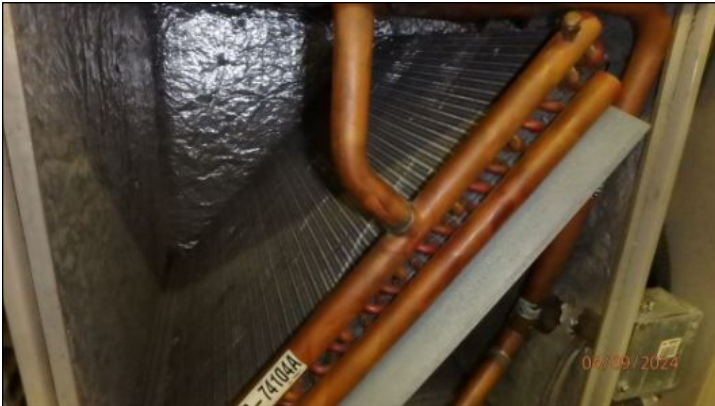
No visible concerns observed at the furnace radiant heaters

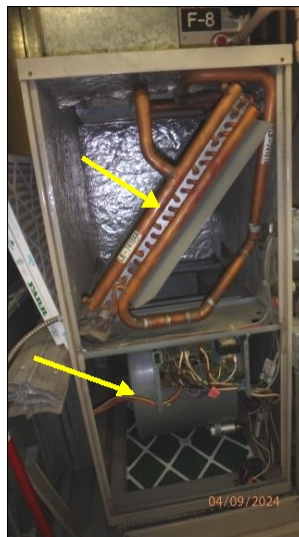
Boilers provide heat to each furnace radiator that in turn has a blower providing heat to each building zone

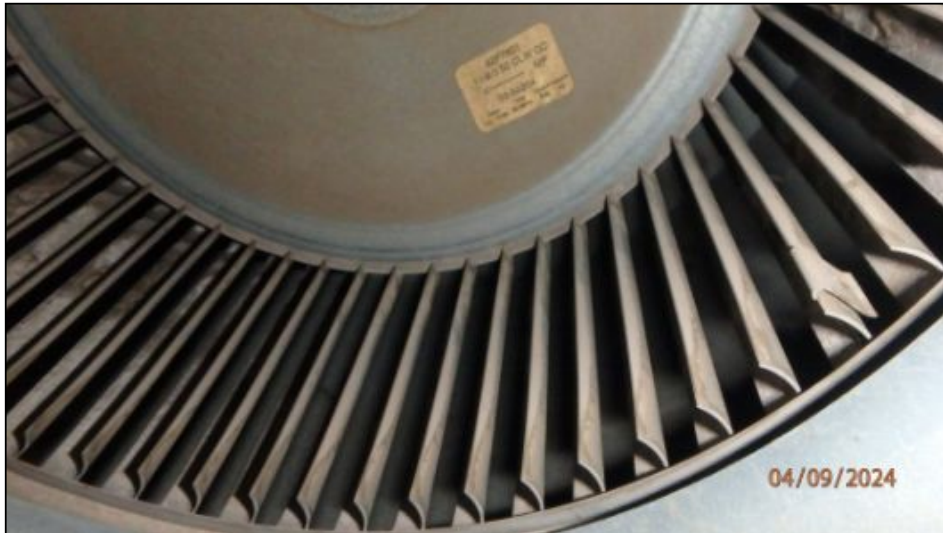
All furnace blowers appear in good condition at time of inspection

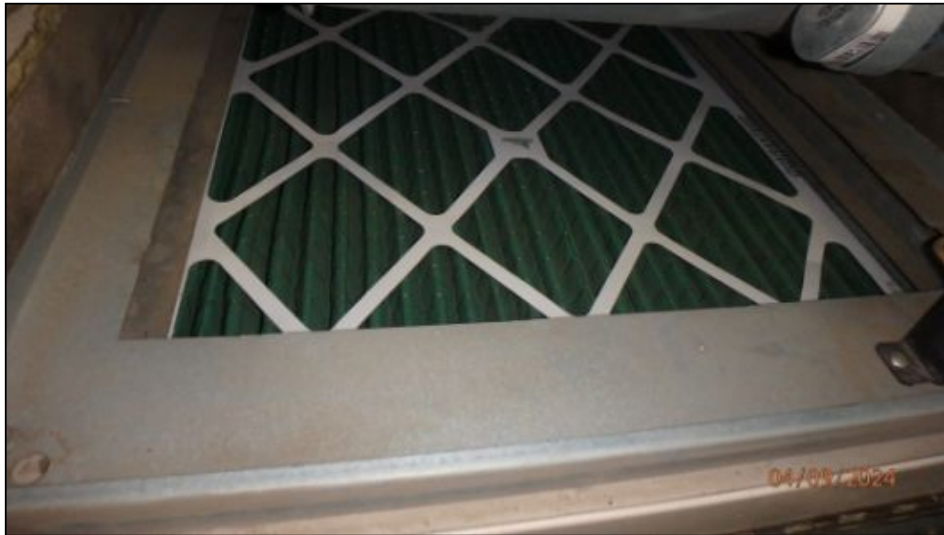
The air filter for this furnace was dirty and should be changed. Filters should be checked every three months and replaced when they reach a condition in which accumulation of particles becomes so thick that particles may be blown loose from the filter and into indoor air. Buildings in areas with high indoor levels of airborne pollen or dust may need to have air filters checked and changed more frequently.

Each furnace air filter should be replaced every 3 months

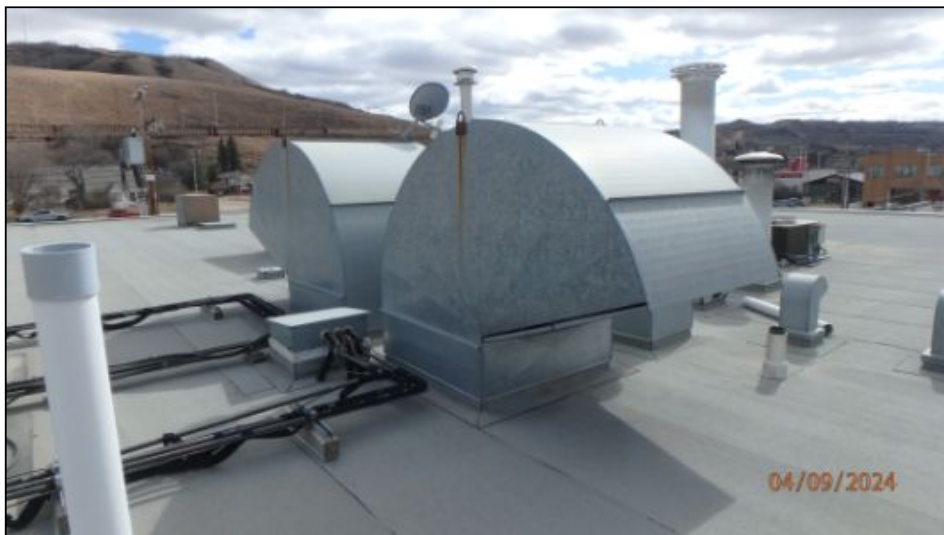
Fresh air intake in good condition at time of inspection

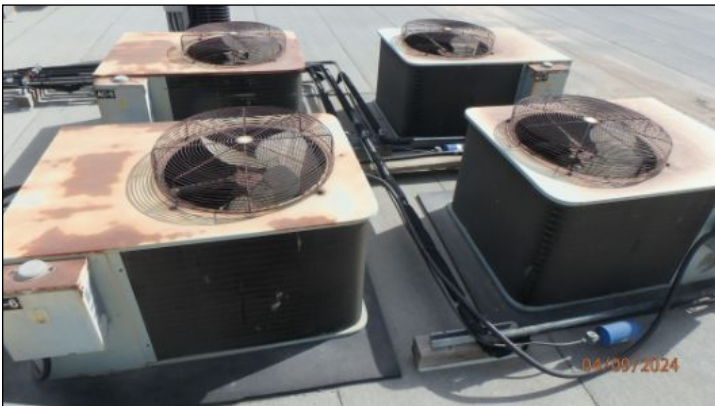
The building is equipped with (11) air conditioning units. (3) units have been upgraded leaving 8 very old units. The remaining air-conditioning units appeared to be beyond design life and may need to be replaced soon.

Building equipped with (11) air conditioning units. (8) of the units are at or very near the end of service life. Replacement likely needed

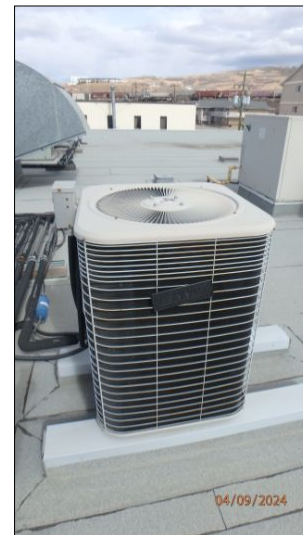
Building has (3) newer air conditioners that appear in good condition at time of inspection

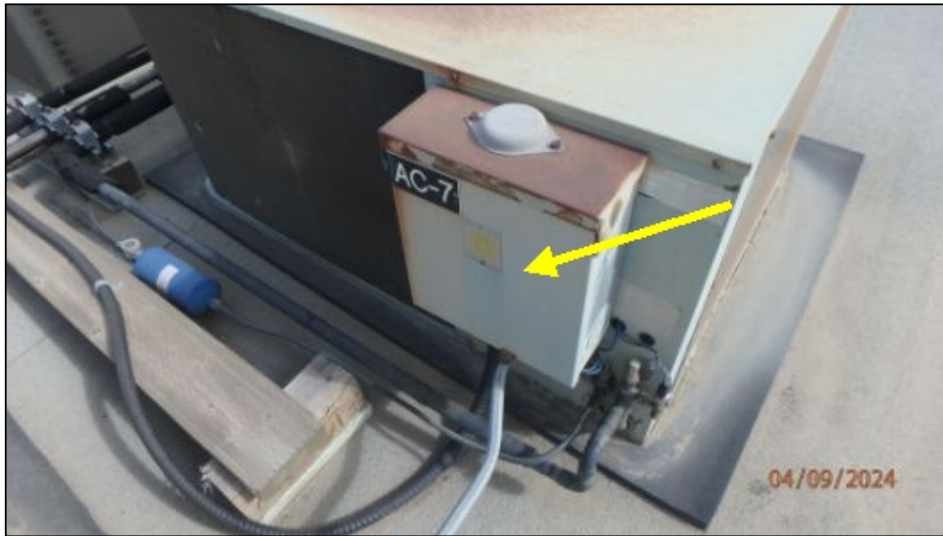
Each air conditioner equipped with a local disconnect as required

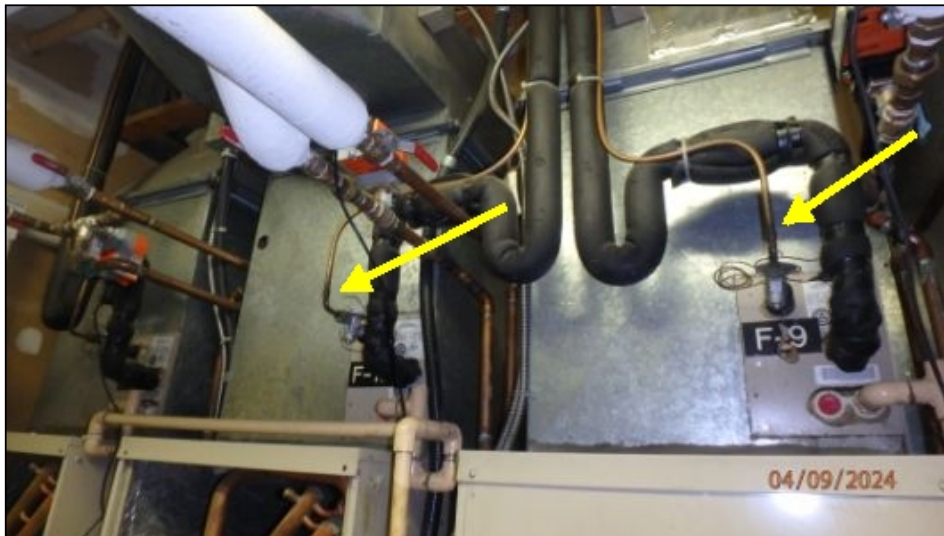
Air conditioner evaporator coils are not accessible for inspection

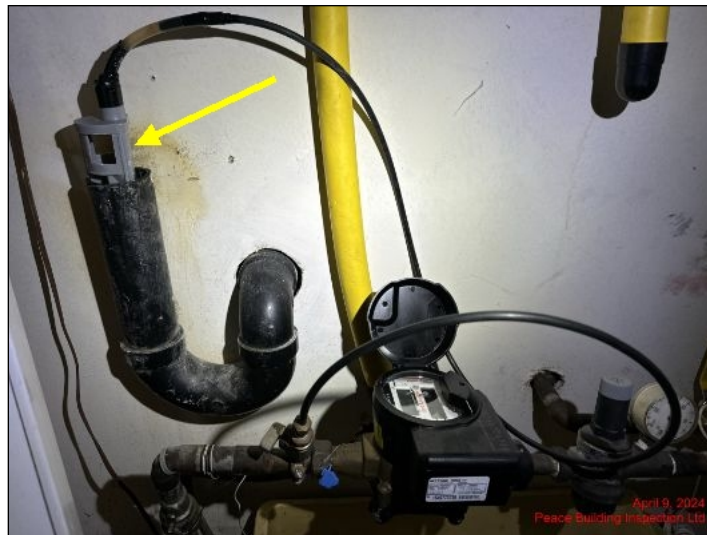
Building equipped with anti freeze water dribble line

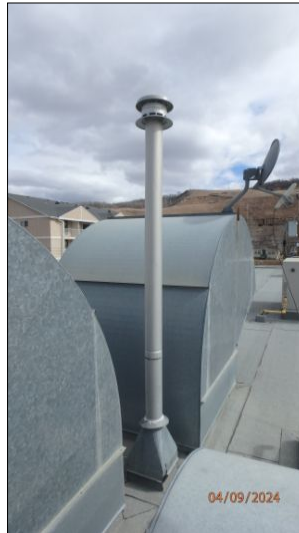
Water heater exhaust flue in good condition at time of inspection

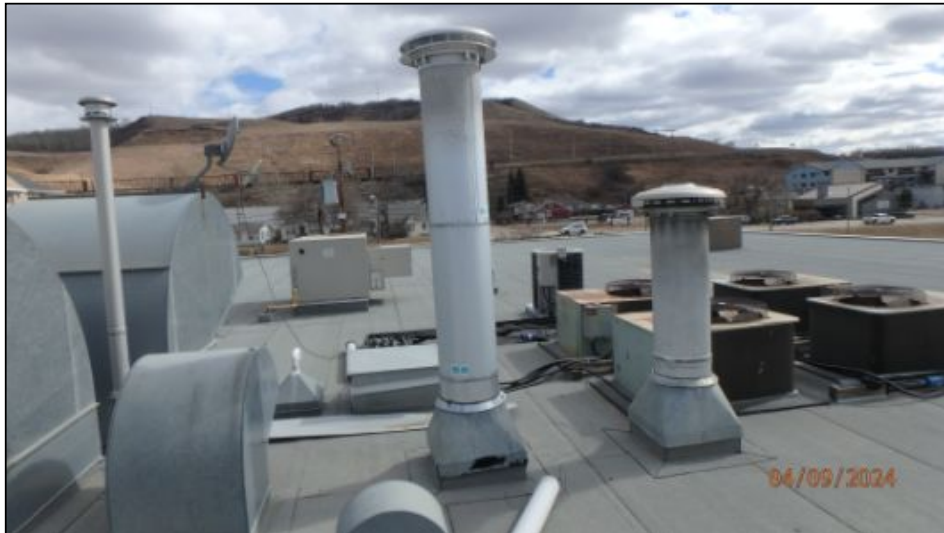
Boiler exhaust flue in good condition at time of inspection

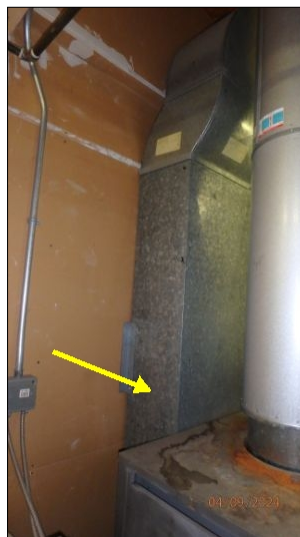
Mechanical room properly equipped with combustion air

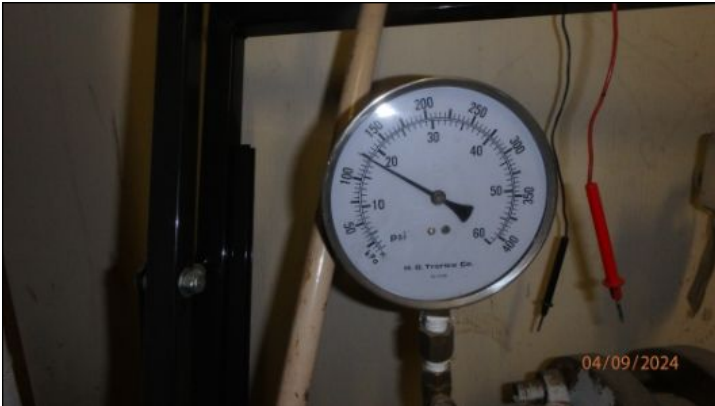
Boiler system operating at proper pressure at time of inspection

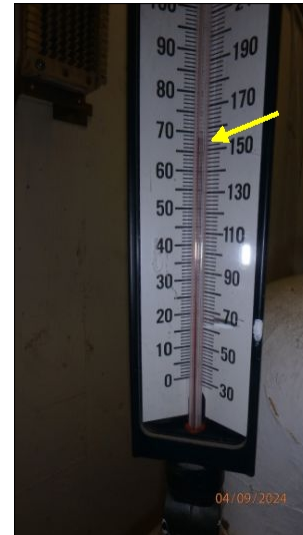
Boilers operating at proper system temperature

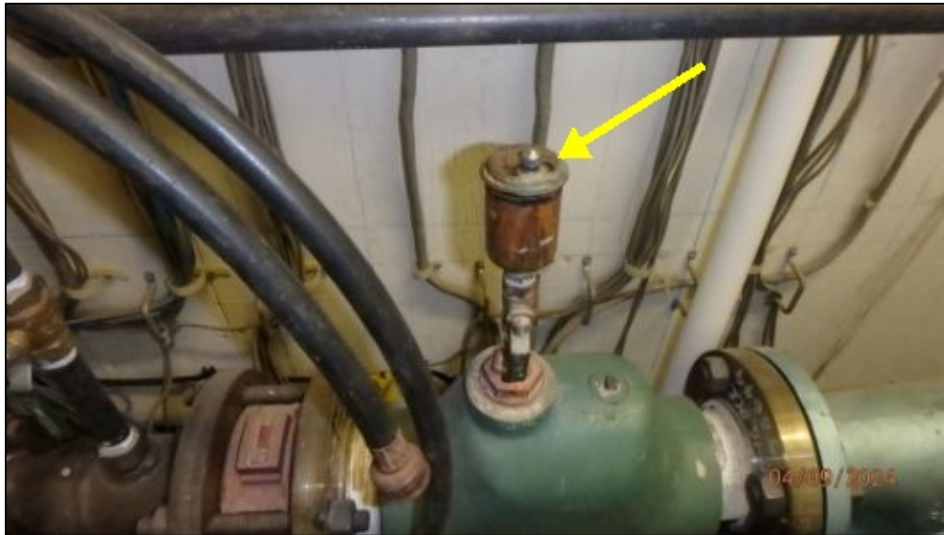
Boiler air vent in good condition at time of inspection

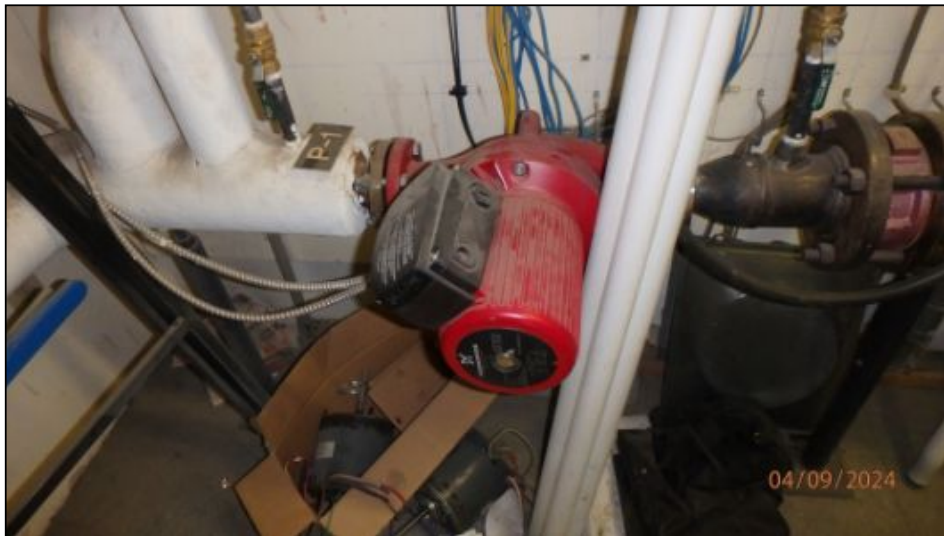
Boiler circulating pump in good condition at time of inspection

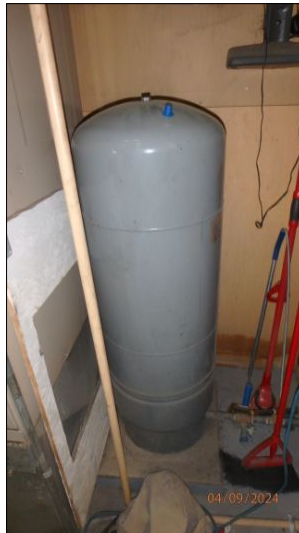
Boiler expansion tank in good condition at time of inspection

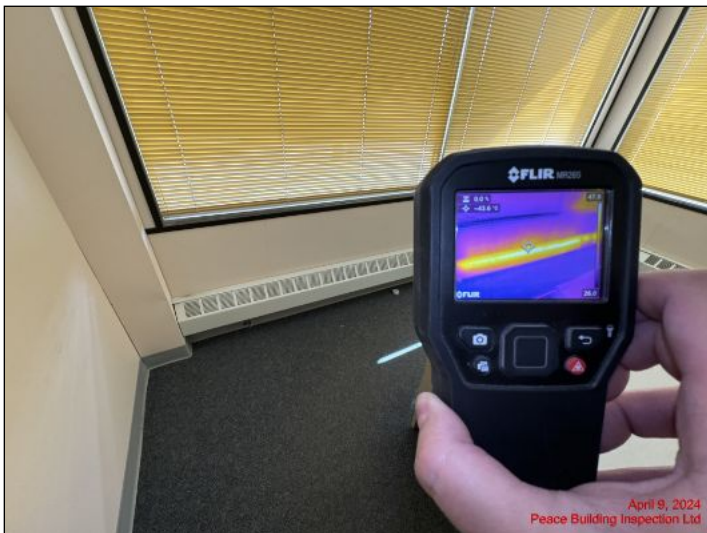
Most baseboard heaters were operational at time of inspection

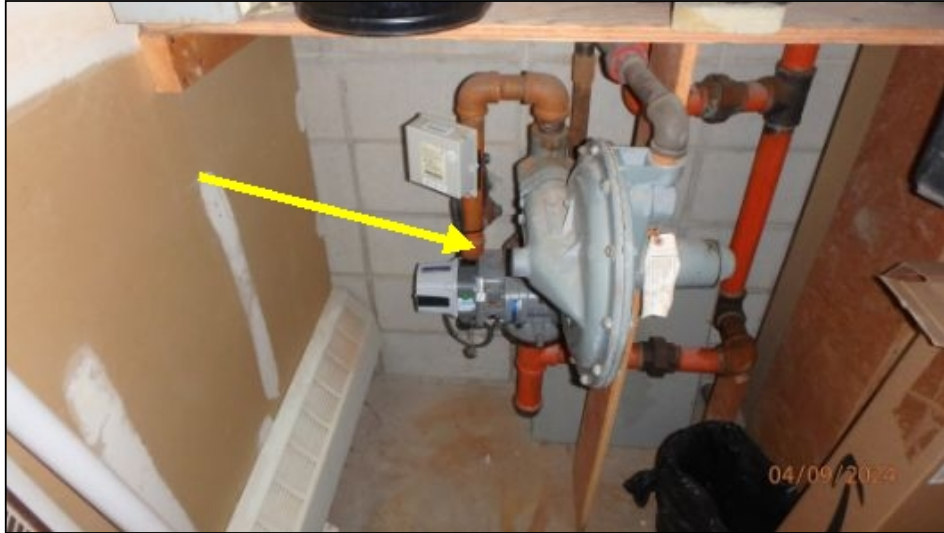
Gas meter located in rear electrical room

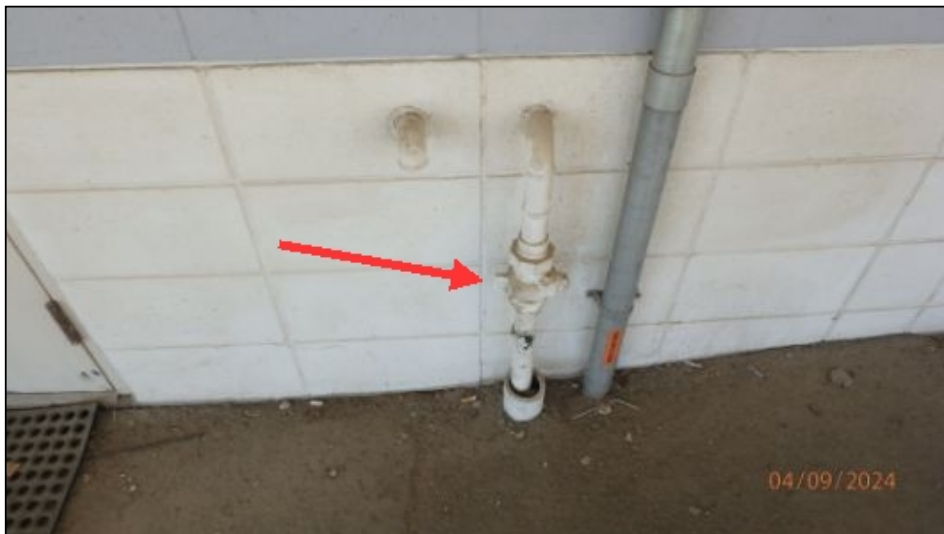
Main gas shutoff located at rear of building
