Peace Building Inspection Ltd. Property Inspection Report

9911 - 100th Street, Peace River, AB.

Inspection prepared for: Tanya Bell (Director of Community Services)

Date of Inspection: 7/16/2024 Time: 11 a.m. Size: 16,500 sq. ft.

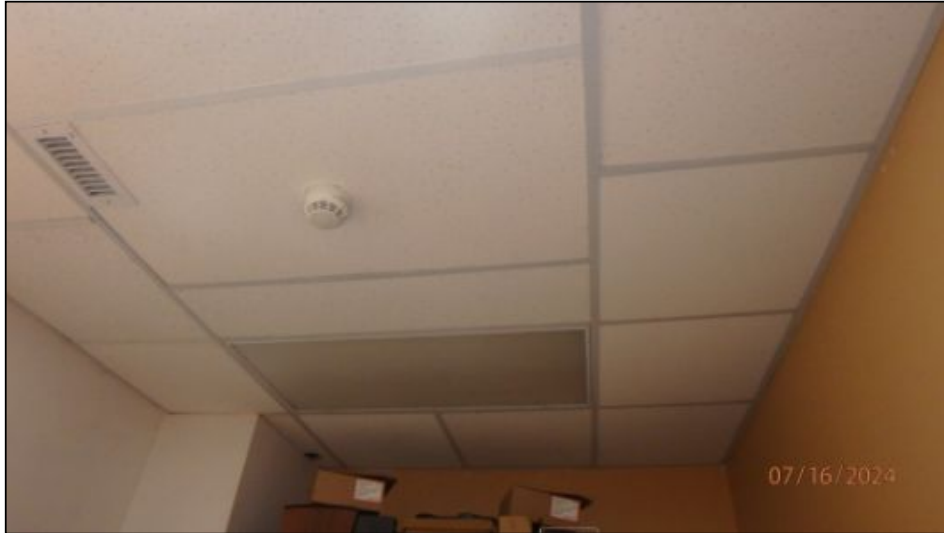
Ceiling tiles are not removed to avoid damage

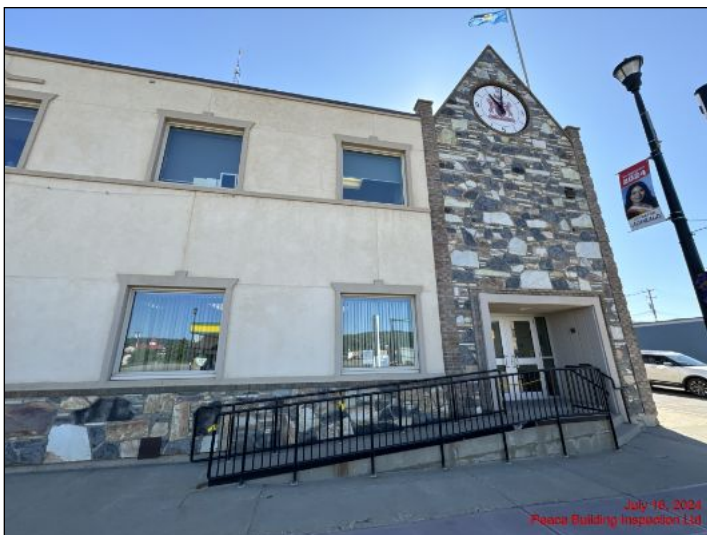
Front walkway ramp was sealed off at time of inspection

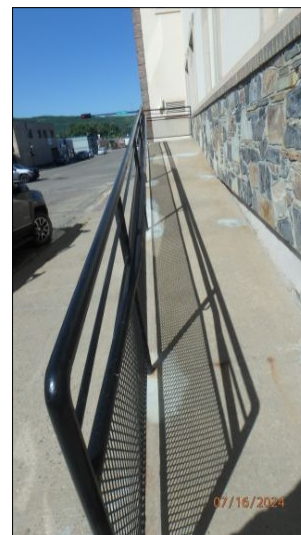
Side exterior ramp in good condition at time of inspection

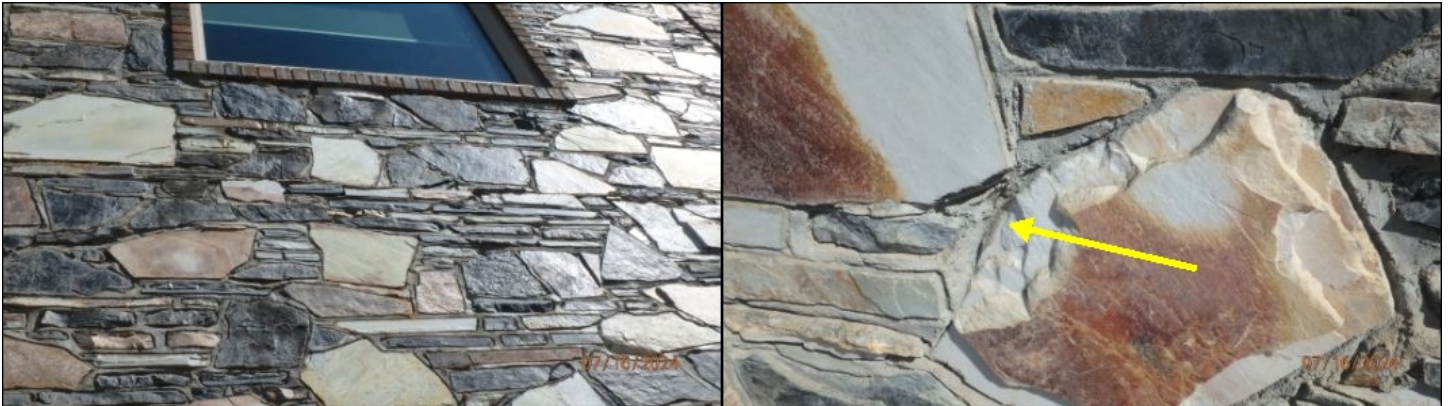
Stone exterior walls in good condition at time of inspection

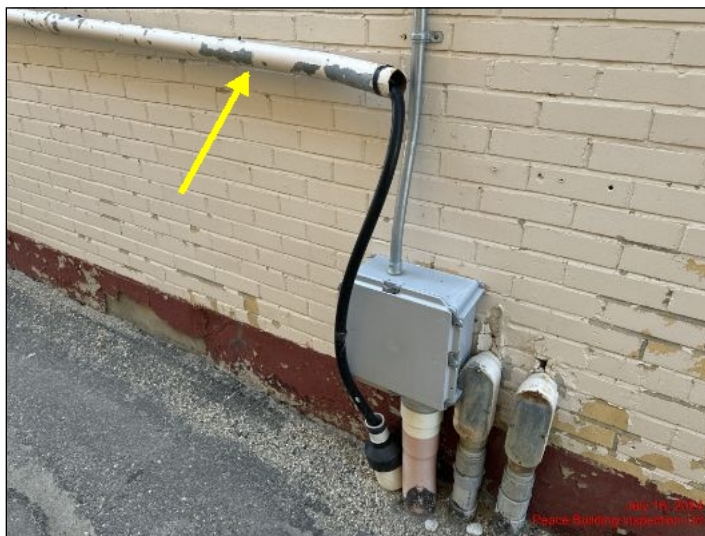
Exterior wiring visible at the rear of the building requires the conduit to be properly anchored to the wall of the building. All electrical work should be performed by a qualified electrical contractor.

Exterior conduit requires proper attachment to building wall

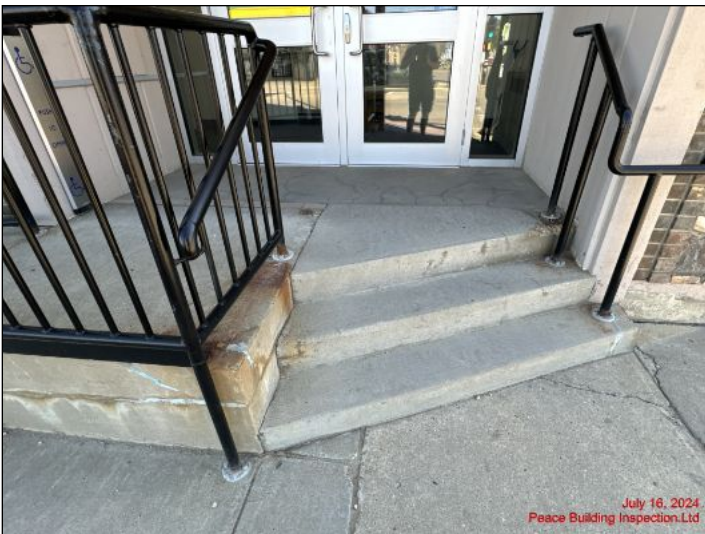
Concrete front steps in good overall condition at time of inspection

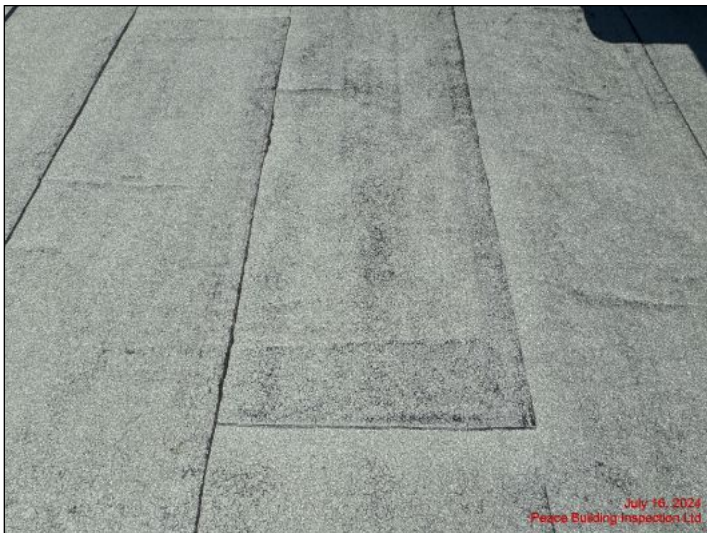
Roof cover in good condition at time of inspection

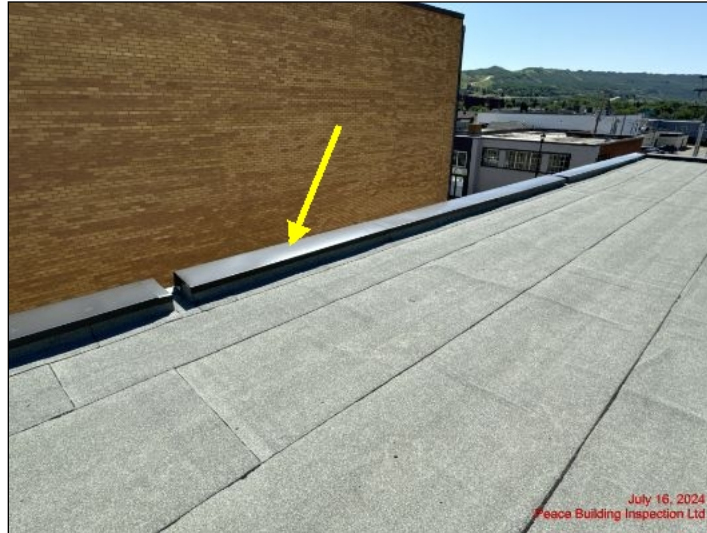
Roof parapet edge flashing in good condition at time of inspection

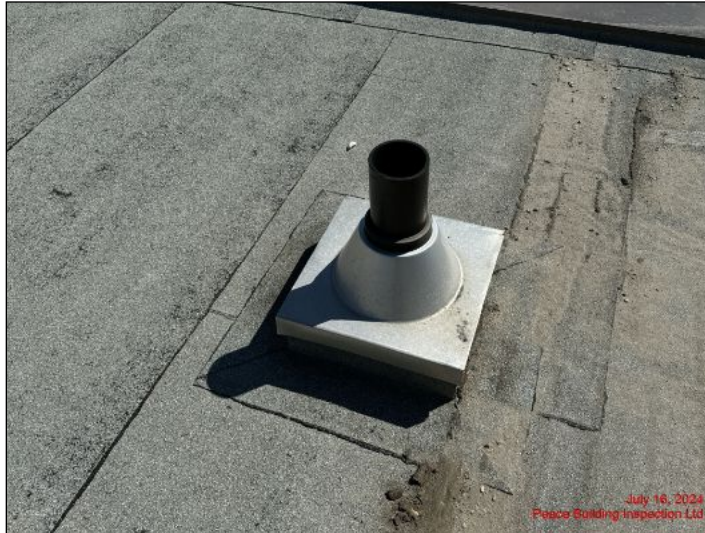
Plumbing vents in good condition at time of inspection

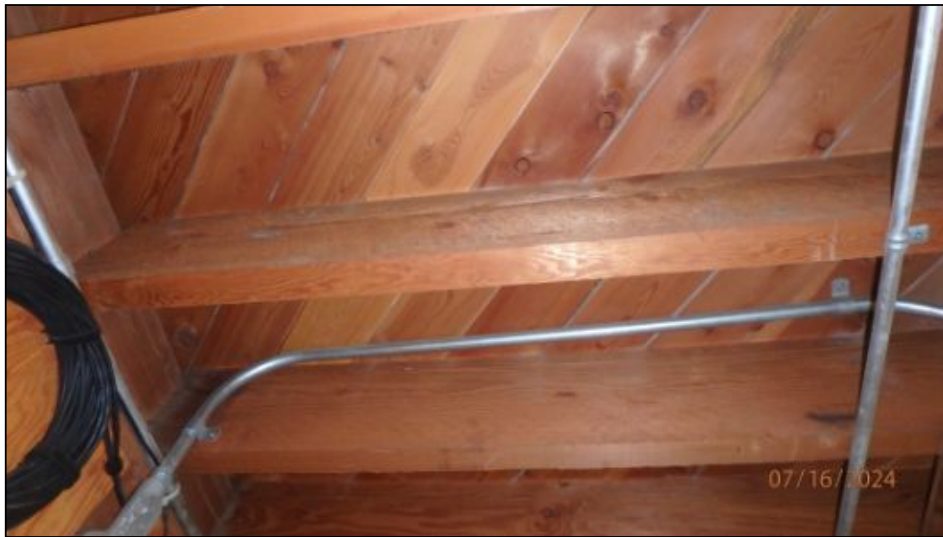
Wood boards over conventional joists in good condition at time of inspection

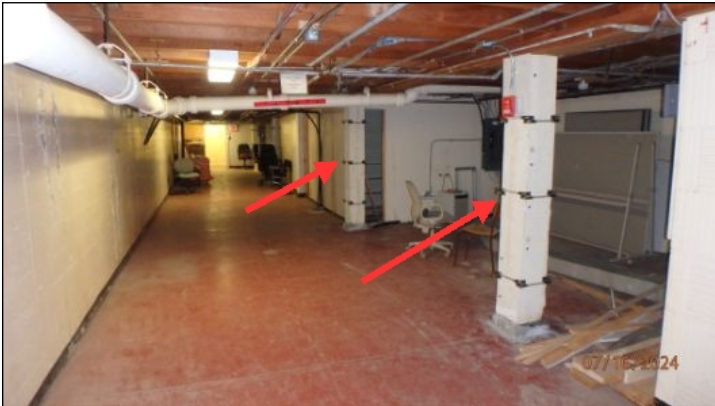
Building equipped with wood support posts

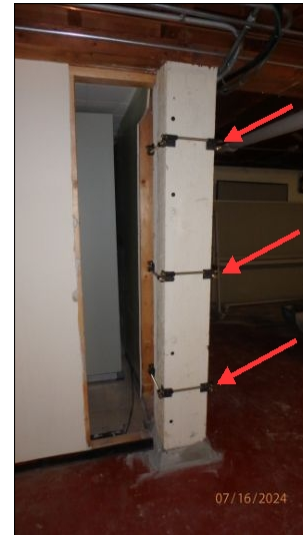
Several posts supporting beams in the basement had prior repairs completed. Several of the posts were cracking and could have potentially lost bearing capability. It appears that properly installed engineered post re-inforcement has been installed at several locations. These repaired posts will need to be monitored for any continued movement. The inspector is unable to determine if there is a continued issue based on a one time inspection.

Wood support posts have engineered reinforcement that appear to perform as intended

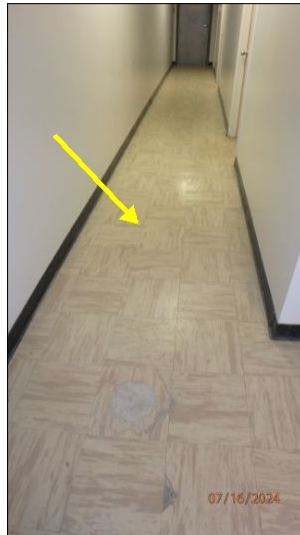
The vinyl floor tiles in the basement appeared to be older. Vinyl floors manufactured before 1980 may contain asbestos. Confirmation would require laboratory testing. Once the presence of asbestos was confirmed, you would be required to disclose its presence when you sell the building. Asbestos can be hazardous to human health if it is in a form in which asbestos fibers may be inhaled. Fibers may become airborne as a result of cutting, tearing, or abrading a material. Vinyl floors are best left in place. If another type of flooring is desired, it is often installed over the existing vinyl.

Some original floor tiles in basement may contain asbestos

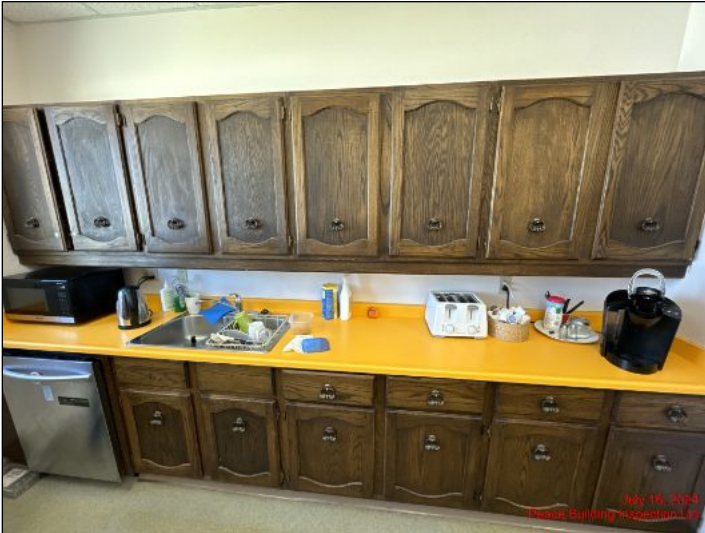
Upper level kitchen area in good condition at time of inspection

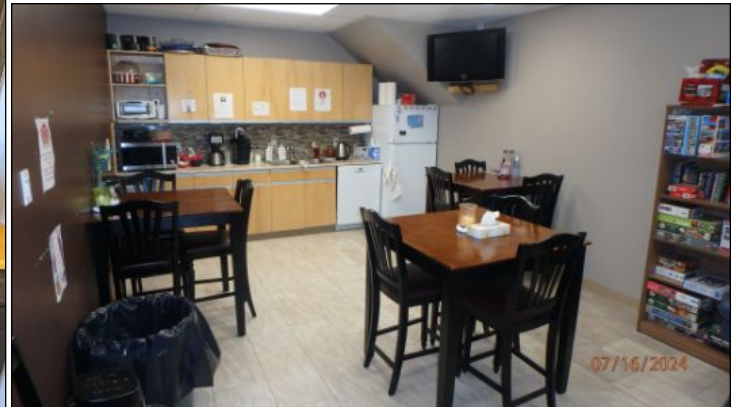
Main level kitchen in good condition at time of inspection

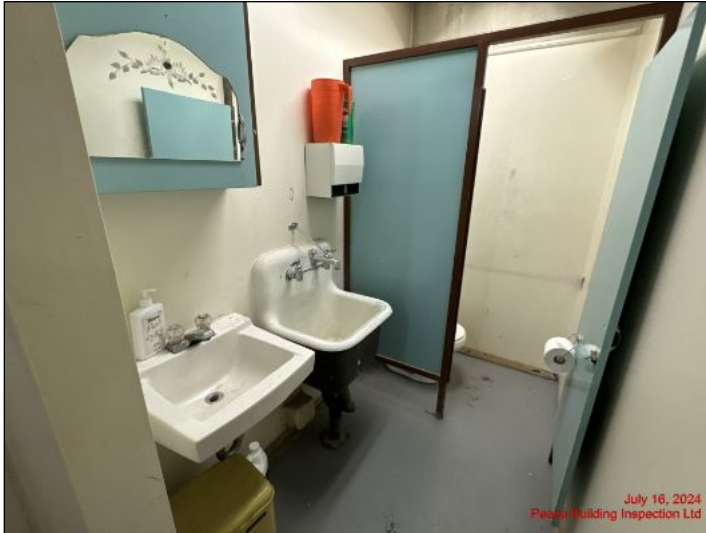
Basement bathroom in good condition at time of inspection

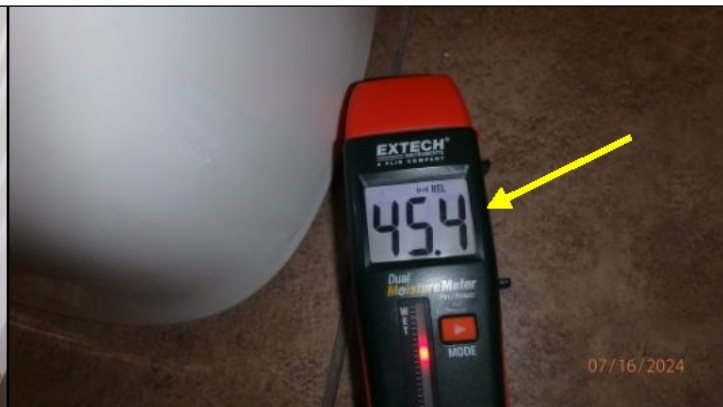
In one or more bathrooms, the toilet was loose at the floor and should be re-attached by a qualified plumbing contractor.

In one or more bathrooms, moisture meter readings indicated elevated moisture levels in the floor around the base of the toilet(s). This condition is typically due to failure of the wax gasket that seals the toilet to the floor. The inspector recommends that the gasket be replaced. All work to be performed by a qualified plumbing contractor to avoid subfloor damage from decay.

Some toilets were loose at floor and show signs of moisture

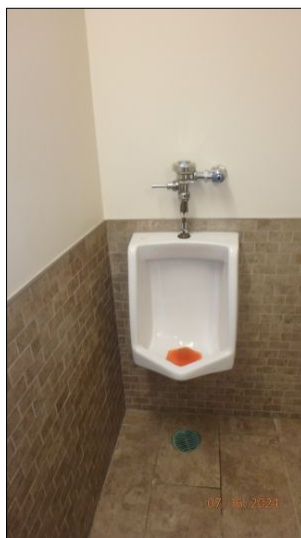
Mens urinals in good condition at time of inspection

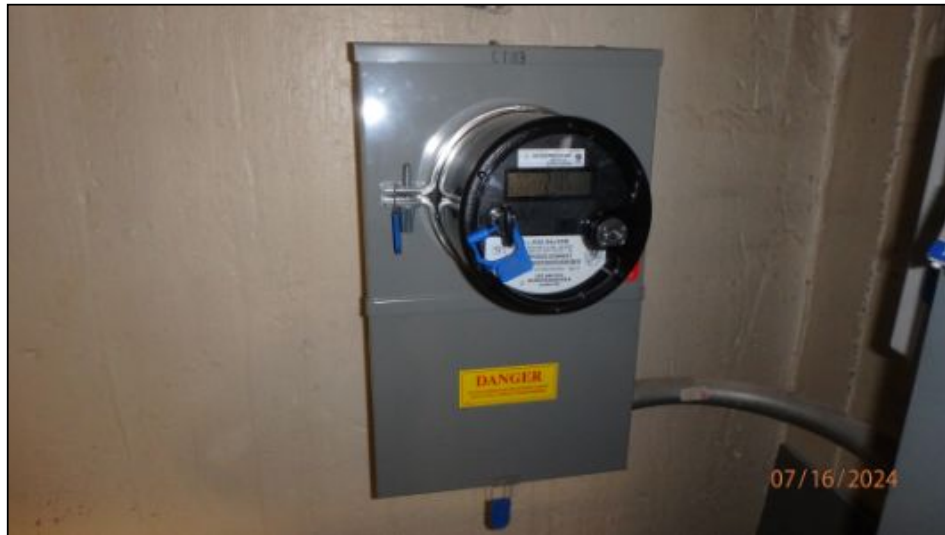
Electrical meter located in basement boiler room

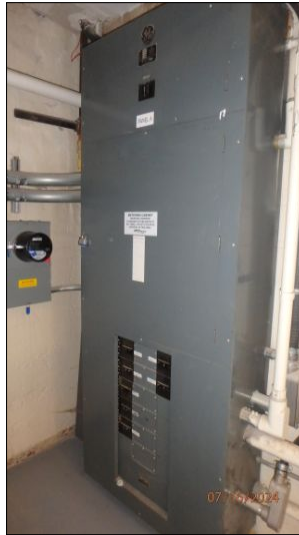
Building equipped with a 300 amp distribution breaker

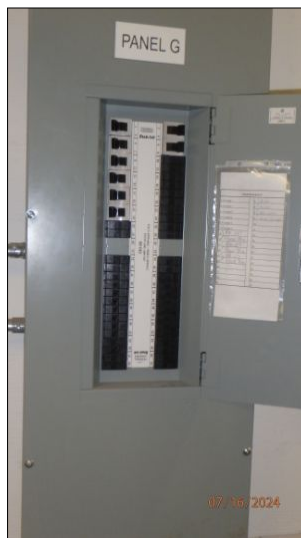
The building is equipped with 10 sub panels in various location. All visible subpanel exterior in good condition at time of inspection

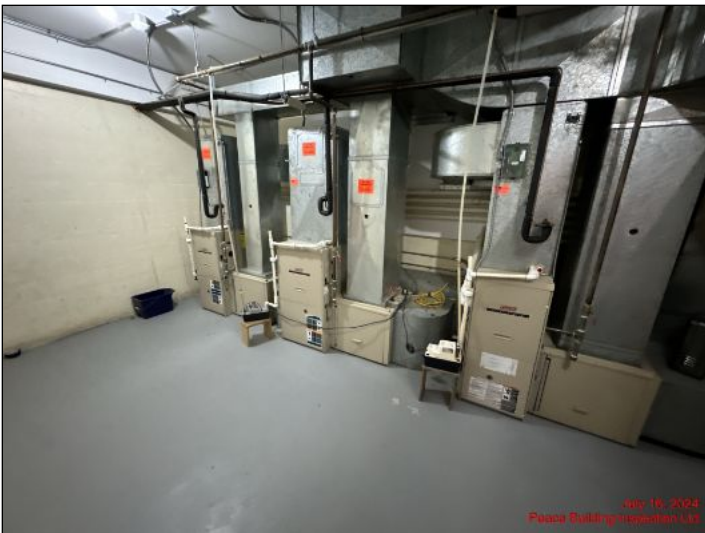
The building is equipped with (7) twenty year old furnaces

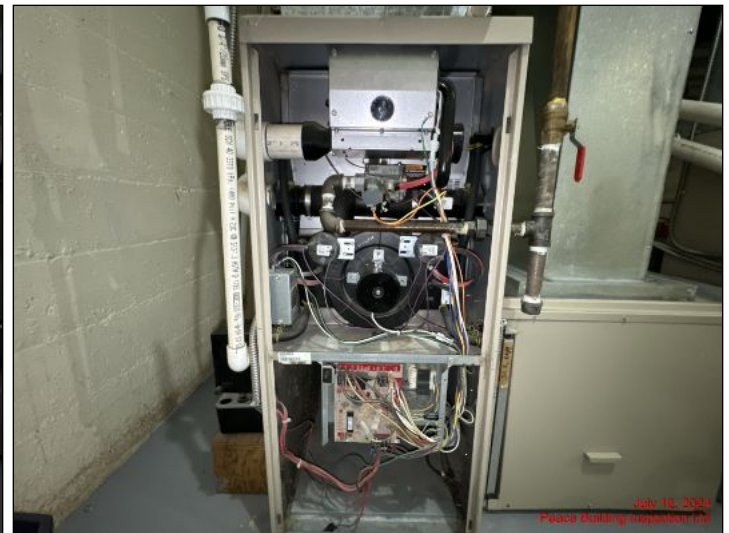
All furnace interiors in good condition at time of inspection

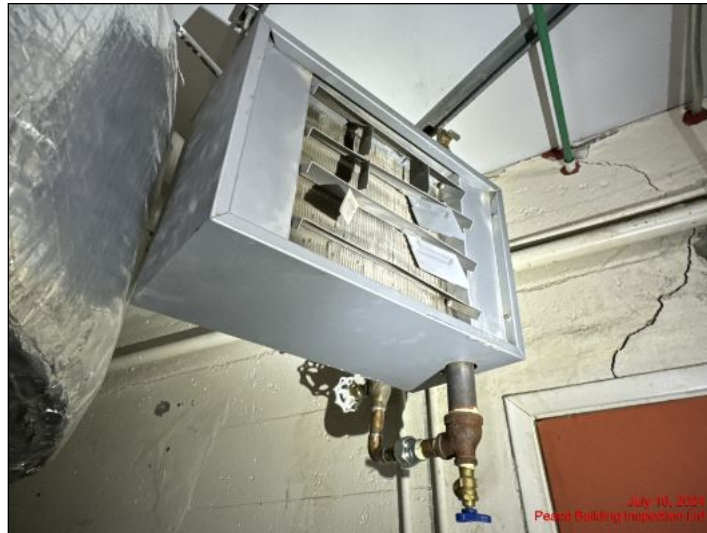
Basement equipped with hot water radiant overhead heaters in good condition at time of inspection

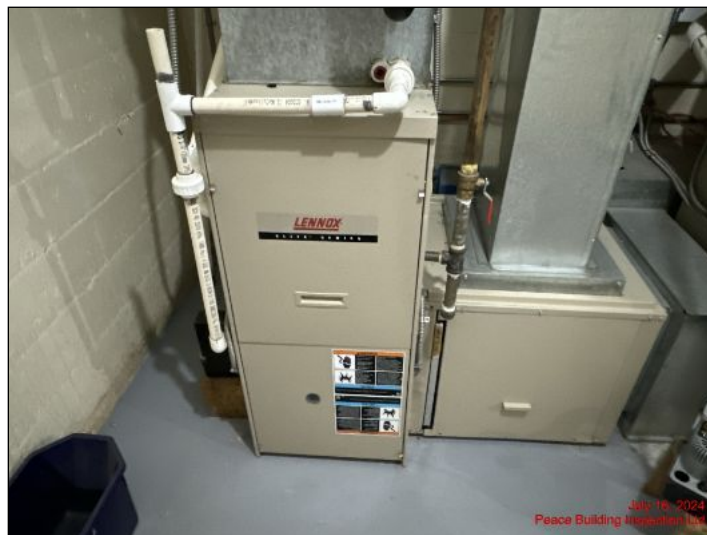
All furnaces in good condition at time of inspection

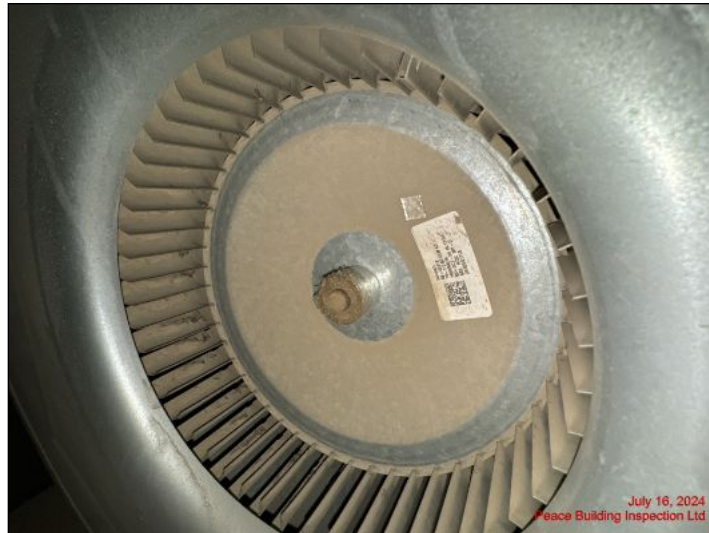
All furnace blowers and motors in good condition at time of inspection

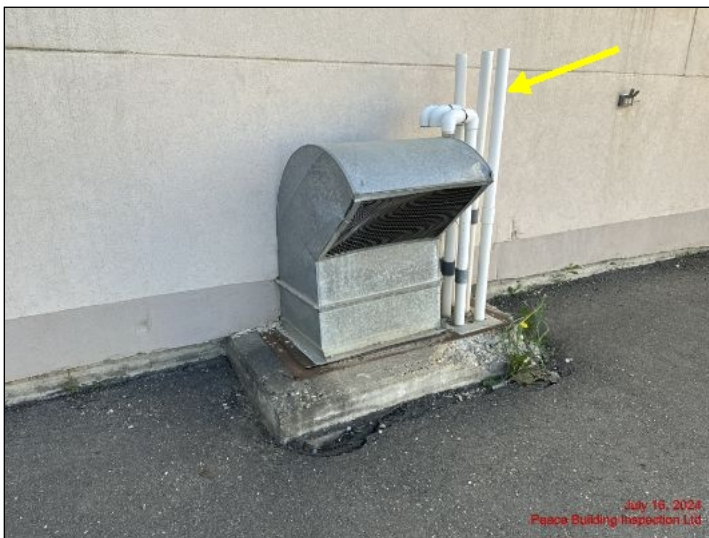
Furnace exhaust venting in good condition at time of inspection

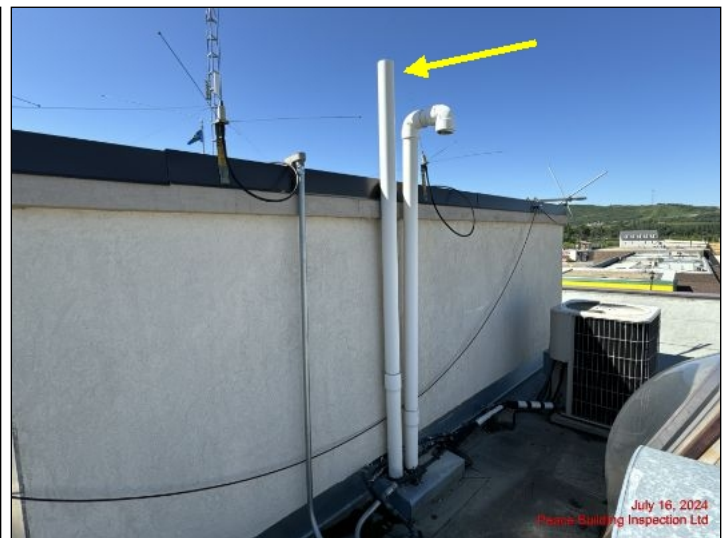
Upper furnace exhaust vent in good condition at time of inspection

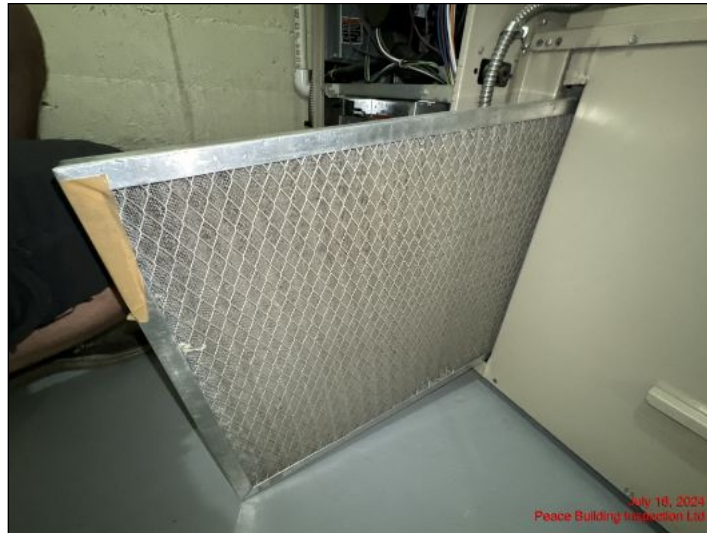
Furnace air filters in good condition at time of inspection

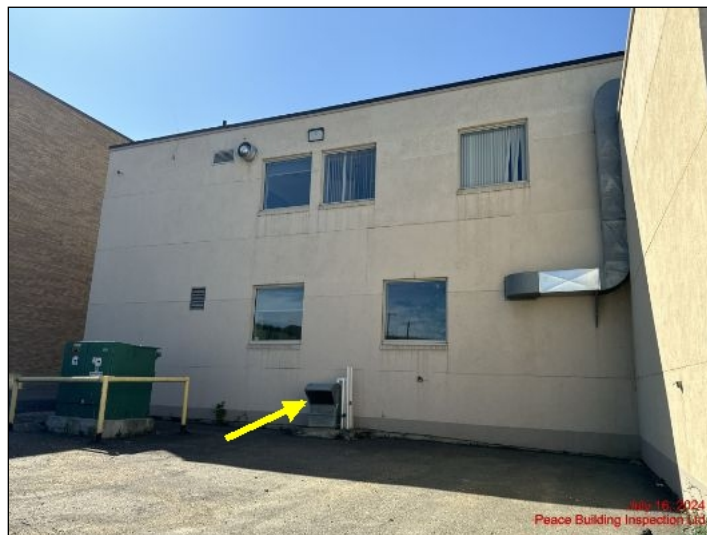
Combustion air in good condition at time of inspection

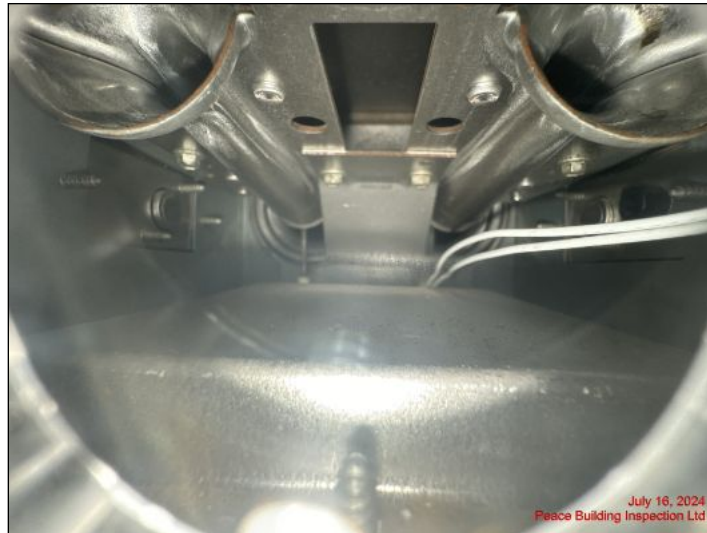
Visible portion of all furnaces in good condition at time of inspection

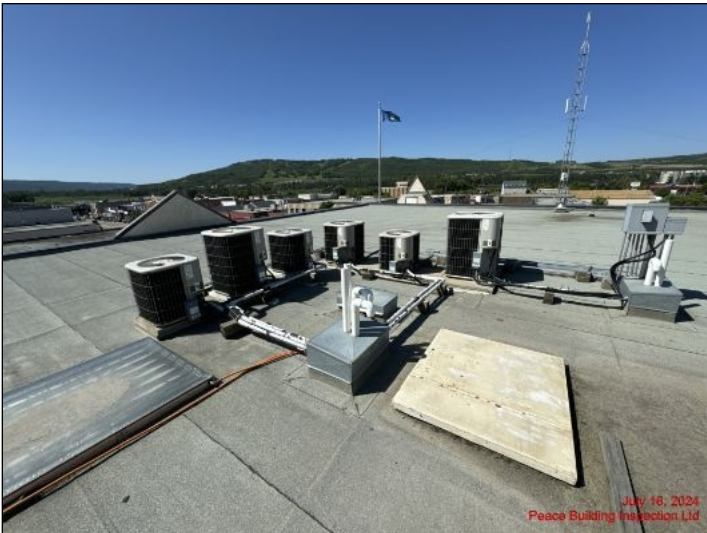
The air-conditioning systems are now (20) years old. Six of the seven air conditioners were functioning at the time of the inspection. The inspector is not required to determine the proper size air conditioners for a building of this size. Examination of the existing air conditioning units indicates that at least 3 of the air condition units may be undersized for this building.

The building is equipped with 7 air conditioning units that are now 20 years old

Further investigation and calculation by a qualified contractor/engineer is recommended to determine if the amount and size of existing air conditioners adequately meet the cooling requirements for a building of this size and configuration.

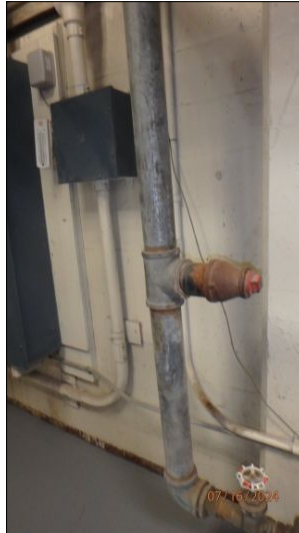
Several water supply pipes in the building were galvanized steel. These pipes are now over 50 years old, and of a material no longer installed for this purpose due to bore shrinkage from accumulation of interior corrosion that over time reduces water flow. These pipes may need to be replaced soon. The Inspector recommends that you consult with a qualified contractor to discuss the necessity, options and costs for replacement should leakage occur.

Some building water supply pipes are galvanized

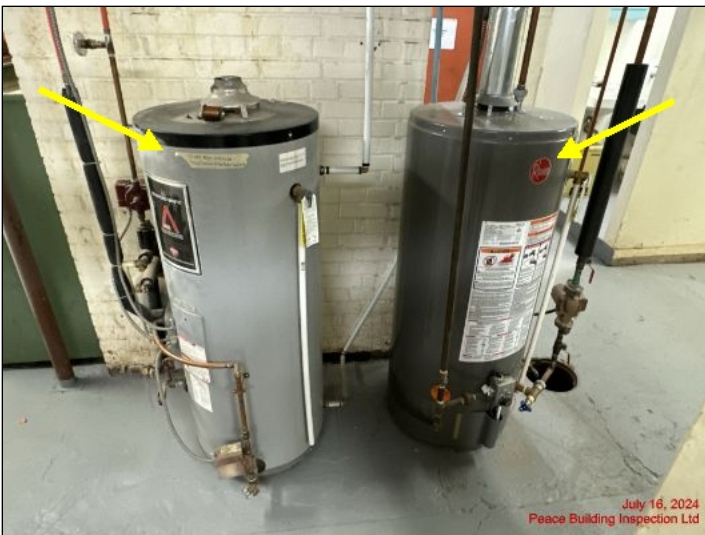
The solar water heater is equipped with a solar panel on the roof of the building. This solar panel has failed and is no longer operational. The solar panel will require replacement and the water tank it services is an older unit approaching end of service life. The Inspector recommends replacement by a qualified contractor.

Building equipped with a solar water heater and a conventional water heater

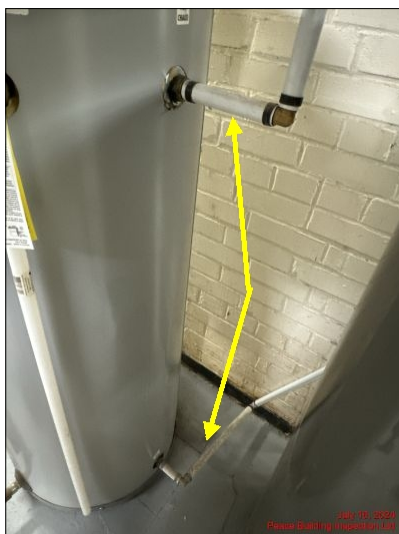
Solar water heater is provided with hot water from the conventional water heater

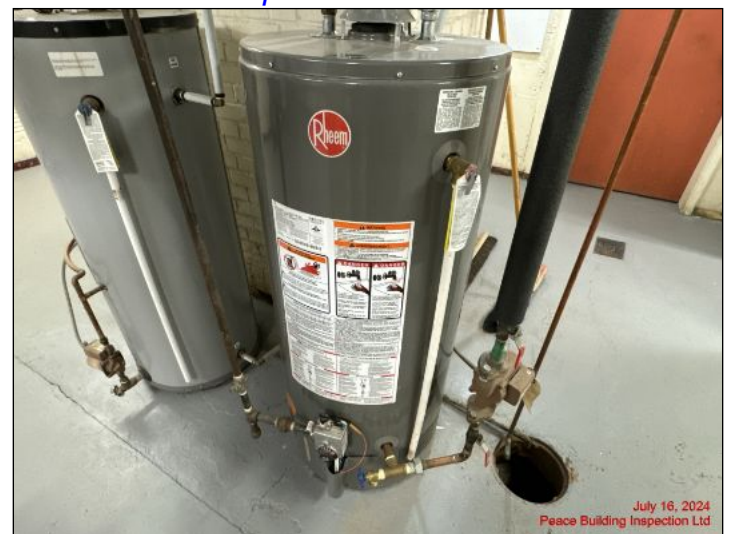
At the time of the inspection, the Inspector observed no deficiencies in the condition or operation of the gas fired water heater.

5 year old conventional water heater in good condition at time of inspection

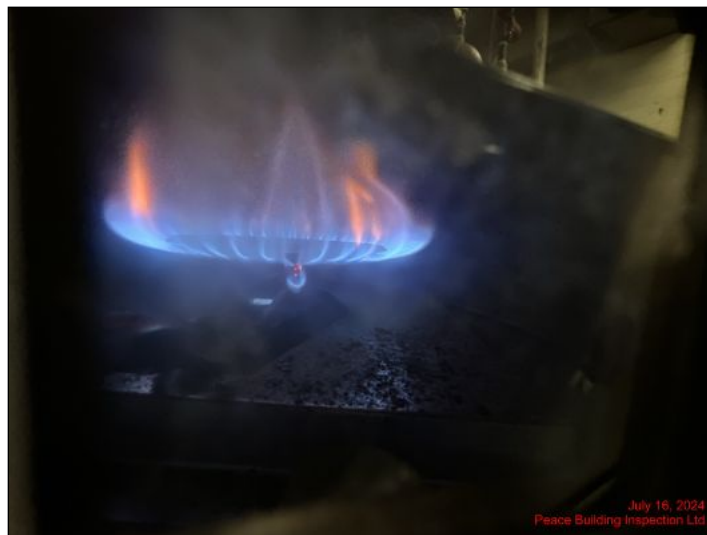
The water heater burn chamber was clean and in good condition at the time of the inspection.

Water heater burner operated properly when tested

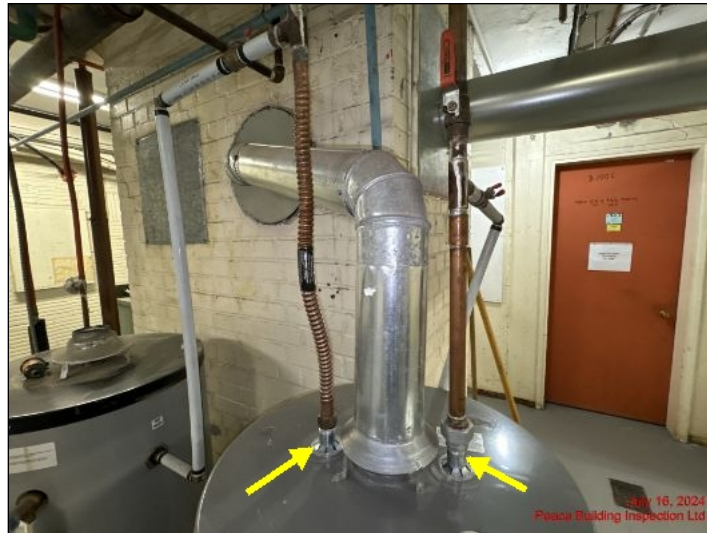
At the time of the inspection, the Inspector observed no deficiencies in the condition of water pipe fittings connected to this water heater.

Water heater pipe connections in good condition at time of inspection

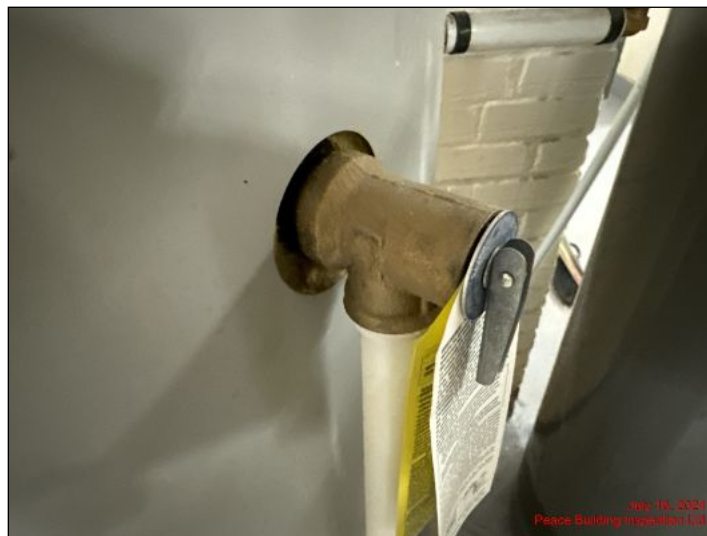
At the time of the inspection, the Inspector observed no deficiencies in the condition of the temperature/pressure relief (TPR) valve (not tested) and the TPR discharge pipe.

Water heater pressure relief valves in good condition at time of inspection

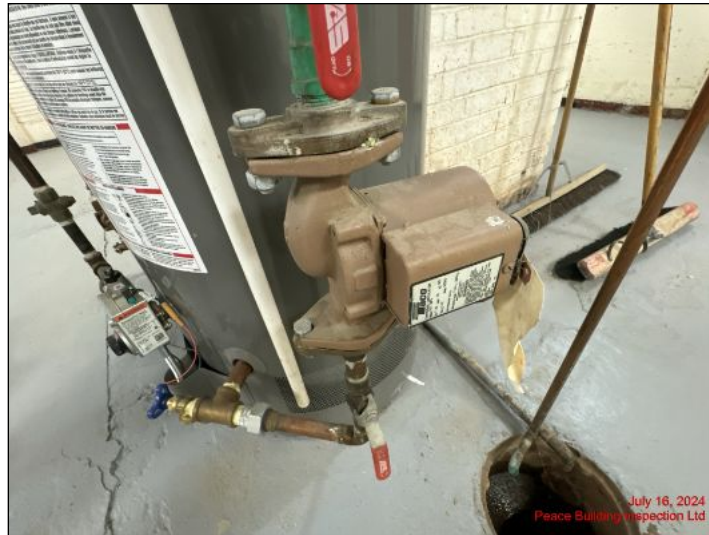
The building had a hot water recirculation system installed. This system includes a second hot water supply pipe in which hot water circulates through the building.

Water heater Circulation system operated properly at time of inspection

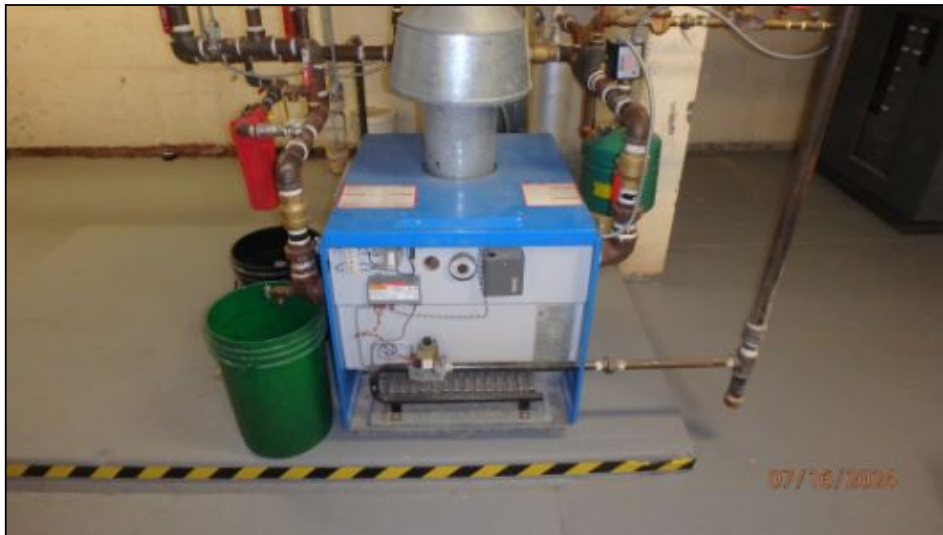
At the time of the inspection, the Inspector observed no deficiencies in the condition and operation of the boiler.

Boiler in good condition at time of inspection

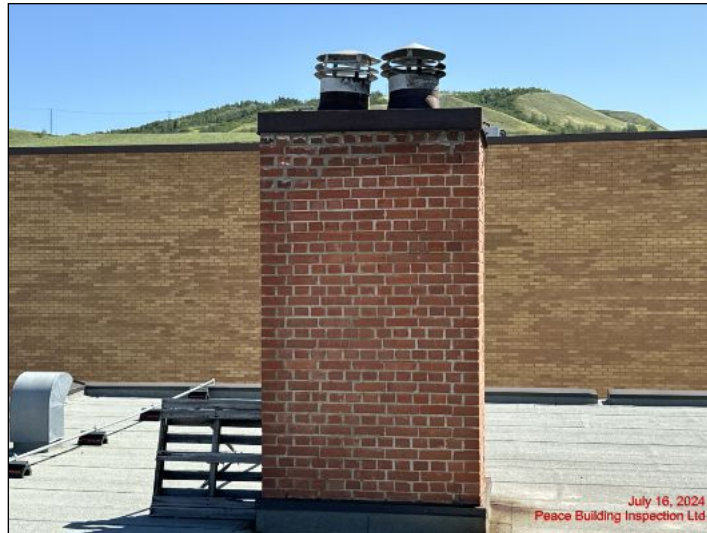
The boiler combustion exhaust flue appeared to be properly configured and in serviceable condition at the time of the inspection.

Boiler exhaust flue in good condition at time of inspection

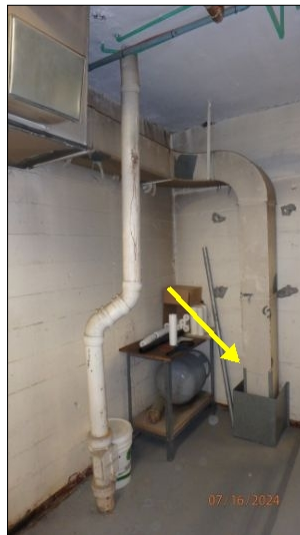
Combustion air supply appeared to be sufficient at the time of the inspection.

Boiler room combustion air in good condition at time of inspection

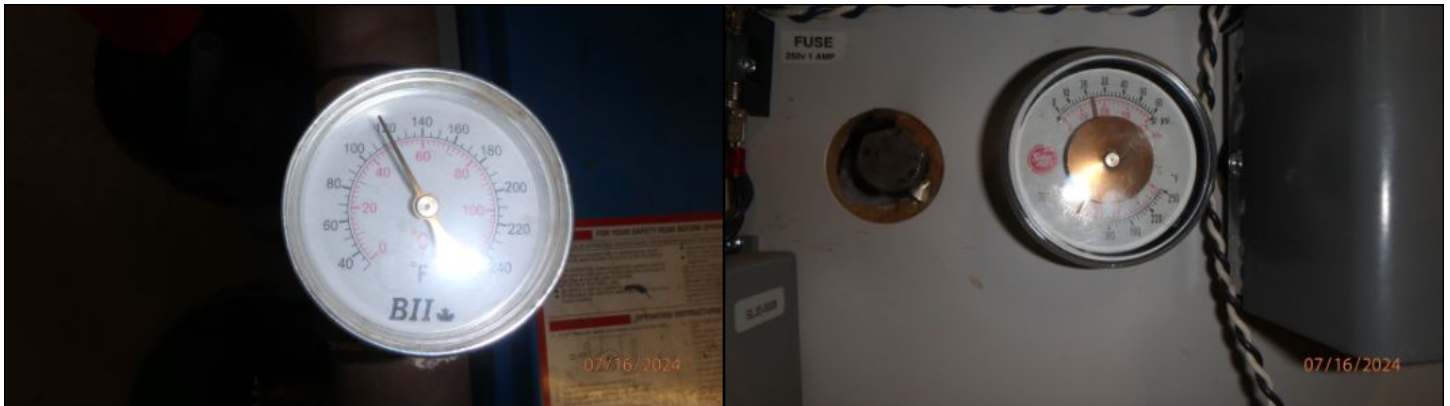
According to the installed system gauge, the boiler system water temperature was within the acceptable range at the time of the inspection.

According to the installed system gauge, boiler system pressure was within the typical safe design limits at the time of the inspection.

Boiler operating at proper temperature

Boiler system operating at the proper pressure

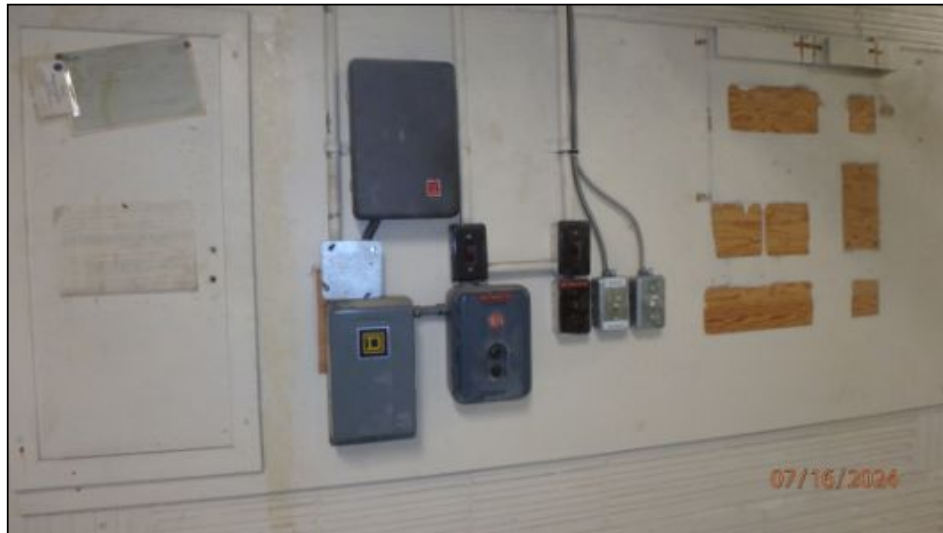
Boiler and system shutoff properly located

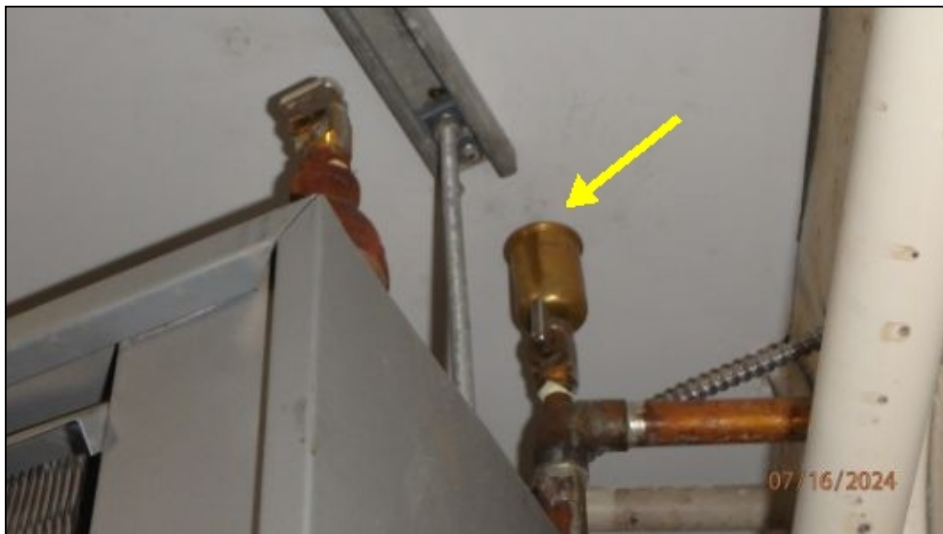
At the time of the inspection, the Inspector observed no deficiencies in the condition of the boiler air vent.

Visible boiler air vent in good condition at time of inspection

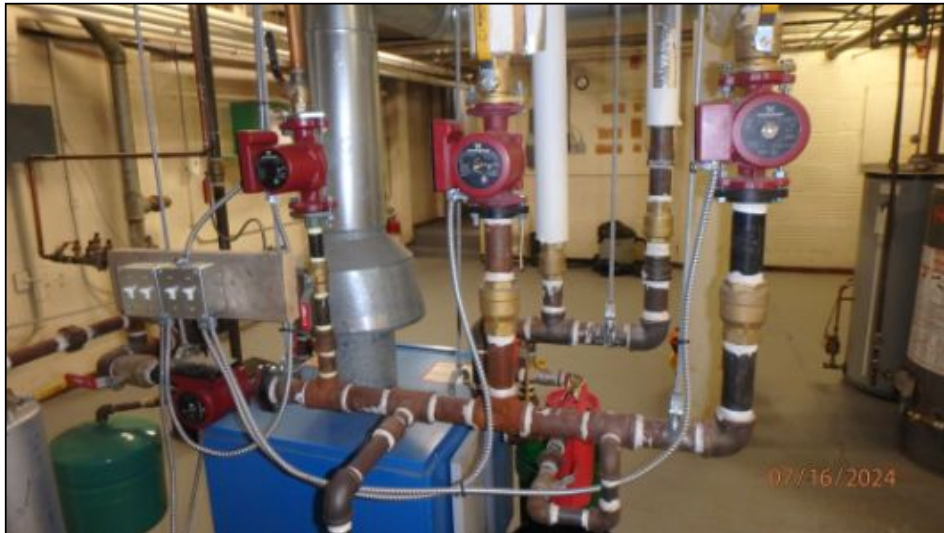
At the time of the inspection, the Inspector observed no deficiencies in the condition of the circulation pump.

Boiler circulating pumps in good condition at time of inspection

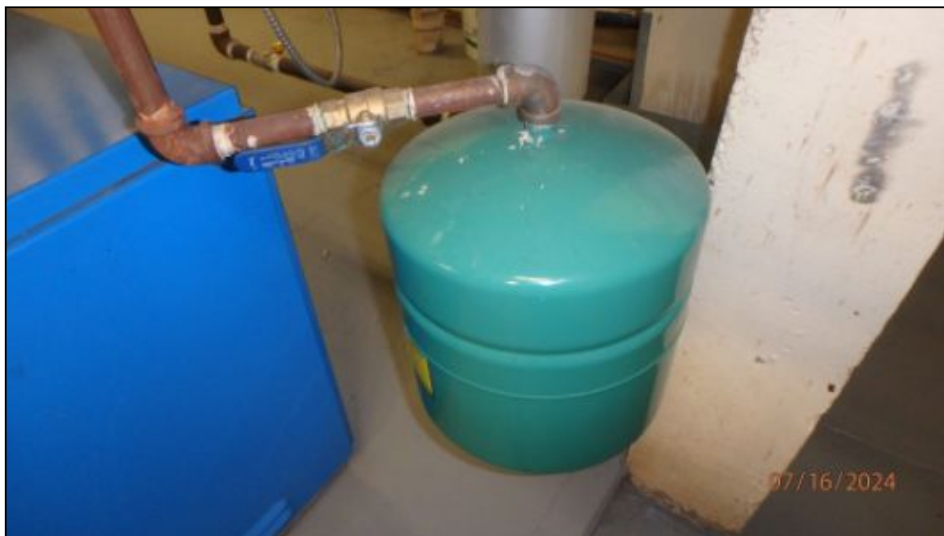
The boiler had an expansion tank installed to allow for thermal expansion of water in the plumbing pipes. The expansion tank appeared to be properly installed.

Boiler expansion tank in good condition at time of inspection

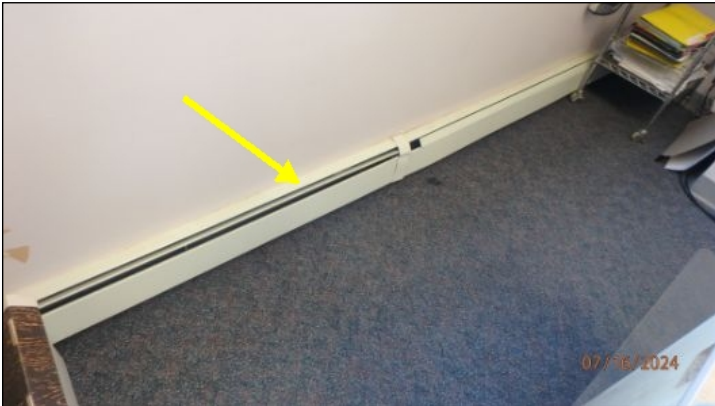
Building equipped with baseboard heaters

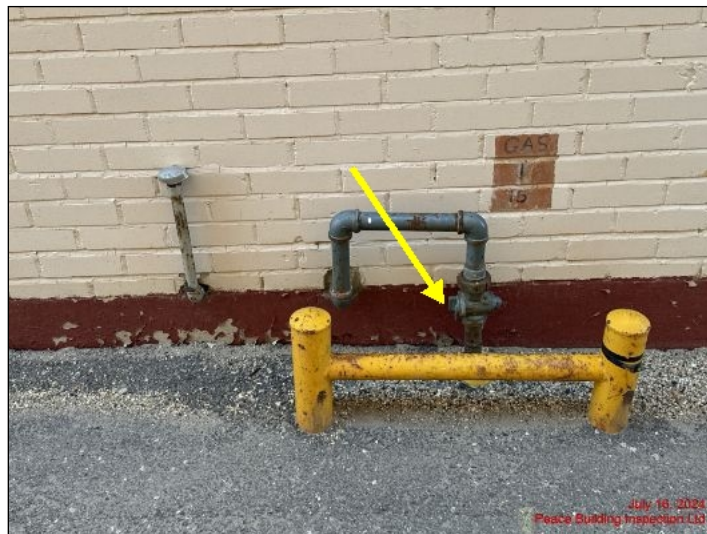
The gas shutoff appeared to be in serviceable condition at the time of the inspection. Shutoffs were not operated, but were visually inspected.

Gas line located at rear of building and properly protected from vehicle damage

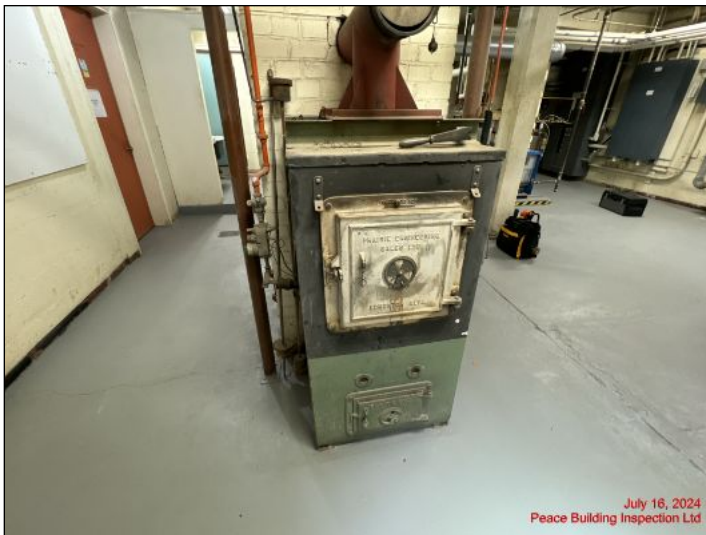
A wood stove was located in the basement. This unit is no longer used and should be removed.

Building equipped with a wood stove that is no longer used and not fully inspected

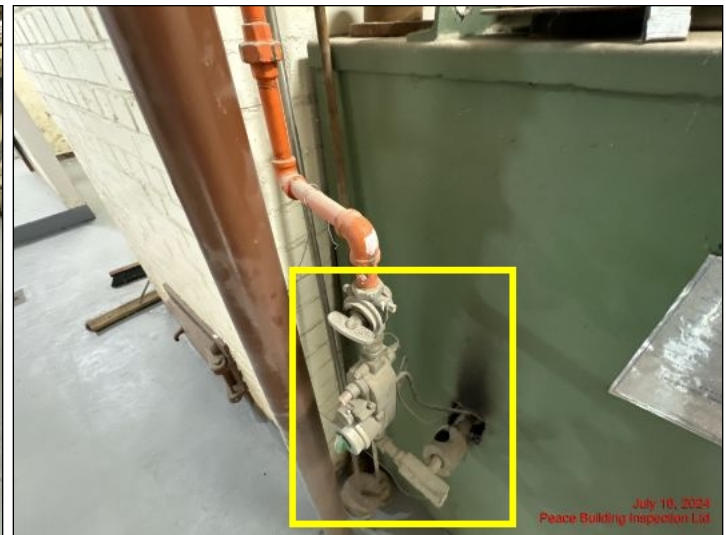
The wood stove is equipped with a natural gas lighter. This was commonly used in years past. Unfortunately gas lines into a wood firebox is no longer allowed. The gas line will need to be disconnected and no longer used. The first gas valve in the line should be shut off and the end of the gas line capped off for safety reasons. The Inspector recommends correction by a qualified gas fitting contractor.

Gas line to wood stove needs to be removed and capped off

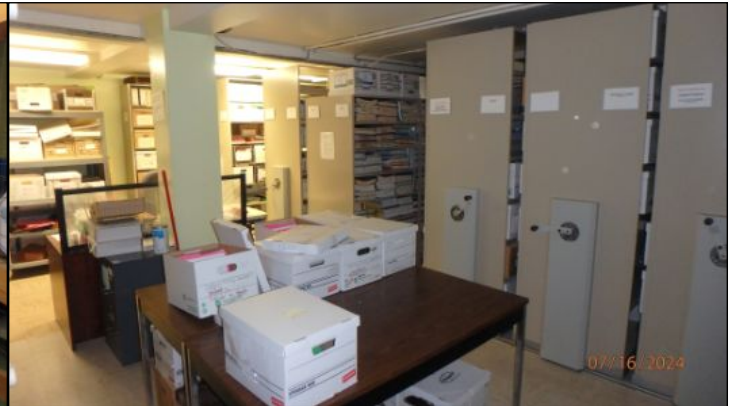
Filing area in good condition at time of inspection

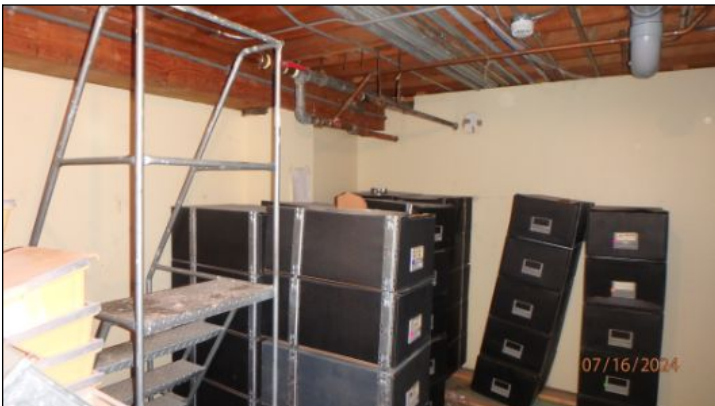
Storage area in good condition at time of inspection

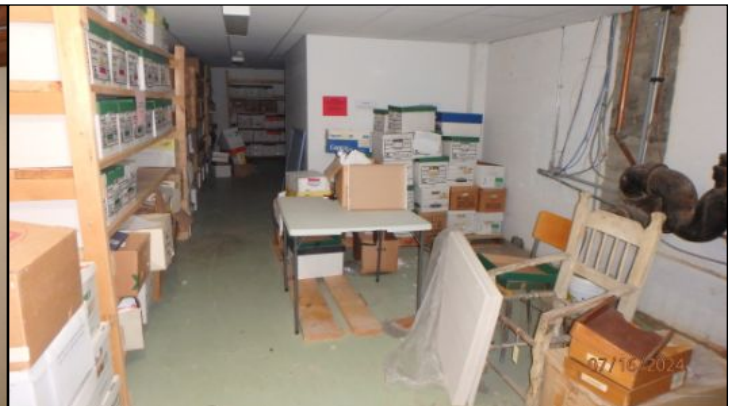
Basement storage area in good condition at time of inspection

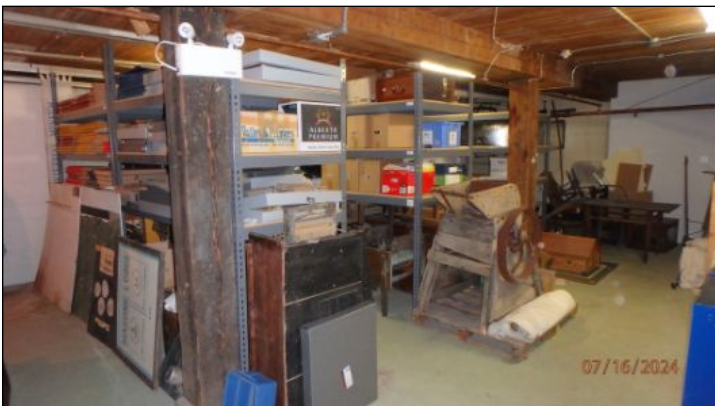
Basement storage area in good condition at time of inspection

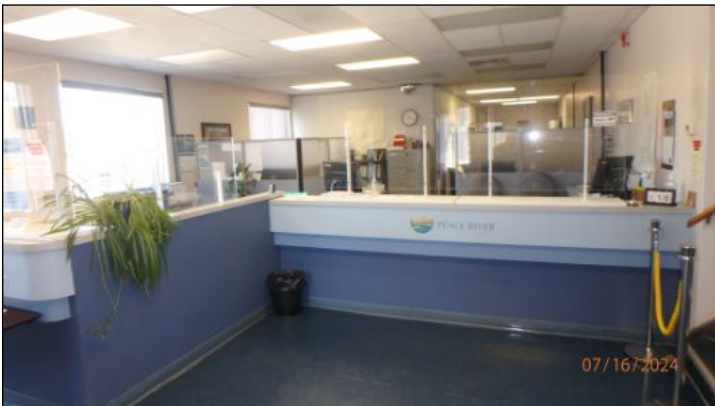
Reception area in good condition at time of inspection
