Airport Assessment and Gap Report Peace River Airport

Airport Assessment and Gap Report Peace River

August 16th, 2013

LPS Aviation Inc.
One Antares Drive, Suite 250
Ottawa, Ontario
CANADA K2E 8C4

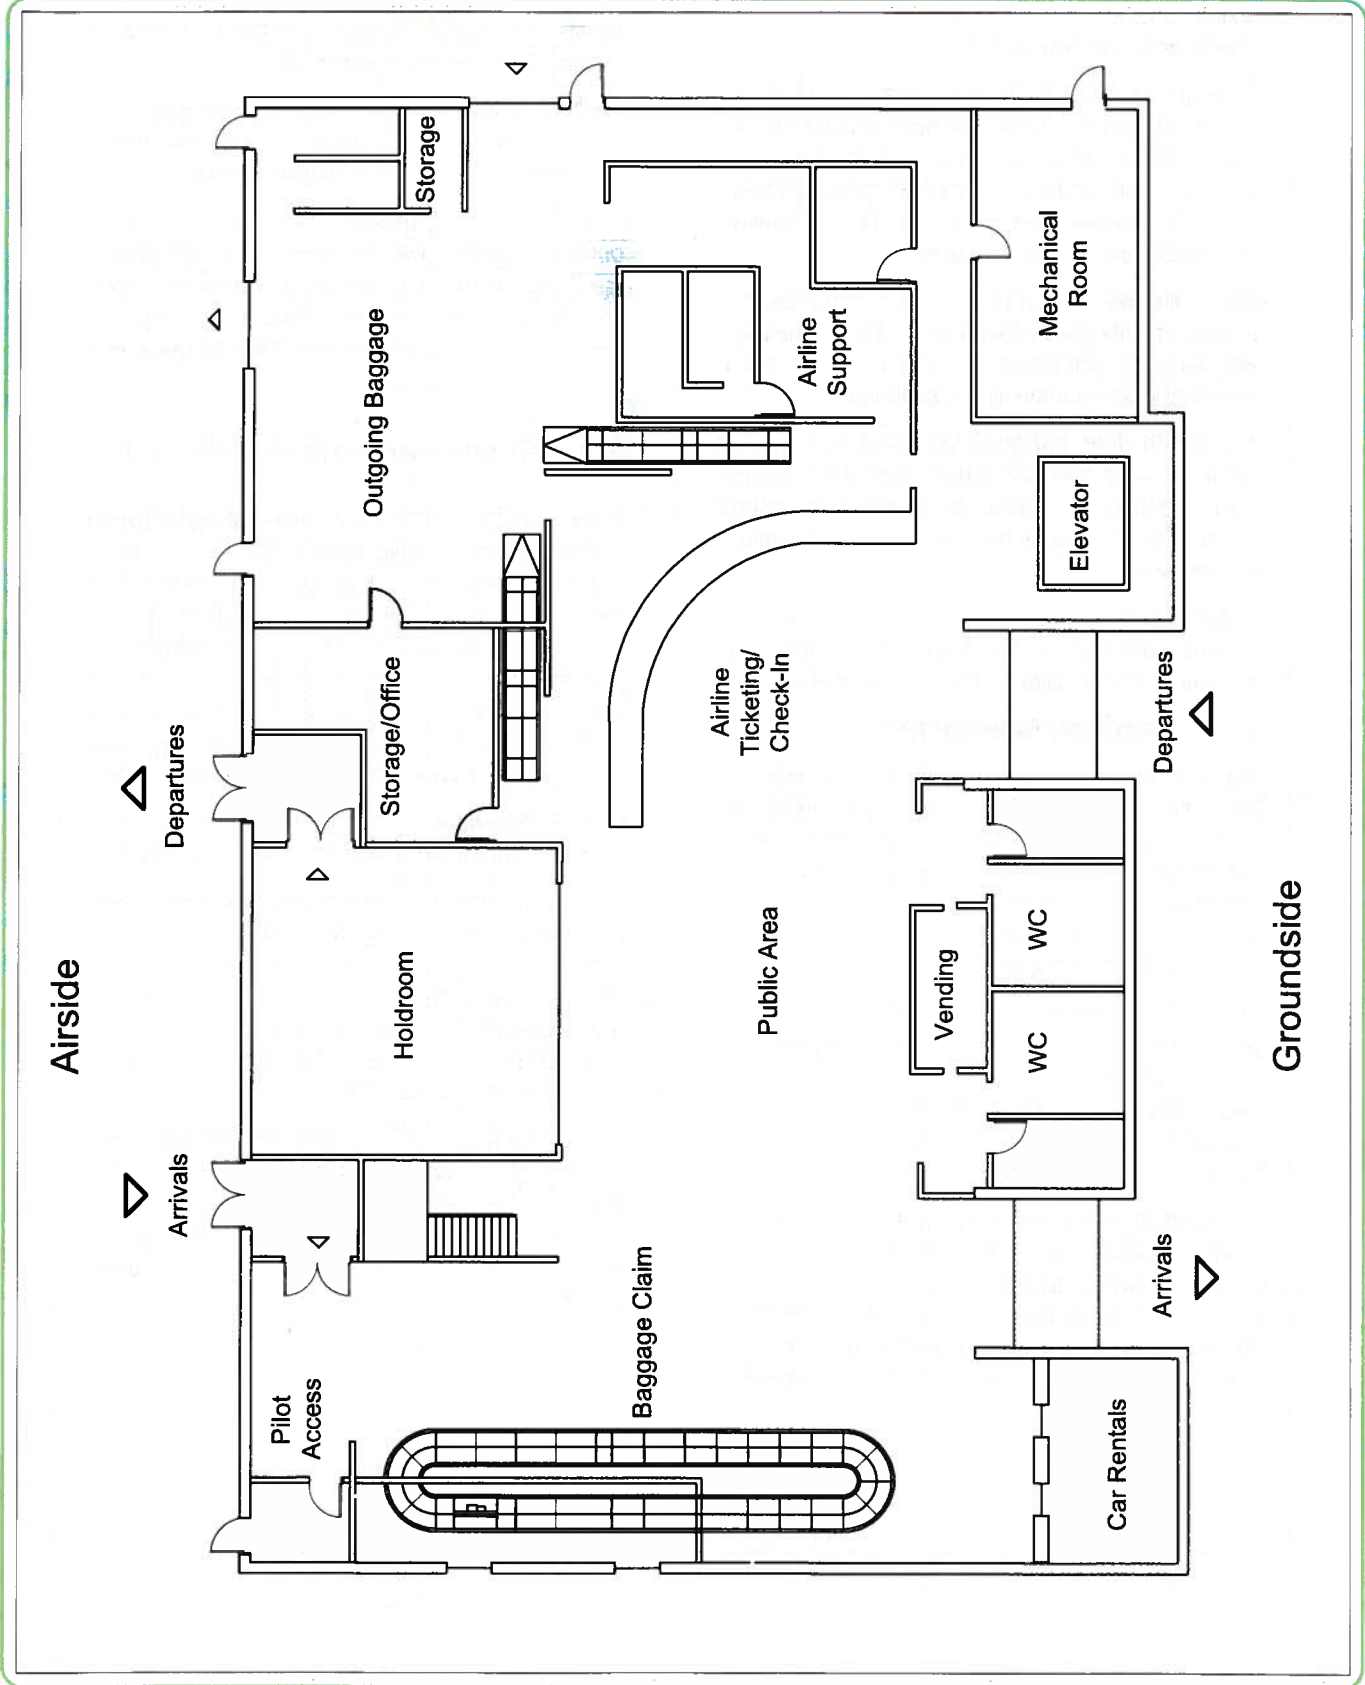
Figure No. 2-2

A breakdown of the ATB's functional areas (main floor only) is provided in Table 2-2, and a layout of the ATB's main floor is provided in Figure 2-2.

The air terminal building was found to be in generally good operating condition during a recent inspection with significant areas underused. Surplus space was observed for example on the ground floor in the airline check-in area, baggage make-up area and public waiting areas.

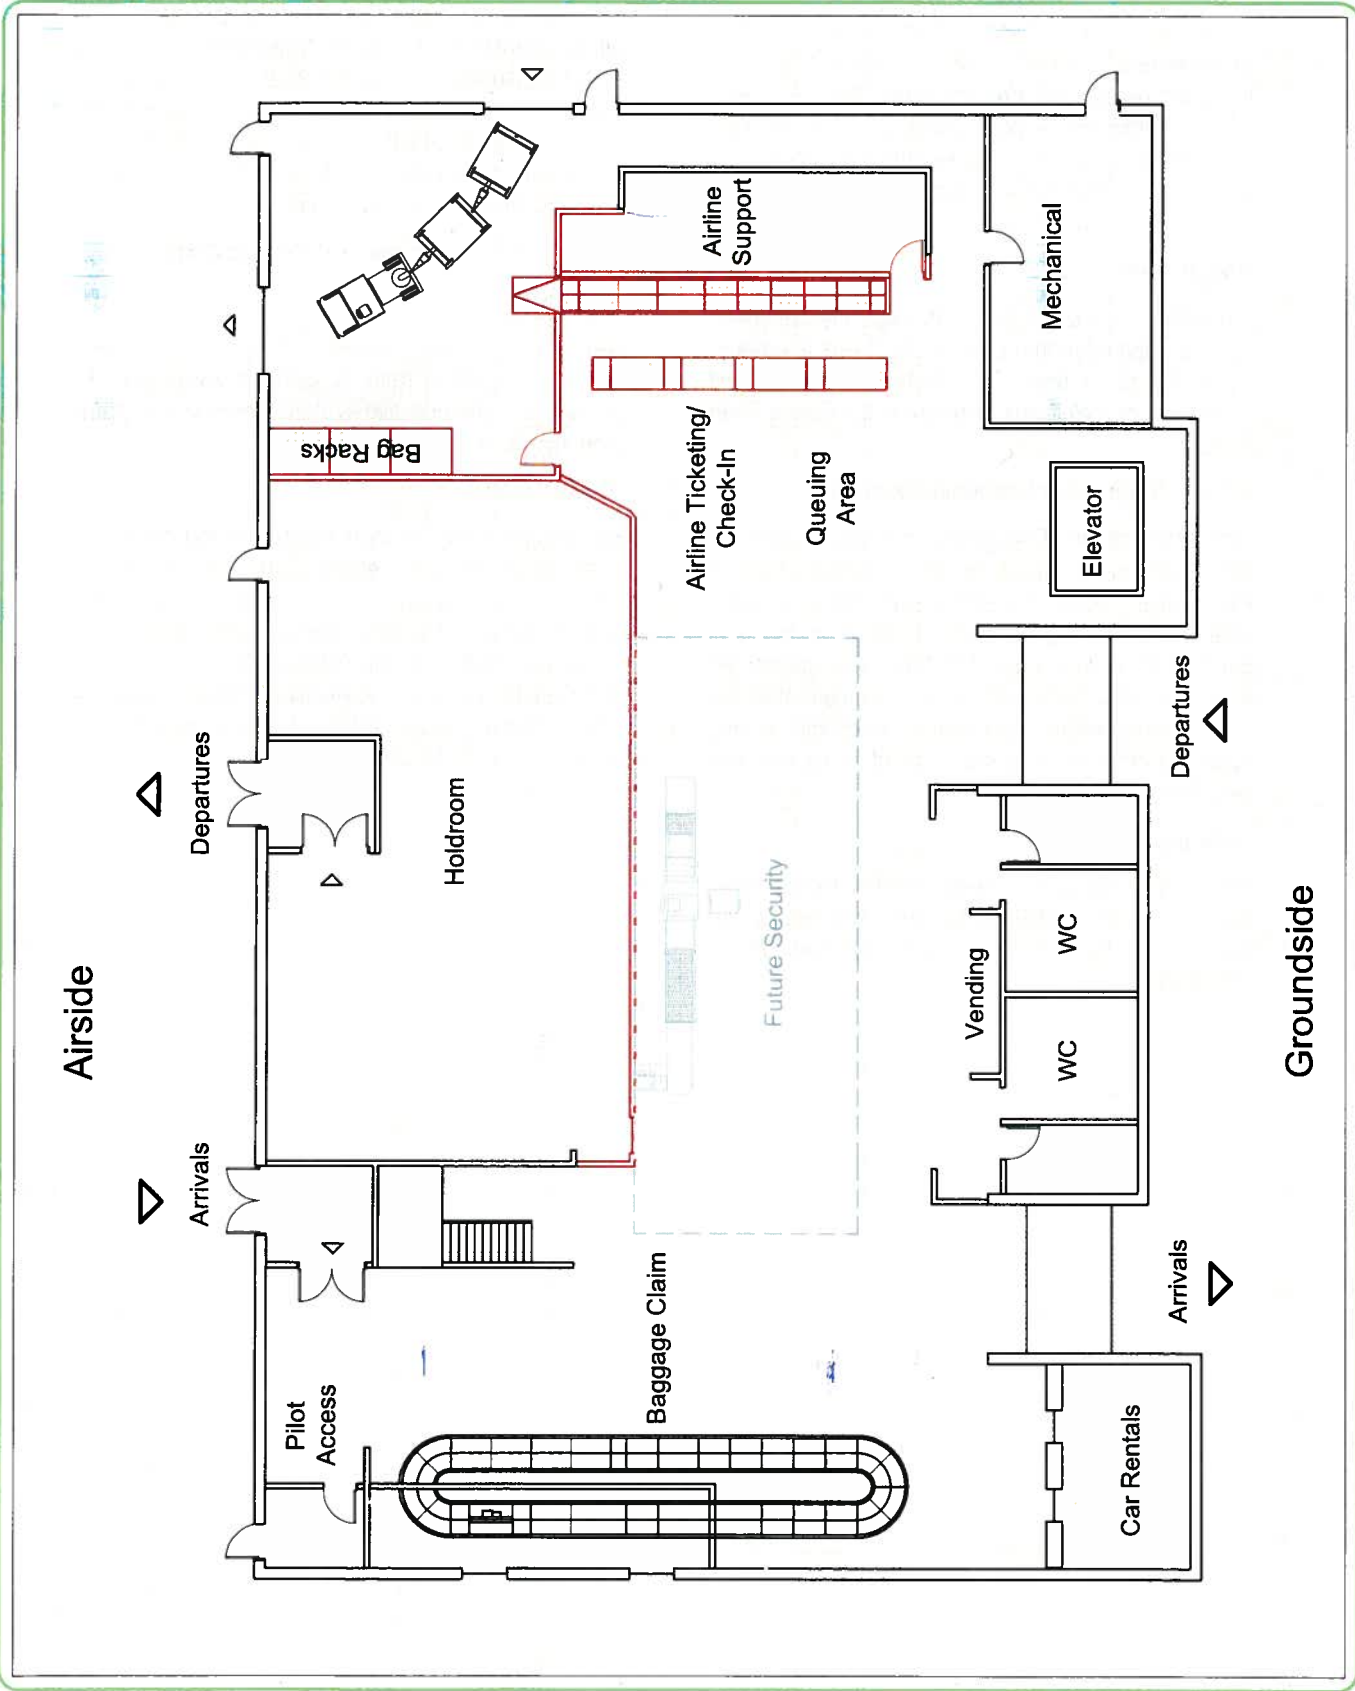
Figure No.	4-2
Drawn By	EDH
Approved By	RAM
Date	AUGUST 2, 2013
Scale	NTS
Filename	PR Terminal

The baggage belt and chute will be removed/relocated. Out-bound Baggage Make-up Room will be reduced in size and drive-through capability for baggage carts re-established.

It is recommended that a portion of the public area within the core of the ATB be reserved for a future passenger security processing area, potentially using a temporary swing wall. A proposed ATB Development Concept is presented in Figure 4-2.
