Peace Building Inspection Ltd.

Property Inspection Report

9715 - 100th Street, Peace River, AB. T8S 1S8
Inspection prepared for: Tanya Bell (Town of Peace River, AB.)
Real Estate Agent: Layne Gardner - Re/Max Northern Realty

Date of Inspection: 4/9/2024 Time: 11 a.m. Size: 19,300 sq. ft.
Weather: Sunny
Building is 41 years old.

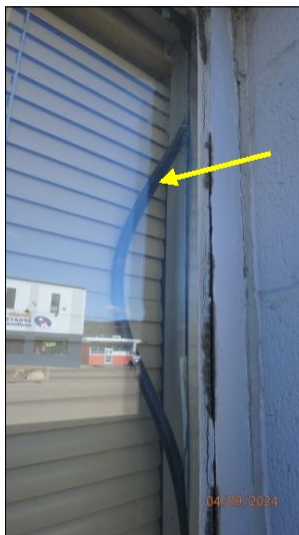
Although no condensation was visible at the time of the inspection, several windows basement indicated a loss of thermal integrity. The seal gasket was visible in the window. The Inspector recommends that you consult with a qualified contractor to discuss options and costs for repair or replacement of any window with exposed loose seals.

A few window seals have failed

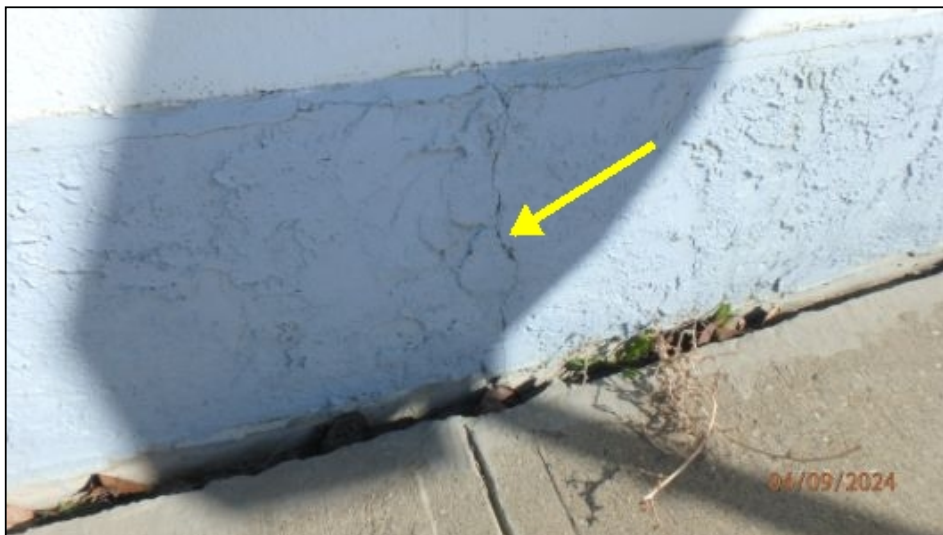
Concrete foundation in good condition at time of inspection. Some minor cracking observed

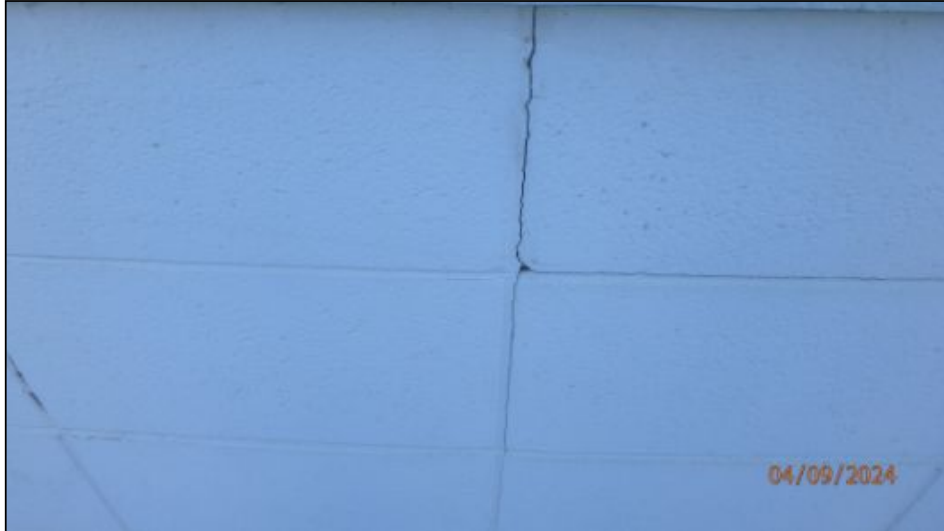
Concrete masonry unit walls/foundation has typical minor cracks but is very good overall condition

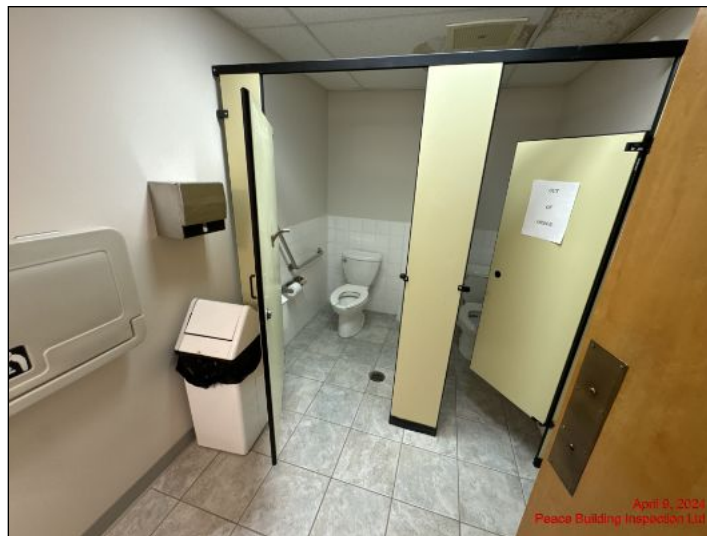
The Toilets in bathrooms appeared to be in serviceable condition at the time of the inspection. Water shut off at time of inspection. The Inspector recommends evaluation and any corrections be performed by a qualified contractor once water is restored.

Bathroom sinks and toilets could not be tested as water supply was off at time of inspection

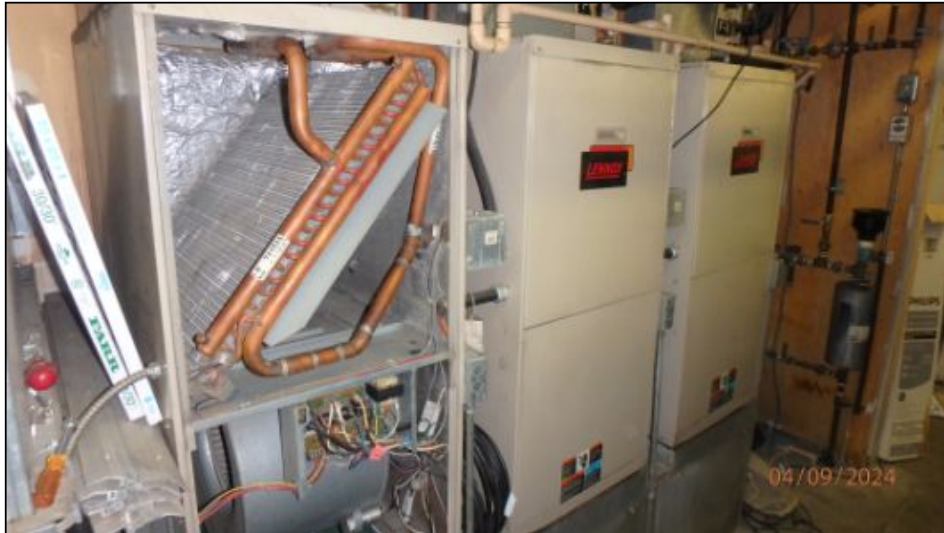
The building is equipped with (11) - (25 year old) hot water radiant coil furnaces in the upper level mechanical room

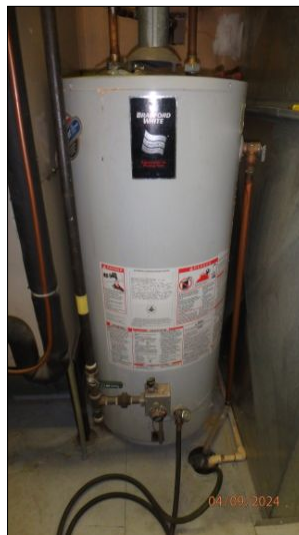
The water heater was old, and may need to be replaced soon.

Water heater is (25) years old and at end of service life. Replacement recommended

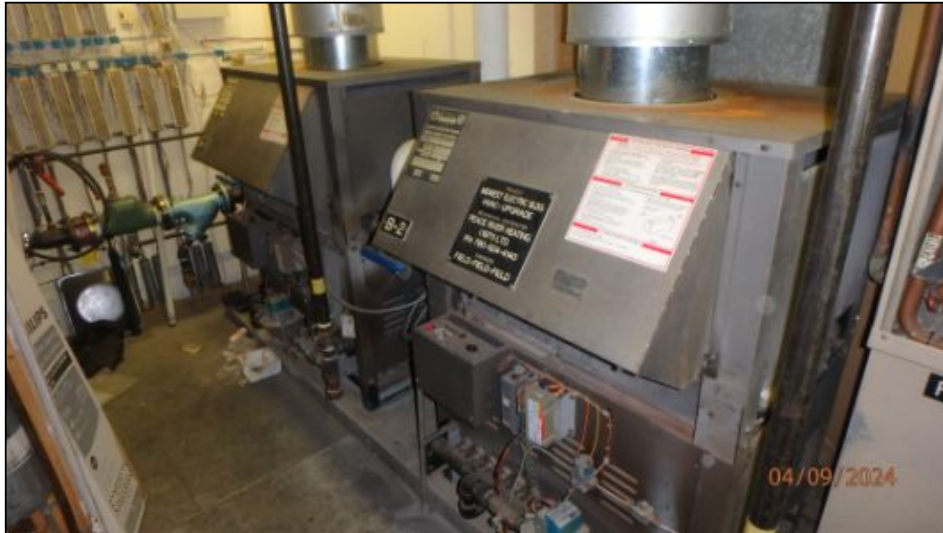
The building is equipped with (2) - (25) year old boilers located in the upper level mechanical room
