Peace Building Inspection Ltd. Property Inspection Report

9911 - 100th Street, Peace River, AB.

Inspection prepared for: Tanya Bell (Director of Community Services)

Date of Inspection: 7/16/2024 Time: 11 a.m. Size: 16,500 sq. ft.

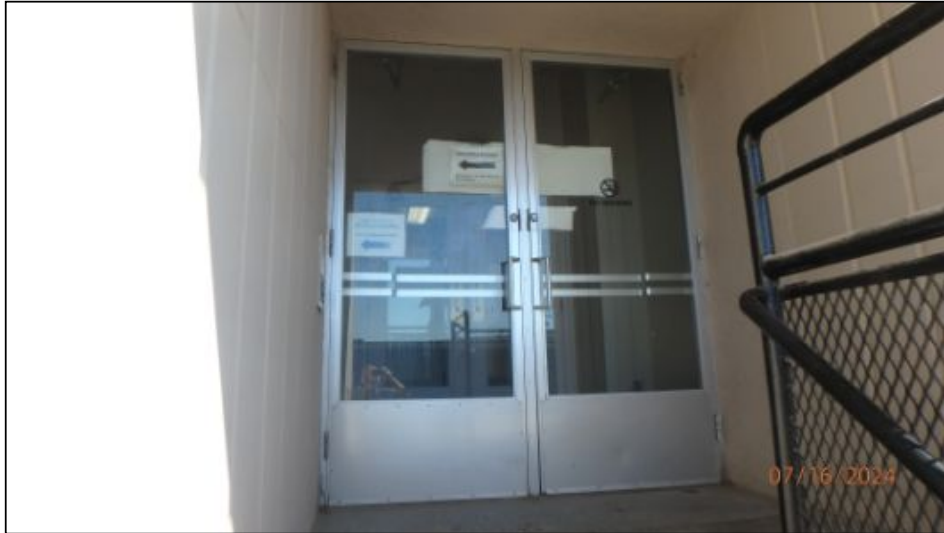
All exterior doors in good condition at time of inspection

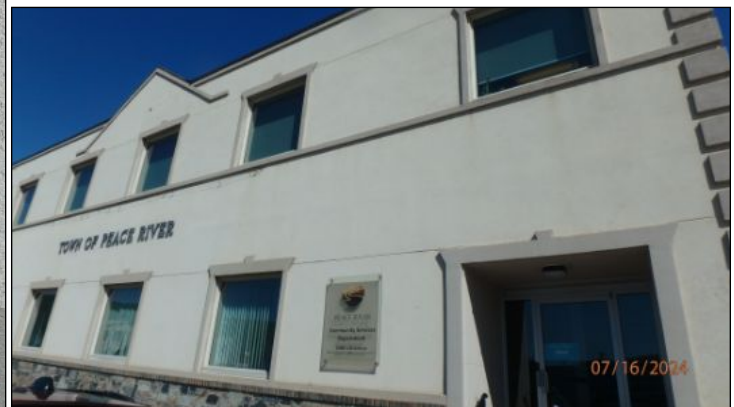
Stucco covering exterior walls of the building had minor damage visible at the time of the inspection.

Some minor stucco damage observed at the lower portion of the building *Exterior synthetic stucco in mostly good condition at time of inspection*

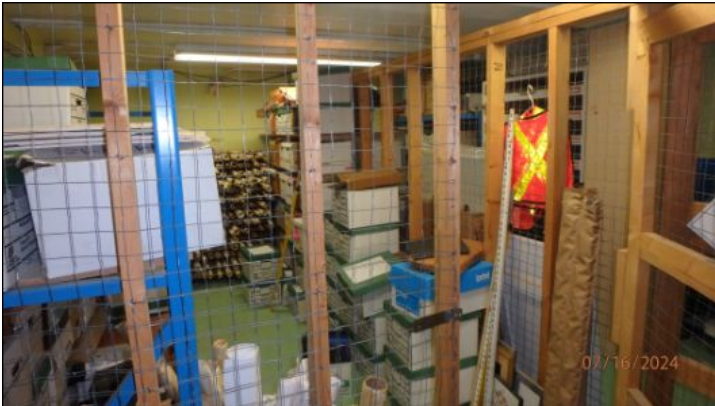
Basement storage area in good condition at time of inspection

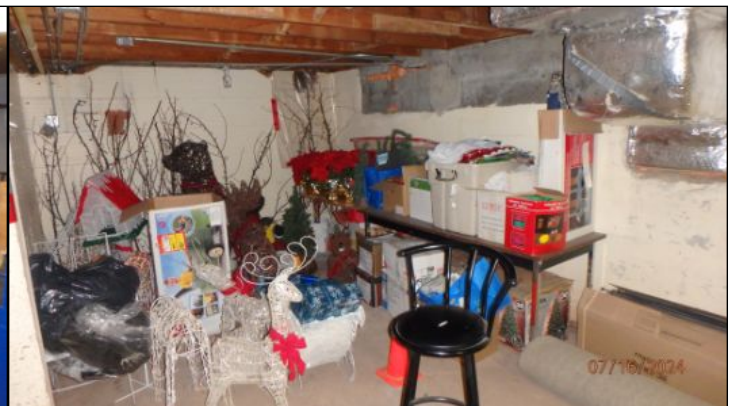
Basement storage area in good condition at time of inspection

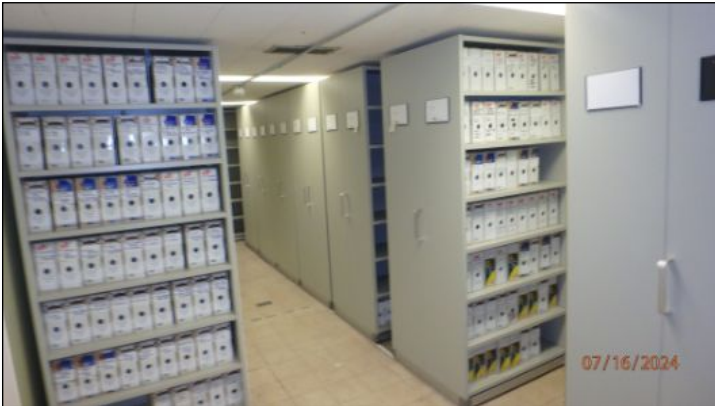
Basement storage area in good condition at time of inspection
